TVA Solar Commissioning Experience

September 28, 2022

Jonathan Sides, PE

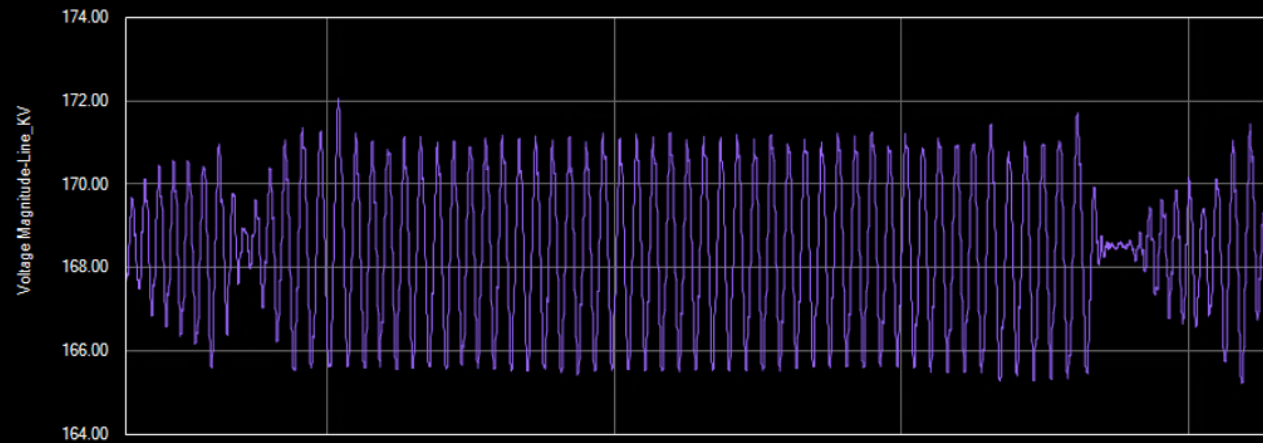
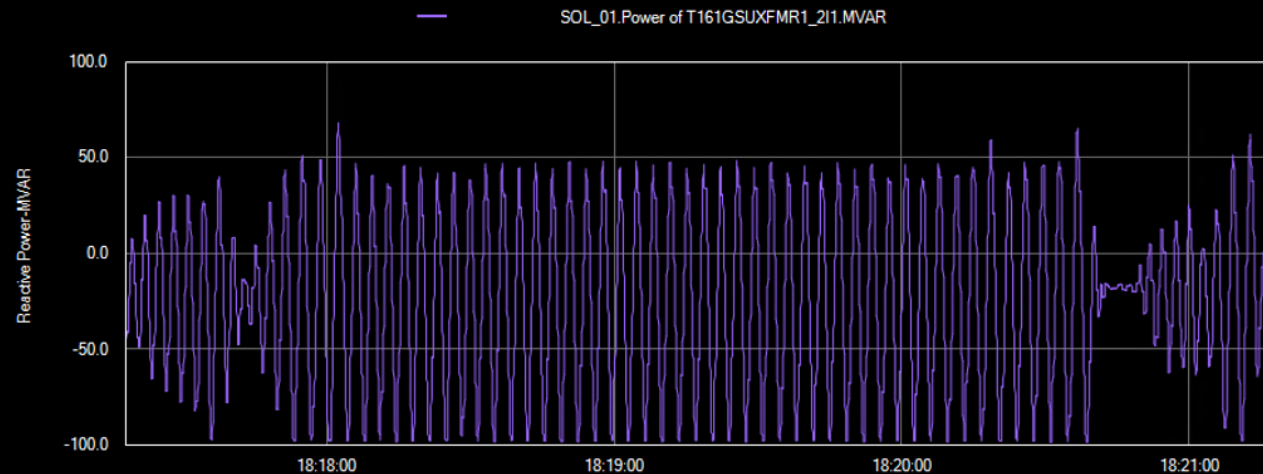
Plant 1

- PSCAD model for PPC did not match installed equipment.
- Numerous modeling parameters for inverter and PPC did not align with installed equipment. Signal time delays not incorporated.
- Performance issues were observed before testing began.
- Issues noted before testing:
 - Reactive power oscillations
 - Real power oscillations (or pulsing)

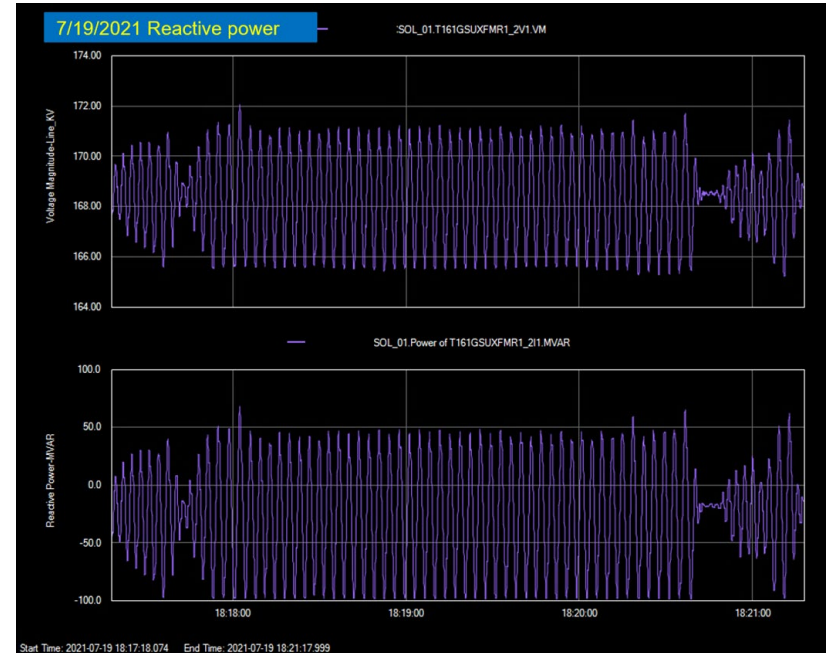
Plant 1 - Reactive Power Oscillations

- Caused by aggressive tuning to meet 2 second rise time requirement for voltage step test.
- Oscillations occurred during normal configuration (all ties closed)
- Weaker configurations, such as strong-source out, were not considered during plant tuning.
- Plant retuned voltage controller for 2 second rise time during weak condition with strong-source out. Note this resulted in a 20 second rise time for normal conditions.

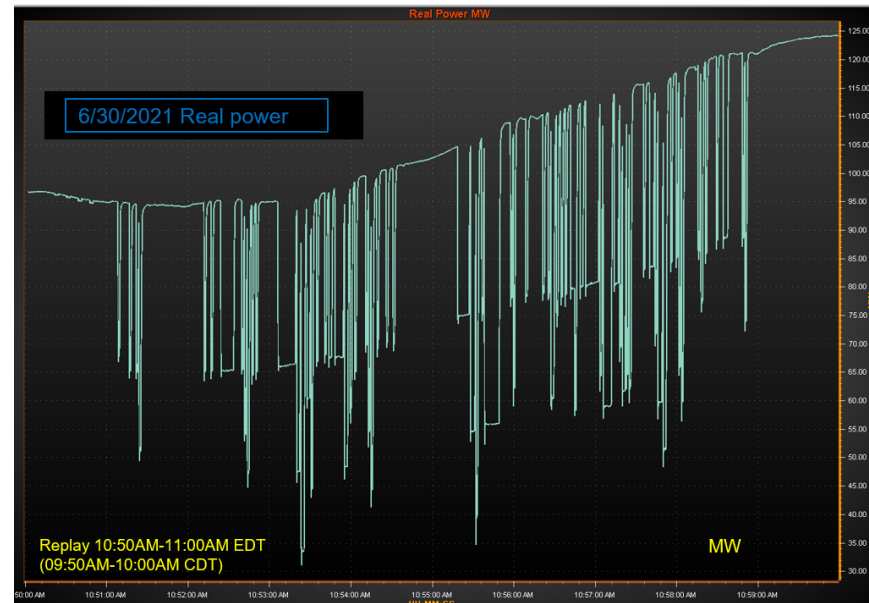
Plant 1 - Real Power Oscillations

- Caused by algorithm used to account for unconnected inverters for primary frequency response.
- Problem would occur when system frequency would go above 60.036 Hz (upper deadband). When this happened, the plant controller would activate curtailment mode and assume that non-communicating inverters were at full output to prevent exceeding curtailment limits.
- Contributing to the problem was a cut fiber line to inverters.
- This issue occurred multiple times and lasted for extended durations (10+ minutes)
- Could have been a major impact to local chemical plant if strong source had been out of service during event.
- A solution was worked out to ramp inverters down to zero for loss of communications and temporarily disable PFR during the ramp down.

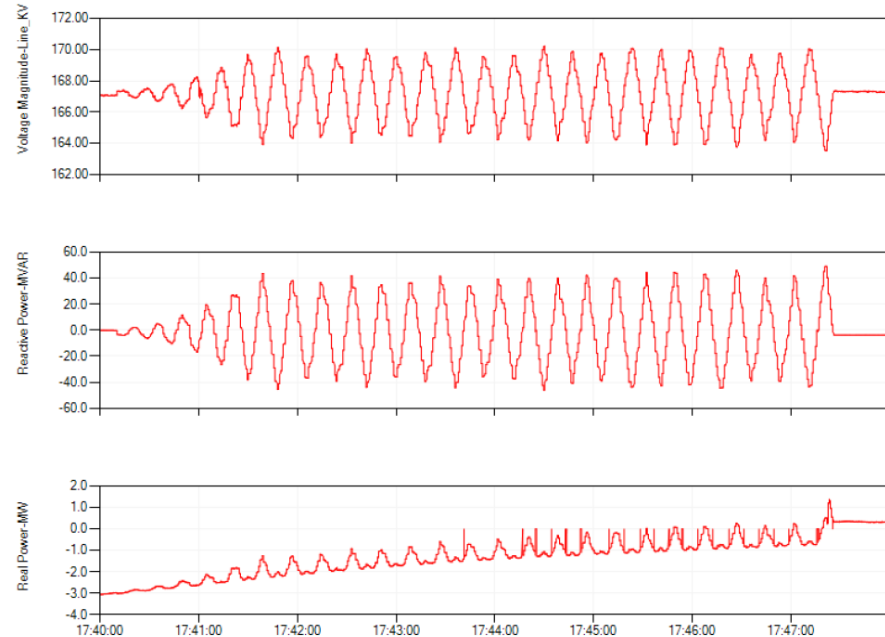
Plant 2 - Reactive Power Oscillations (March 2022)

- Occurred during evening when solar output winding down (3 MW)
- Occurred three days in a row during burn-in period
- Problem addressed by greatly restricting the reactive power ramp rate for low power outputs

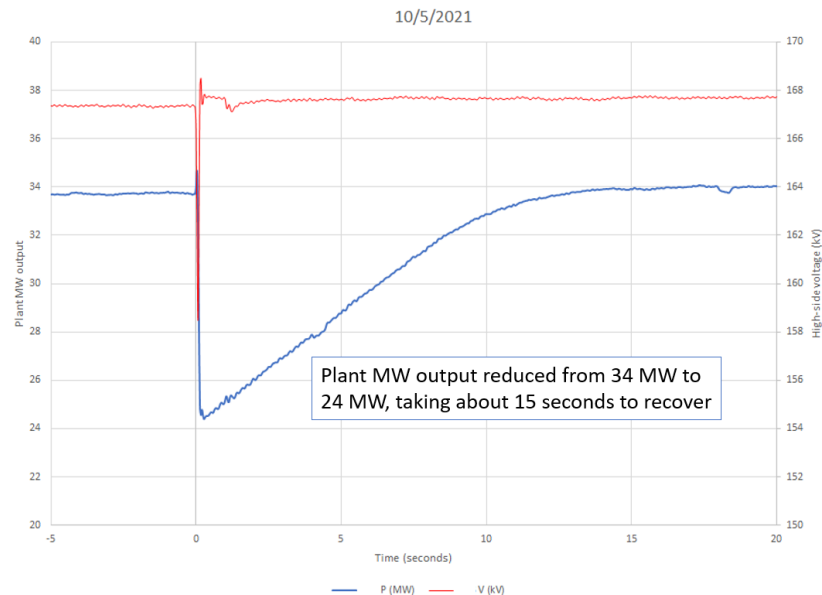
Plant 1 Output Reduction and Delayed Recovery for Nearby Ground Fault

- A normally cleared phase-to-ground fault occurred on the 161kV system about 40 miles from POI
- Plant 1 was operating at about 15% output and reduced power from 34 MW to 24 MW and took about 15 seconds to recover
- POI voltage did not fall below LVRT threshold and plant did not report entering LVRT
- PSCAD model shows near immediate recovery
- Working with GO and OEM to address both plant performance and modeling issues

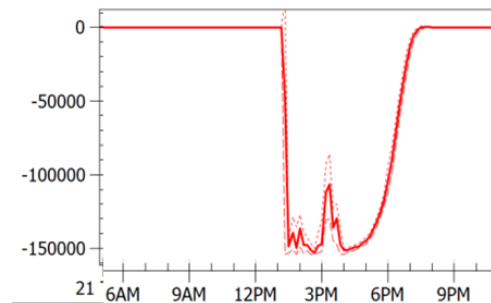
Plant 2 Reactive Power Oscillations (Apr 2022)

- Primary Frequency Response (PFR) was enabled during plant startup as frequency was below lower deadband 59.964
- PFR is set to disable ramp rate and latches for 4 seconds.
- After 4 seconds, there is a pause until frequency goes below deadband again.
- Still being investigated, but it appears the high ramp rate may have triggered a reactive power oscillation.

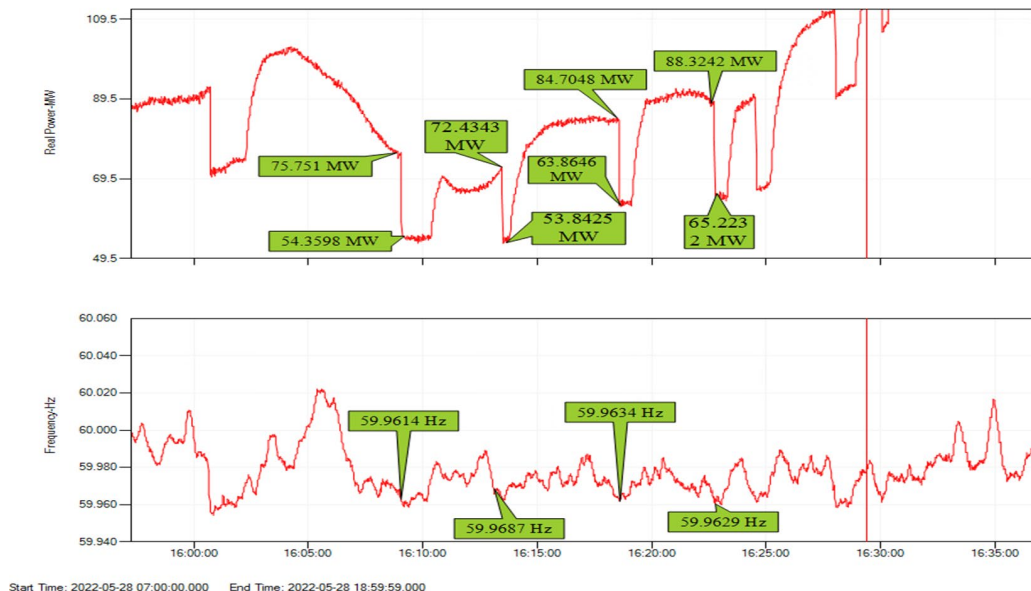
Plant 2 Primary Frequency Response Issues (May 2022)

- Problem: It appears there is potentially an issue with the way the inverter controls respond when it measures a system frequency below 59.964Hz. The drops should be an increase in real power and only be a fraction of a MW, but the plant is reducing power in the 20-25MW range.
- Solution: GO reprogrammed PFR controller. TVA has not retested new controls.

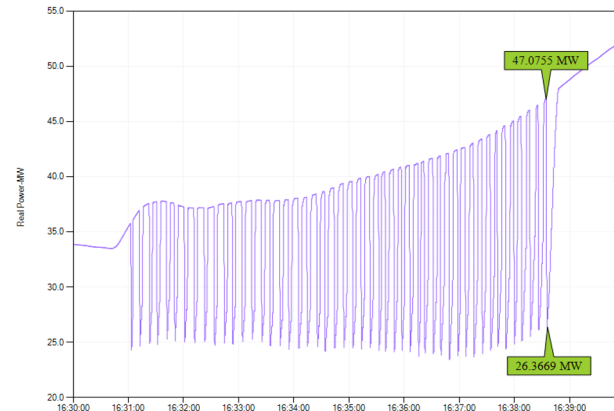
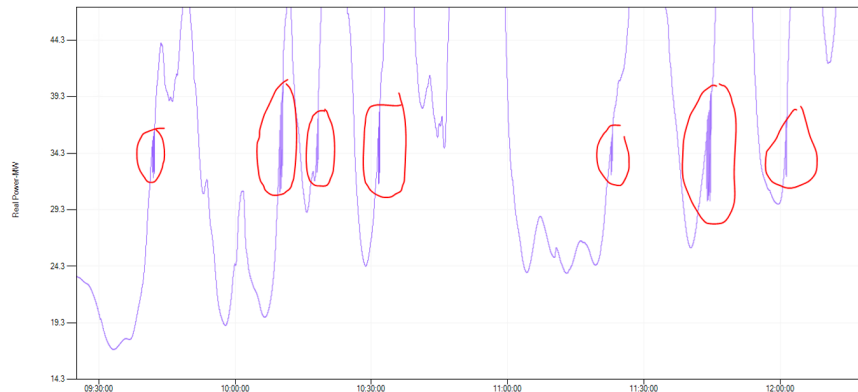
Plant 0 Real Power Oscillations

- Plant 0 is a 75 MW solar plant that has been operating for several years
- Operational data has shown frequent 20 MW power swings occurring for a duration of about 10 seconds
- Appears to occur while plant is ramping up and crossing the 50% power threshold
- Unknown how long this condition has been present as it is just beneath our threshold for alarming.
- GO is presently looking into this issue.
