American Transmission Company Lessons from the field

NASPI Work Group Meeting October 12-13, 2011

Concerns related to down-sampling of data for SE input

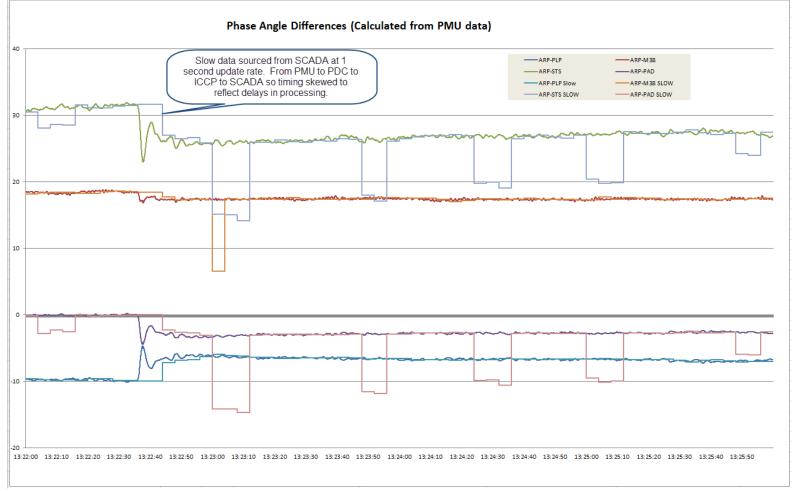
We compared angle data scanned directly from our PDC to that being fed via ICCP to our SCADA system. The plot below shows calculated angle differences between sites using the SCADA data and the difference using the PMU data.

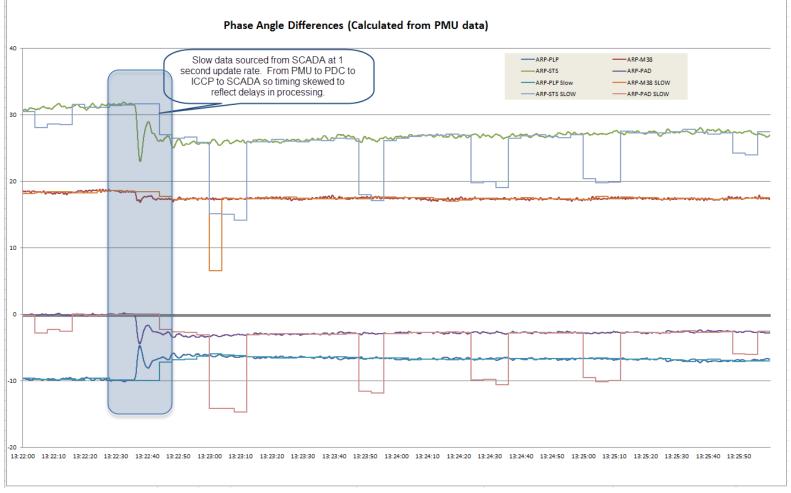
When the event occurs at the left of the screen it takes several seconds for the SCADA data to respond. If we had happened to try solving a state estimator case at that time our angle data could have been time skewed causing solution issues.

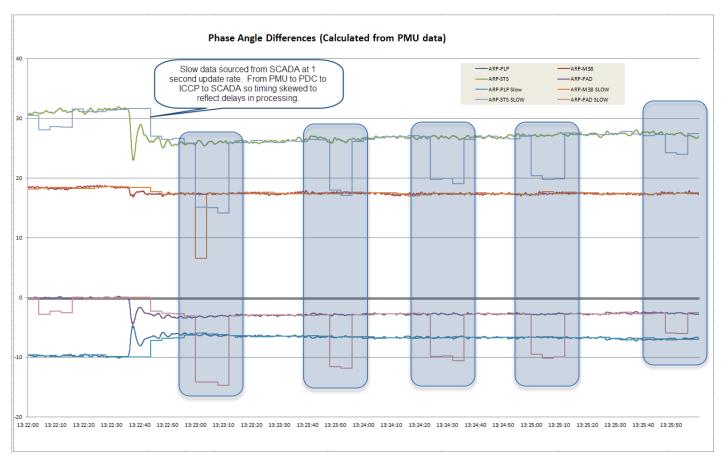
• The other odd blips in the SCADA data calculations appear to relate to synchronization issues when down-sampling the data at the PDC level. This is concerning as the assumption to date had been that this would not be an issue once we got the data into the PDC at a central site.
