Debugging PDC to PDC data flows

Oncor Electric Delivery

NASPI Working Group Meeting

June 8-9, 2011

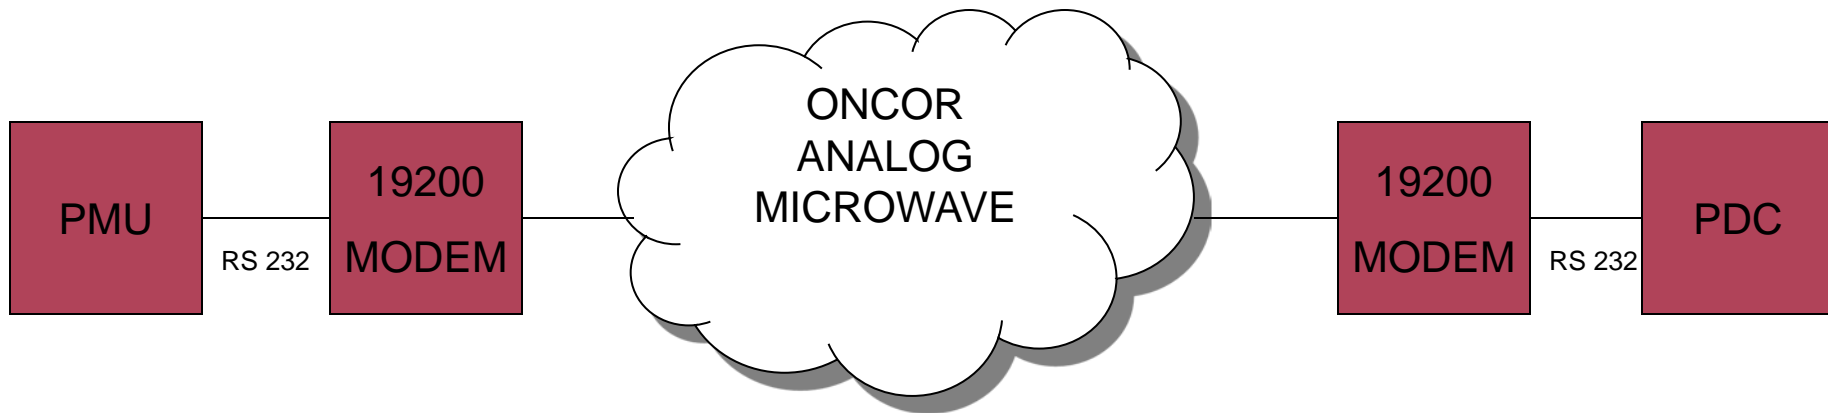
Communication Difference Between Oncor's PMU locations

- Two PMU Locations

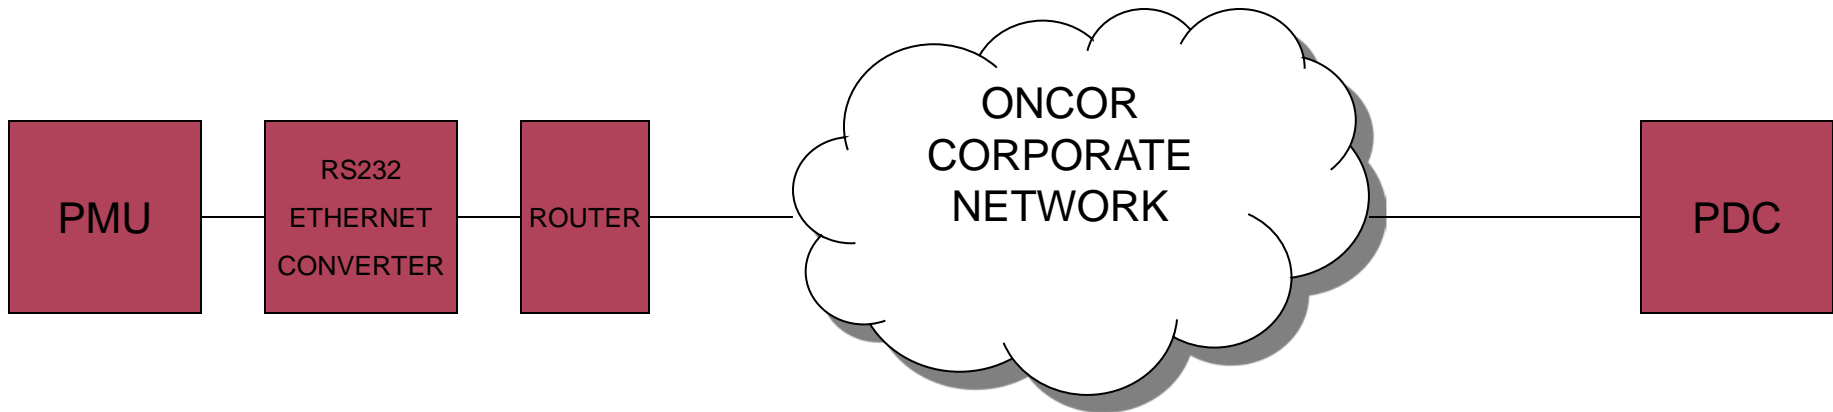
Communication Difference Between Oncor's PMU locations

- Three PMU Locations

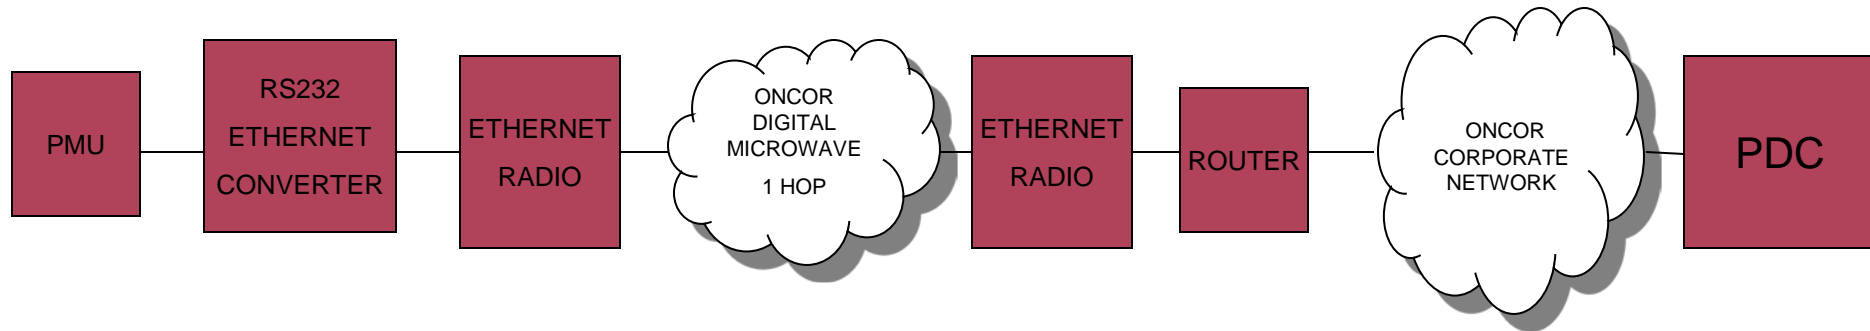
Communication Difference Between Oncor's PMU locations

- Two PMU Locations

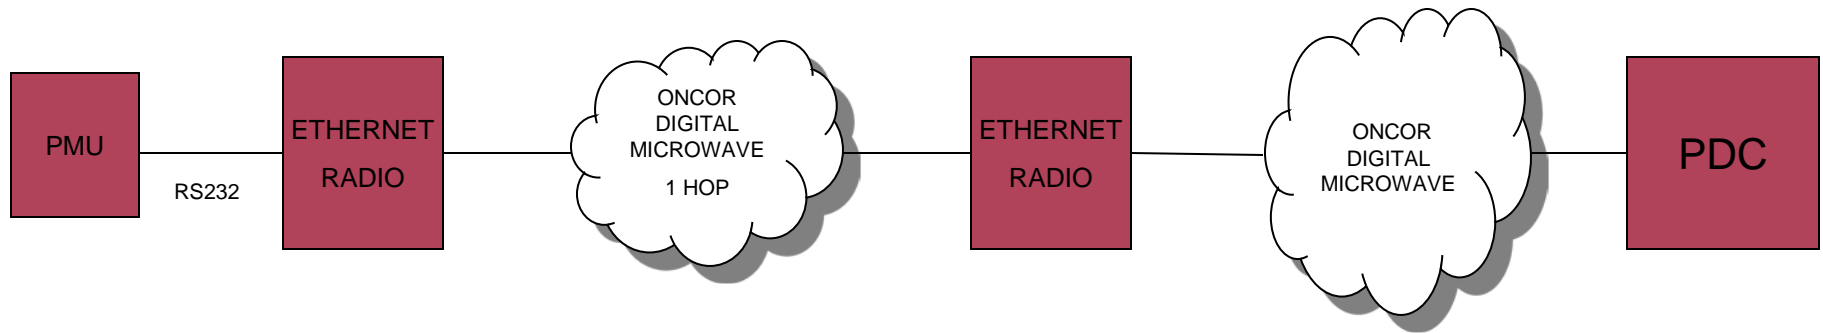
Communication Difference Between Oncor's PMU locations

- Two PMU Locations

- 2-28-2011 – It was determined two PMU locations data were being buffered by the microwave radio at each site and this was causing data from these two sites to be dropped (instead of streaming the data packet by packet, the radio waits until it has 12-14 packets before sending the data). This buffering of data was having an affect on the timing of the data being sent to ERCOT. We began working with our IT people to find a solution to the buffering of data.
- 3-9-2011, SEL released a new version of PDC software that supports data that comes in bursts caused by buffering and this solved the missing data problem with ERCOT. We will continue to work with our IT department to solve the buffering of data by the radios, as this increases the latency from the PMU to the PDC. We may have to replace the radios.

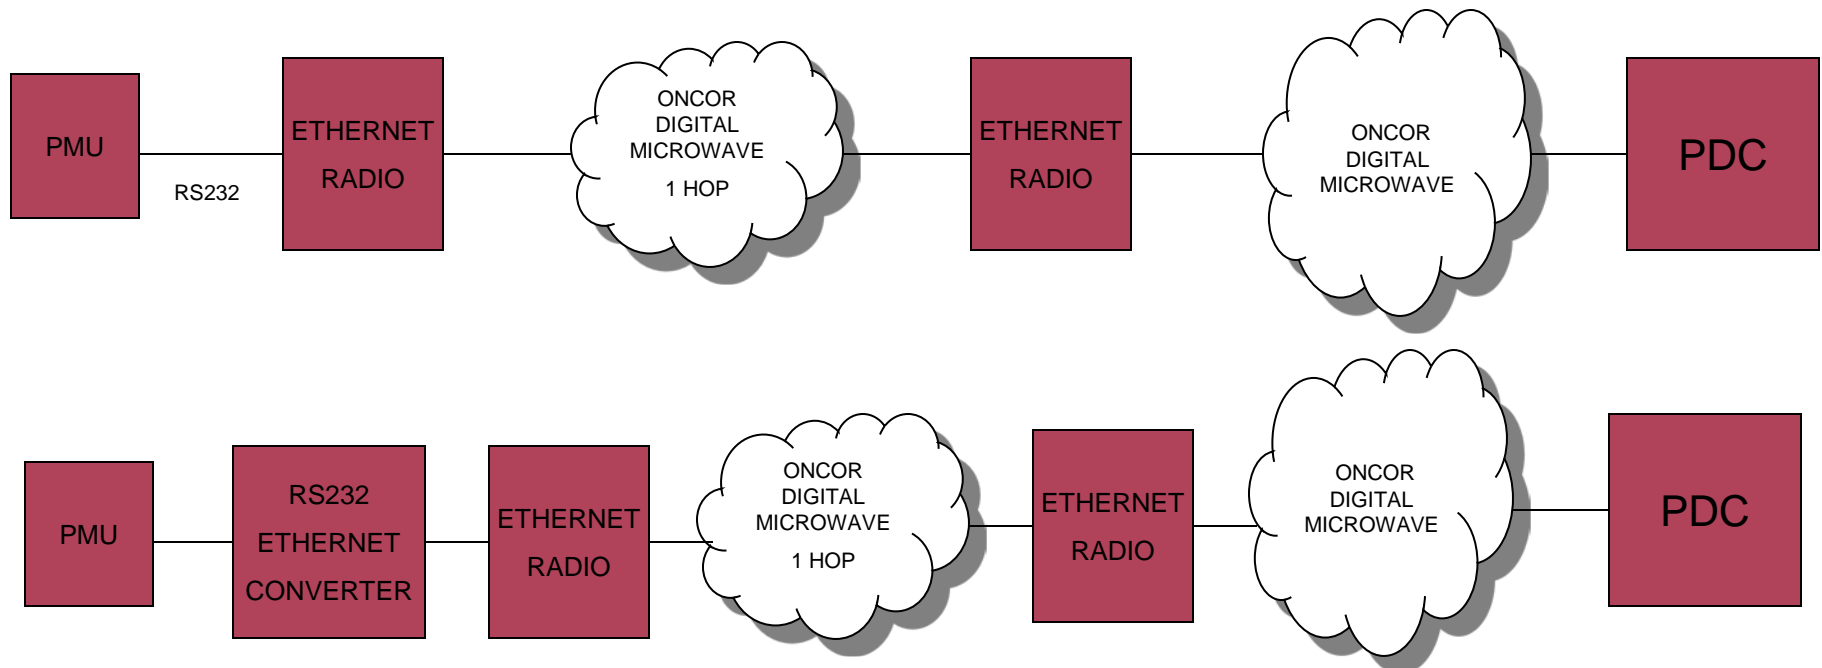
Resolving the Data buffering Issue

- 4-8-2011 - Determined that going serial from the PMU to the radio was causing the buffering of data. Added a serial to Ethernet converter on the output of the PMU and connected to the radio Ethernet and this stopped the buffering problem.
