2016 Leap Second Experiences

NASPI Work Group Meeting
March 23, 2017
PNNL-SA-124681

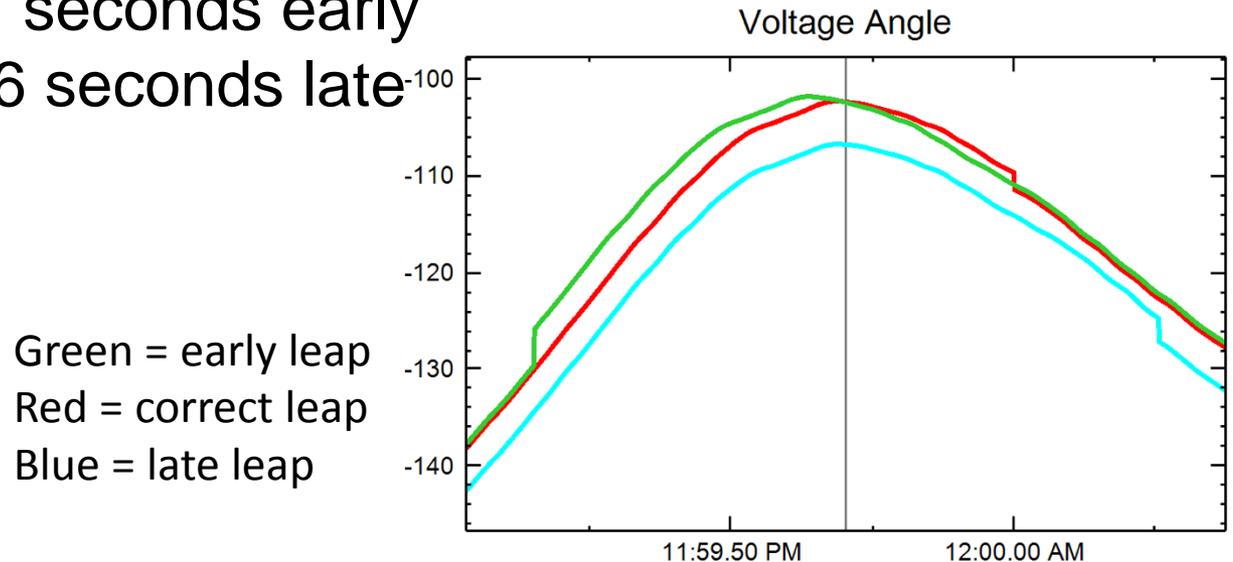
OG&E

- 82% of PMUs leapt correctly
- Discovered 8 GPS clocks with old firmware, that leapt 1 week early
- Discovered 2 PMU models that need firmware updates
 - 1 leapt 17 seconds early
 - 1 leapt 5-6 seconds late
