# NERC

## NERC White Paper: Recommended Disturbance Monitoring for IBR

Tim Fritch  
SMWG

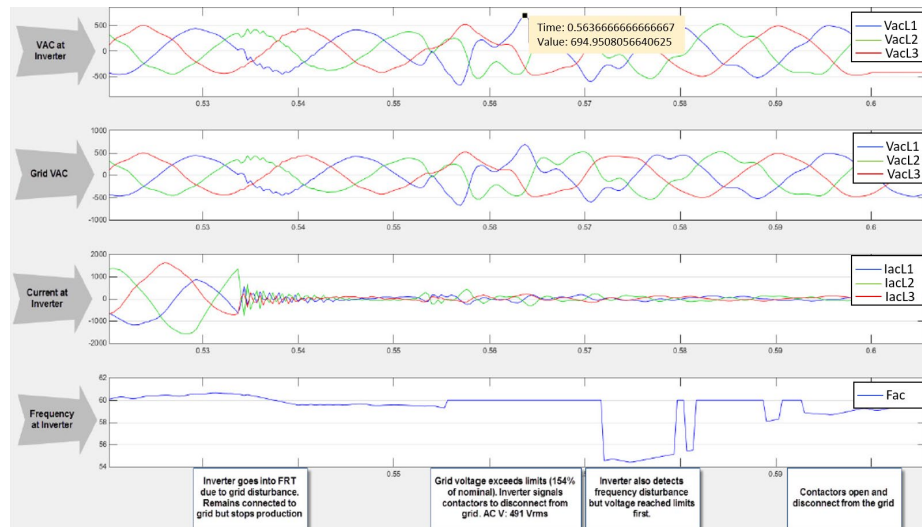
- Data from one of the generator inverter
  - The inverter tripped on transient overvoltage (not detected at the point of interconnection)
  - The inverter also reported a frequency of around 54.5 Hz caused by the distorted waveform during and immediately after the fault event.
- [https://www.nerc.com/pa/rrm/ea/1200 MW Fault Induced Solar Photovoltaic Resource /1200 MW Fault In duced Solar Photovoltaic Resource Interruption Final.pdf](https://www.nerc.com/pa/rrm/ea/1200%20MW%20Fault%20Induced%20Solar%20Photovoltaic%20Resource%20Interruption%20Final.pdf)

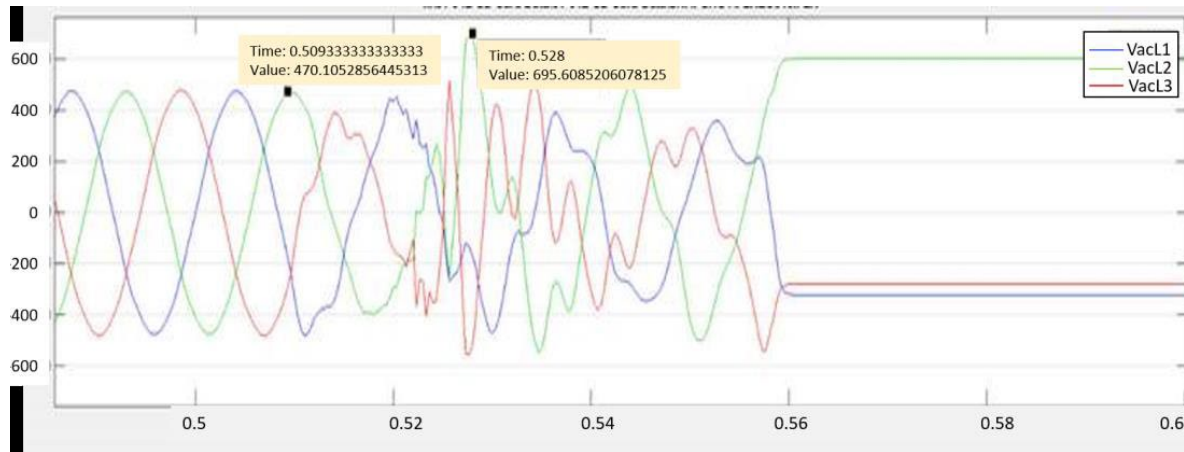
- Multiple plants reported inverter tripping
- Transient overvoltage that occurred during the on-fault conditions that resulted in inverter tripping.

- DFR data at the POI showed voltage below nominal at the POI (within the PRC-024-2 voltage protection ride-through curve).
- Without the inverter-level oscillography data to analyze, the POI data with (unsynchronized) SERs of tripping provided little information to deduce exactly why the inverters were tripping.
- <https://www.nerc.com/pa/rrm/ea/October%209%202017%20Canyon%202%20Fire%20Disturbance%20Report/900%20MW%20Solar%20Photovoltaic%20Resource%20Interruption%20Disturbance%20Report.pdf>
