## PMU versus SCADA Video Events Summary

### March 2014 NASPI Control Room Solutions Task team Meeting

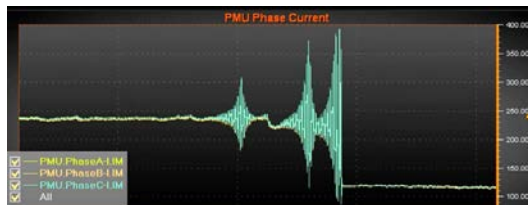
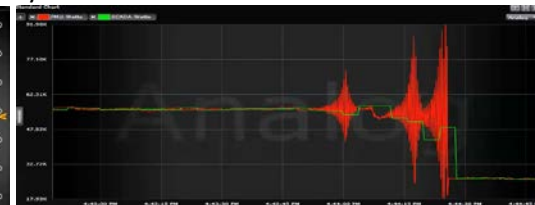
- Event 1: [Video files RTDMS P MU vs SCADA naspi1.wmv](#)

*We had an issue on our 138 Kv system associated with new controls were being tested on a 65 MW max rated gas turbine. When enabled the controls caused the unit output to swing rapidly for approximately 30 seconds and also caused small scale voltage oscillations on the system. Eventually the unit was taken offline and the problems ceased. The event data in the replay is the line current and bus voltage as recorded by a PMU at the substation monitoring one of the two 138 Kv lines leaving the substation and an RTU at the same substation scanned every 4 seconds.*

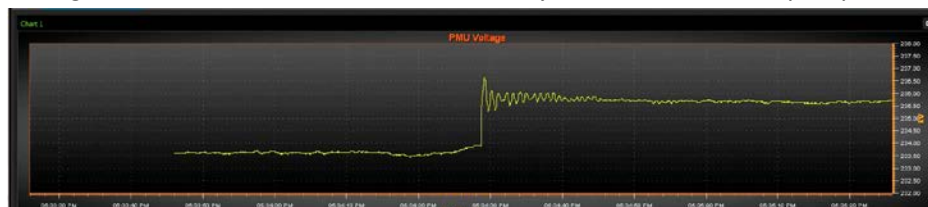
- Event 2: [Video file RTDMS PMU vs SCADA naspi2.wmv](#)

*Voltage oscillations observed on the 230 kV system when a water pump was taken offline.*

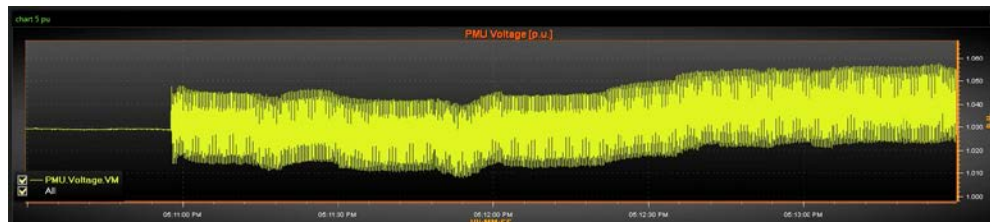
- Event 3: [Video files RTDMS PMU vs SCADA naspi3.wmv](#)

*These oscillations were found to be occurring during periods of high wind generation, above 80% of the nameplate capacity. The voltage oscillations observed were as high as 5% fluctuation at an oscillatory frequency of around 14Hz. In this example, the oscillations began abruptly when a*

345kV line was switched out of service. The oscillations continued for almost 30 minutes until the wind plants were able to be curtailed enough to stop the oscillations. The wind plants had to be curtailed to 45% of nameplate for the oscillations to cease.

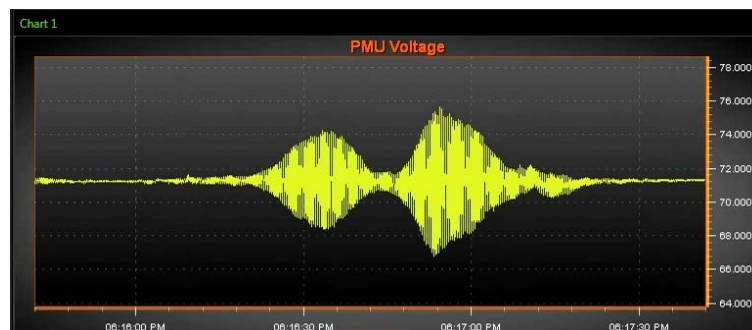
➤ Event 4: [Video file RTDMS PMU vs SCADA naspi4.wmv](#)

Similar to event 3 this event also involves a wind plant. It is 60MW plant looped in on a pretty weak 69kV line. On the date of the event the stronger source was switched out for maintenance, which put the plant into an unstable state. Plant output prior to the switching was 73% of nameplate and it immediately dropped to 48% with some significant ringing. It stabilized for about 5 minutes, and then started oscillating at 3Hz when the MW output began to rise. We were immediately notified with our FFT oscillation detection program. The magnitude of the voltage fluctuation at its peak is about 12%.

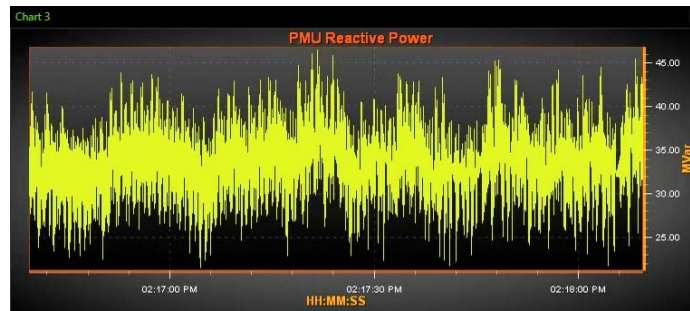
➤ Event 5: [Video file RTDMS PMU vs SCADA naspi5.wmv](#)

During analysis of a system event in 2011, technical staff observed high frequency oscillations at multiple locations across the system, and correlated the oscillations with high amounts of wind generation. However, because there was no visibility of wind generation at the time, we were unable to determine whether the oscillation was due to a specific wind power plant, or a general phenomenon. Recently, PMUs have been installed at wind sites, providing visibility of 13-15 Hz oscillations occurring at specific locations – the data provided is an instance of high wind output from one of these locations.

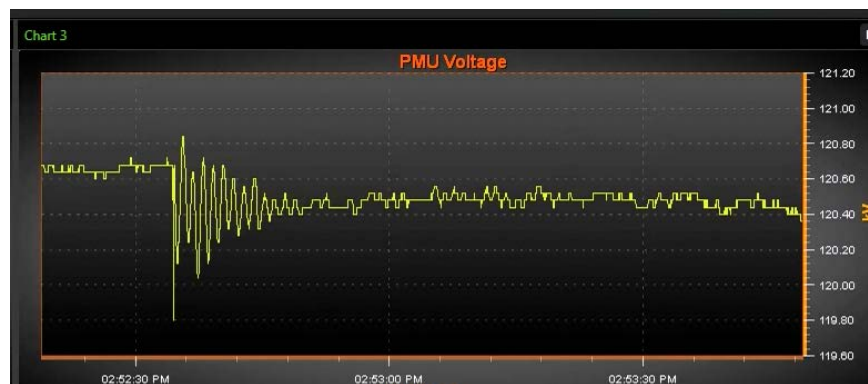
- Event 6: [Video file RTDMS PMU vs SCADA naspi6.wmv](#)

*A large unit trip via relaying in the West caused system frequency to drop to 59.873 Hz momentarily and returned to normal in seven minutes. Post trip oscillations in voltage and power flow were observed on data from an area PMU.*

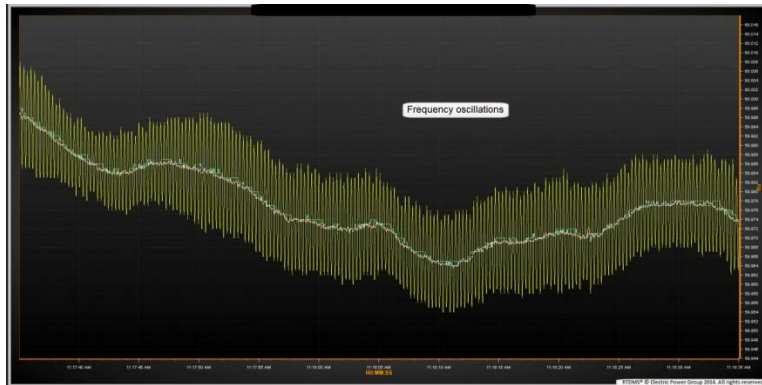
- Event 7: [Wind Farm Oscillation Detection and Mitigation](#)

*The operators at the ISO control center observed oscillations on the Electric Power Group (EPG)'s Real Time Dynamics Monitoring System (RTDMS) oscillation monitor. The oscillations were traced to a PMU located at the wind farm. The oscillation frequency was 3.3 Hz and damping was less than 1%. The ISO operators tried to reduce the oscillations by reducing the wind farm output from 56 MW to lower outputs in steps. At wind farm output of 40 MW, the oscillations stopped. The ISO operators contacted the wind farm operators to determine the cause of oscillations. The wind farm operators in turn contacted the manufacturer, who confirmed that changes were made remotely to wind farm controller settings. These changes were concurrent with the time oscillations started. The manufacturer then reverted to initial controller settings. Subsequently, no oscillations were observed even when the wind farm was ramped up to higher power outputs. This video demonstrates the benefit of Synchrophasor Technology in identifying and mitigating the oscillations in the system.*

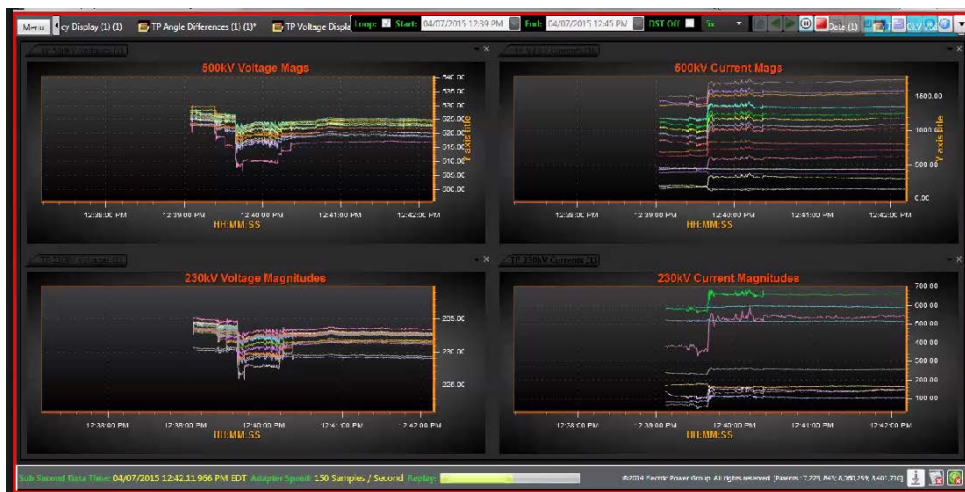
- Event 8: [Clip 1 \(230kV and 500kV Voltages and flows\)](#), [Clip 2 \(Select Unit MW and Mvar output\)](#), and [Clip 3 \(System frequency and voltage angles\)](#)

*A 230kV fault followed by a loss of a large generation plant caused system frequency to drop approximately 72mHz momentarily, while having an impact on nearby system voltages and online generators.*

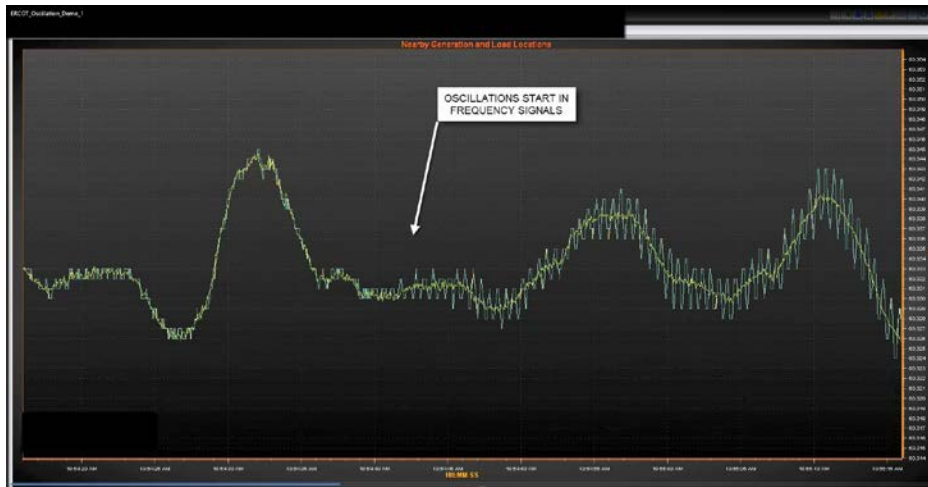
➤ Event 12 ([ERCOT Customer Oscillations](#))

An oscillation event on the ERCOT system displayed using RTDMS.

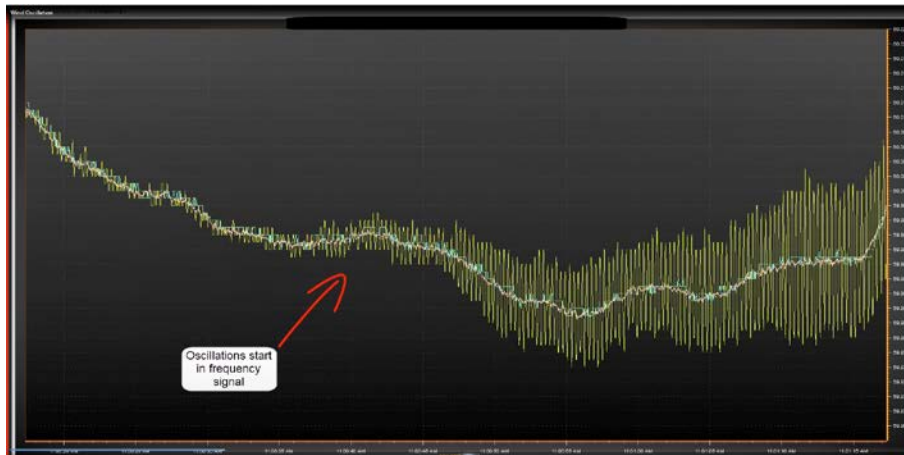
➤ Event 13 ([ERCOT Wind Farm Oscillations](#))

An oscillation event associated with a wind generation plant on the ERCOT system displayed using RTDMS.

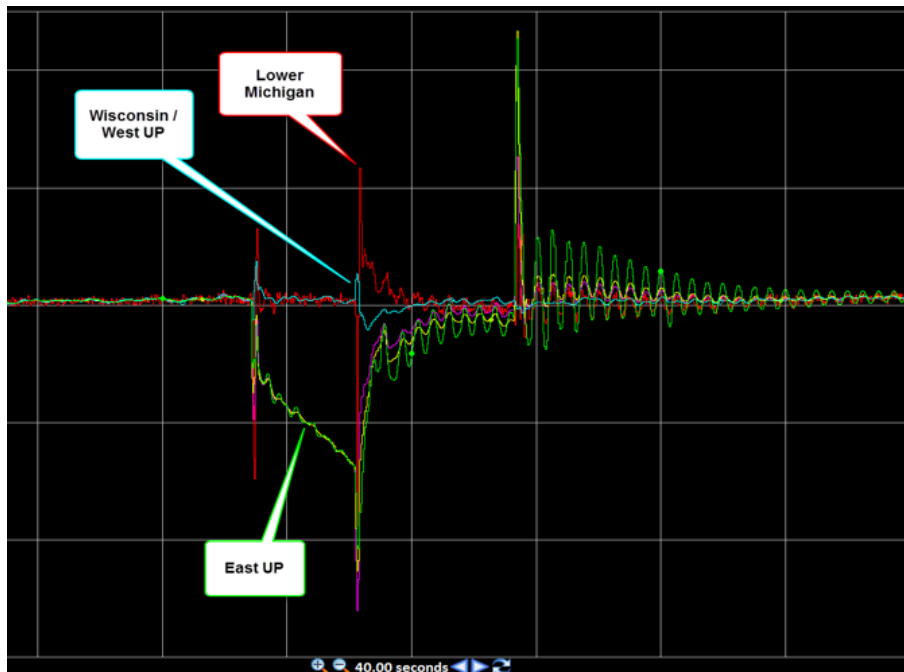
- Event 14 ([Frequency plot showing the opening and reclose of tie lines between the Eastern UP and the central UP of Michigan](#))

*A double circuit outage resulted in the eastern UP being isolated from the rest of the ATC footprint. The system was served via a back to back HVDC link and when it opened and reclosed significant oscillations in frequency were observed. The video compares the frequencies in the small isolated area, the main ATC interconnection, and lower Michigan. SCADA frequency traces (green and cyan traces) are also included which show little response to what was happening during the event.*

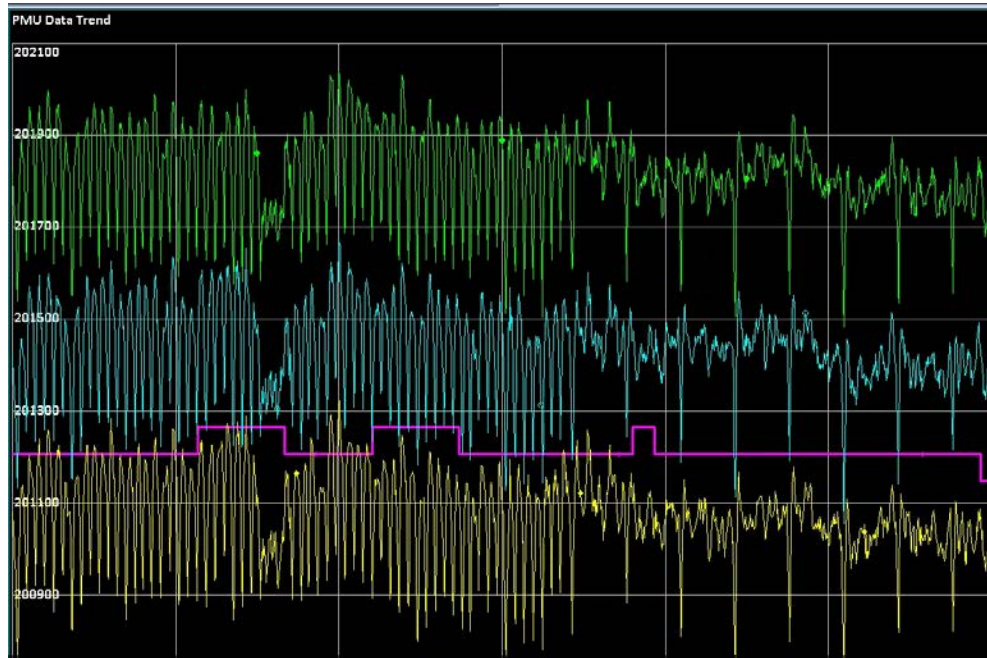
➤ Event 15 ([Observed voltage oscillations in southern Wisconsin not visible in SCADA](#))

*With the implementation of PMU monitoring in southern Wisconsin we started seeing odd oscillatory behavior in the voltage traces. The video shows the oscillations on a particular day where initially we saw the voltage oscillating at ~0.7 HZ with periodic notches in the voltage profile once every minute. It then transitioned to voltage dips that occurred once every 10-15 seconds. Despite the abundance of synchrophasor data available in the area we have yet to pinpoint the source of the oscillations.*
