NASPI TECHNICAL REPORT

**LEAP SECOND EFFECTS ON
SYNCHROPHASOR SYSTEMS --
RECENT LEAP SECOND EXPERIENCES**

**Alison Silverstein
NASPI Project Manager**

November 2016

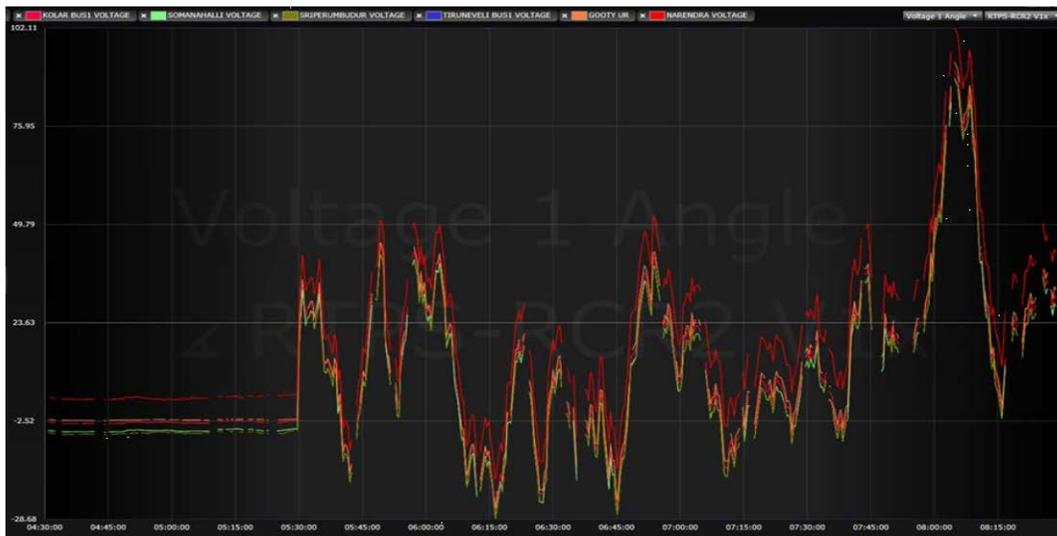
- Random changes in the trend of angular difference in some PMUs after 23h 29m on June 28, 2015 (i.e., these PMUs added the leap second two days in advance)

Utility A -- Random Jumps in Phase Angles Measured After 23:29, June 28, 2015

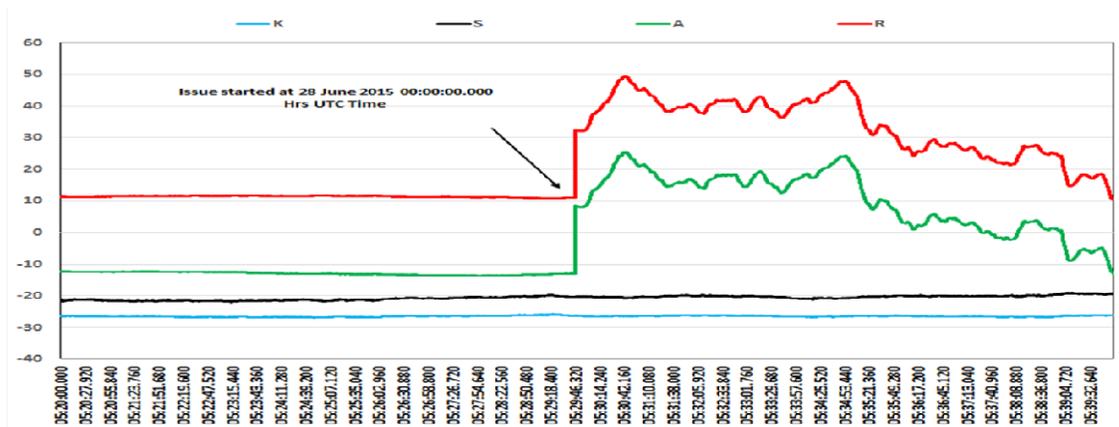
Utility A – Different PMUs behaving badly

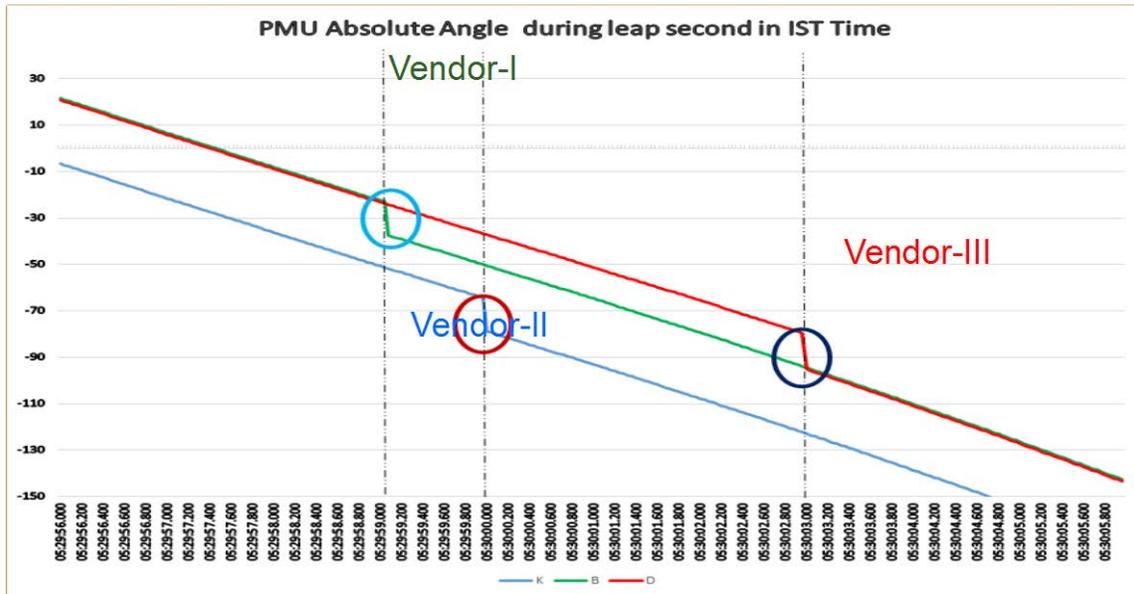
- Around midnight on June 30, 2015, a drift of 1 second in some PMUs relative to others. Specifically, within their PMU fleet they saw four types of responses to the leap second insertion (including one set of PMUs that added the leap second slightly off the top of the second):
 - Added leap second at 05:29:59 (India Standard Time)
 - Added leap second at 05:30:00 (IST)
 - Added leap second at 05:30:03 (IST)
 - No leap second was added.

Utility A – different GPS-PMU combinations handled the leap second differently

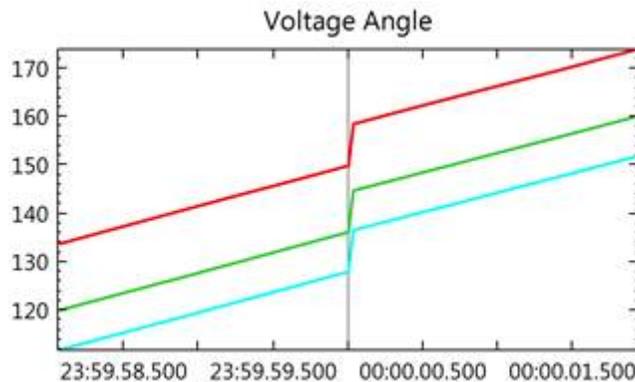
Utility E had a number of PMUs connected to clocks that didn't have the most up-to-date firmware.²⁴ These clocks issued the leap second occurrence on June 27 rather than June 30. The PMUs with updated clocks did issue the leap second correctly on June 30. However, two versions of PDC software did not seem "capable of storing the extra second. So the leap second really gets lost and what we saw when July 1, 2015 came around was a sudden 8.5 degree angle shift (Figure E-1)." Another vendor's clocks all leapt one second late (second screenshot), while a number of PMUs connected to GPS clocks with old firmware "kind of flopped back and forth at random for a second before stabilizing, taking a second leap (first one being on June 27), then correcting itself 6 seconds later."

Utility E – (1) sudden 8.5 degree phase angle shift

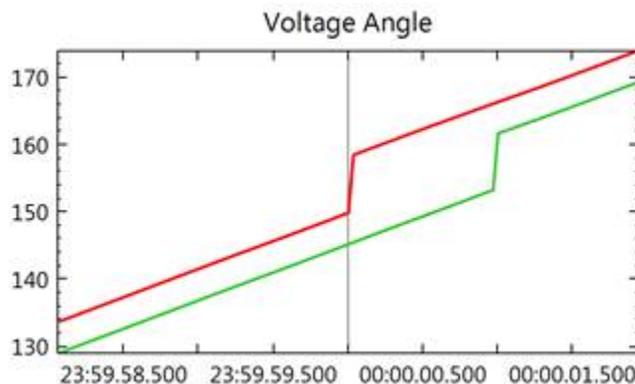
Utility E – (2) some clocks leapt one second late

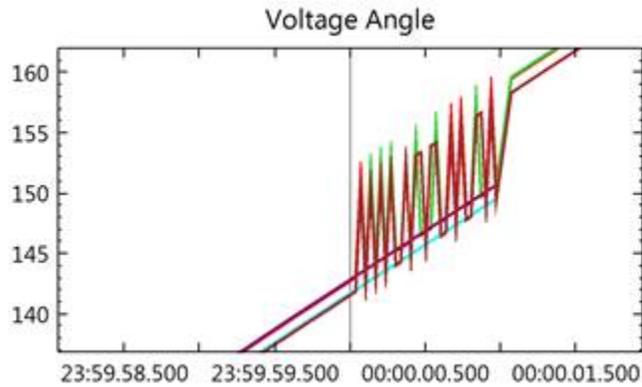
Utility E – (3) clock flopping for six seconds

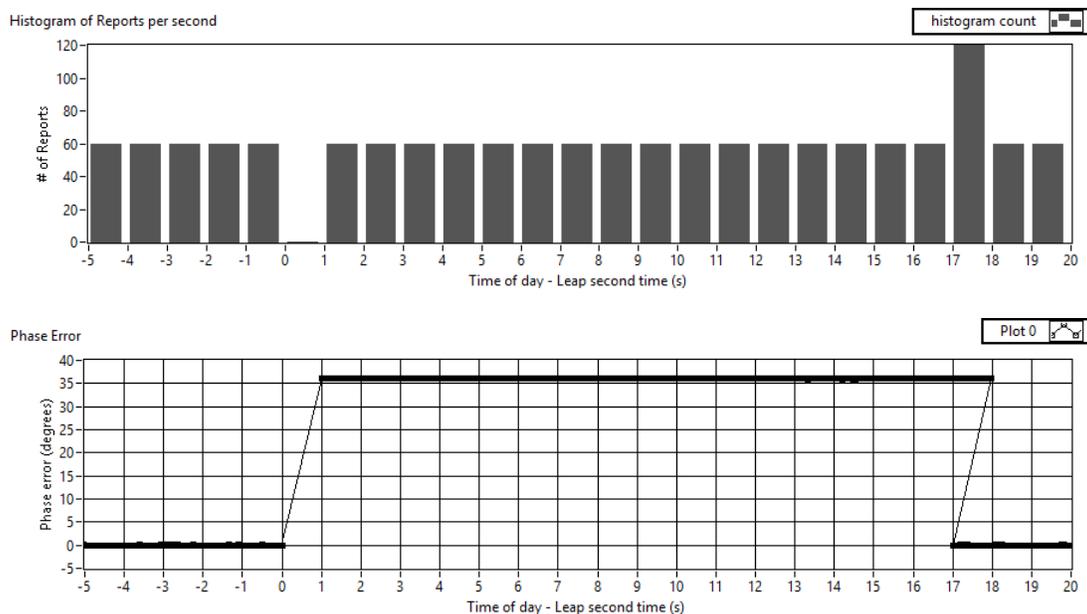
These differing responses caused several problems – missing data frames (as though the time never happened) or duplicated reports (data was reported that should have had a different time stamps); either one would cause incorrect phase angles, as illustrated below for one of the several PMUs that behaved similarly.

NIST PMU data frames and phase error associated with leap second³³
