Pacific Southwest Disturbance

September 8, 2011

NASPI Working Group Meeting – Denver, CO

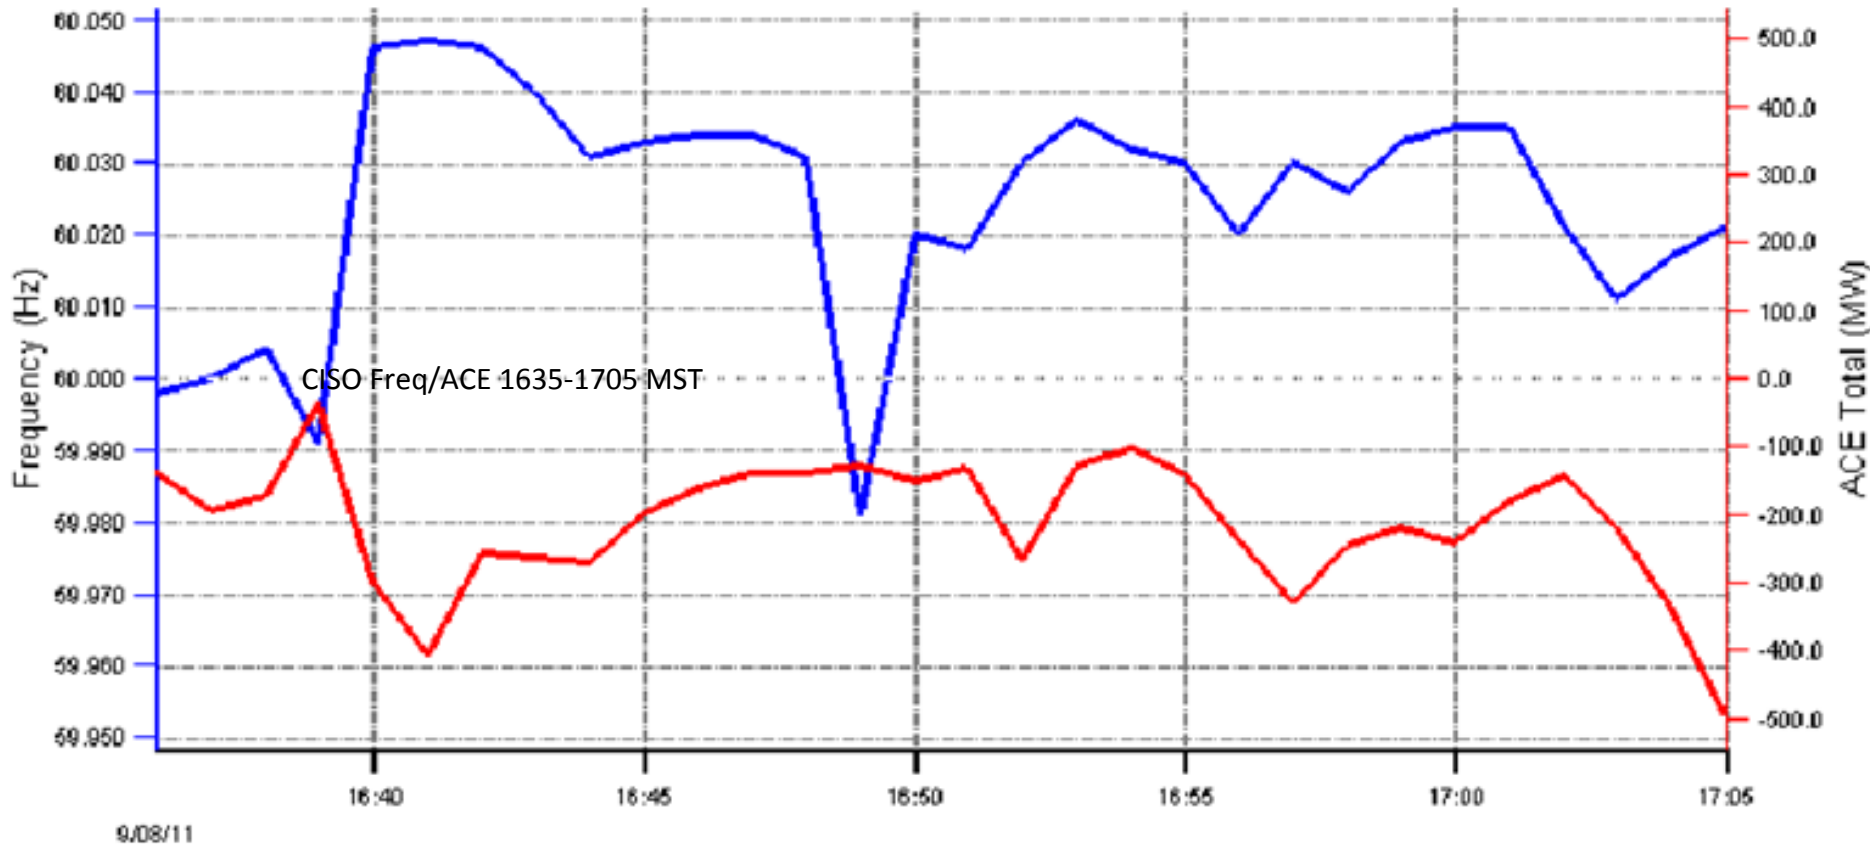
CAISO Freq/ACE 1635-1705 MST

From RA Tool

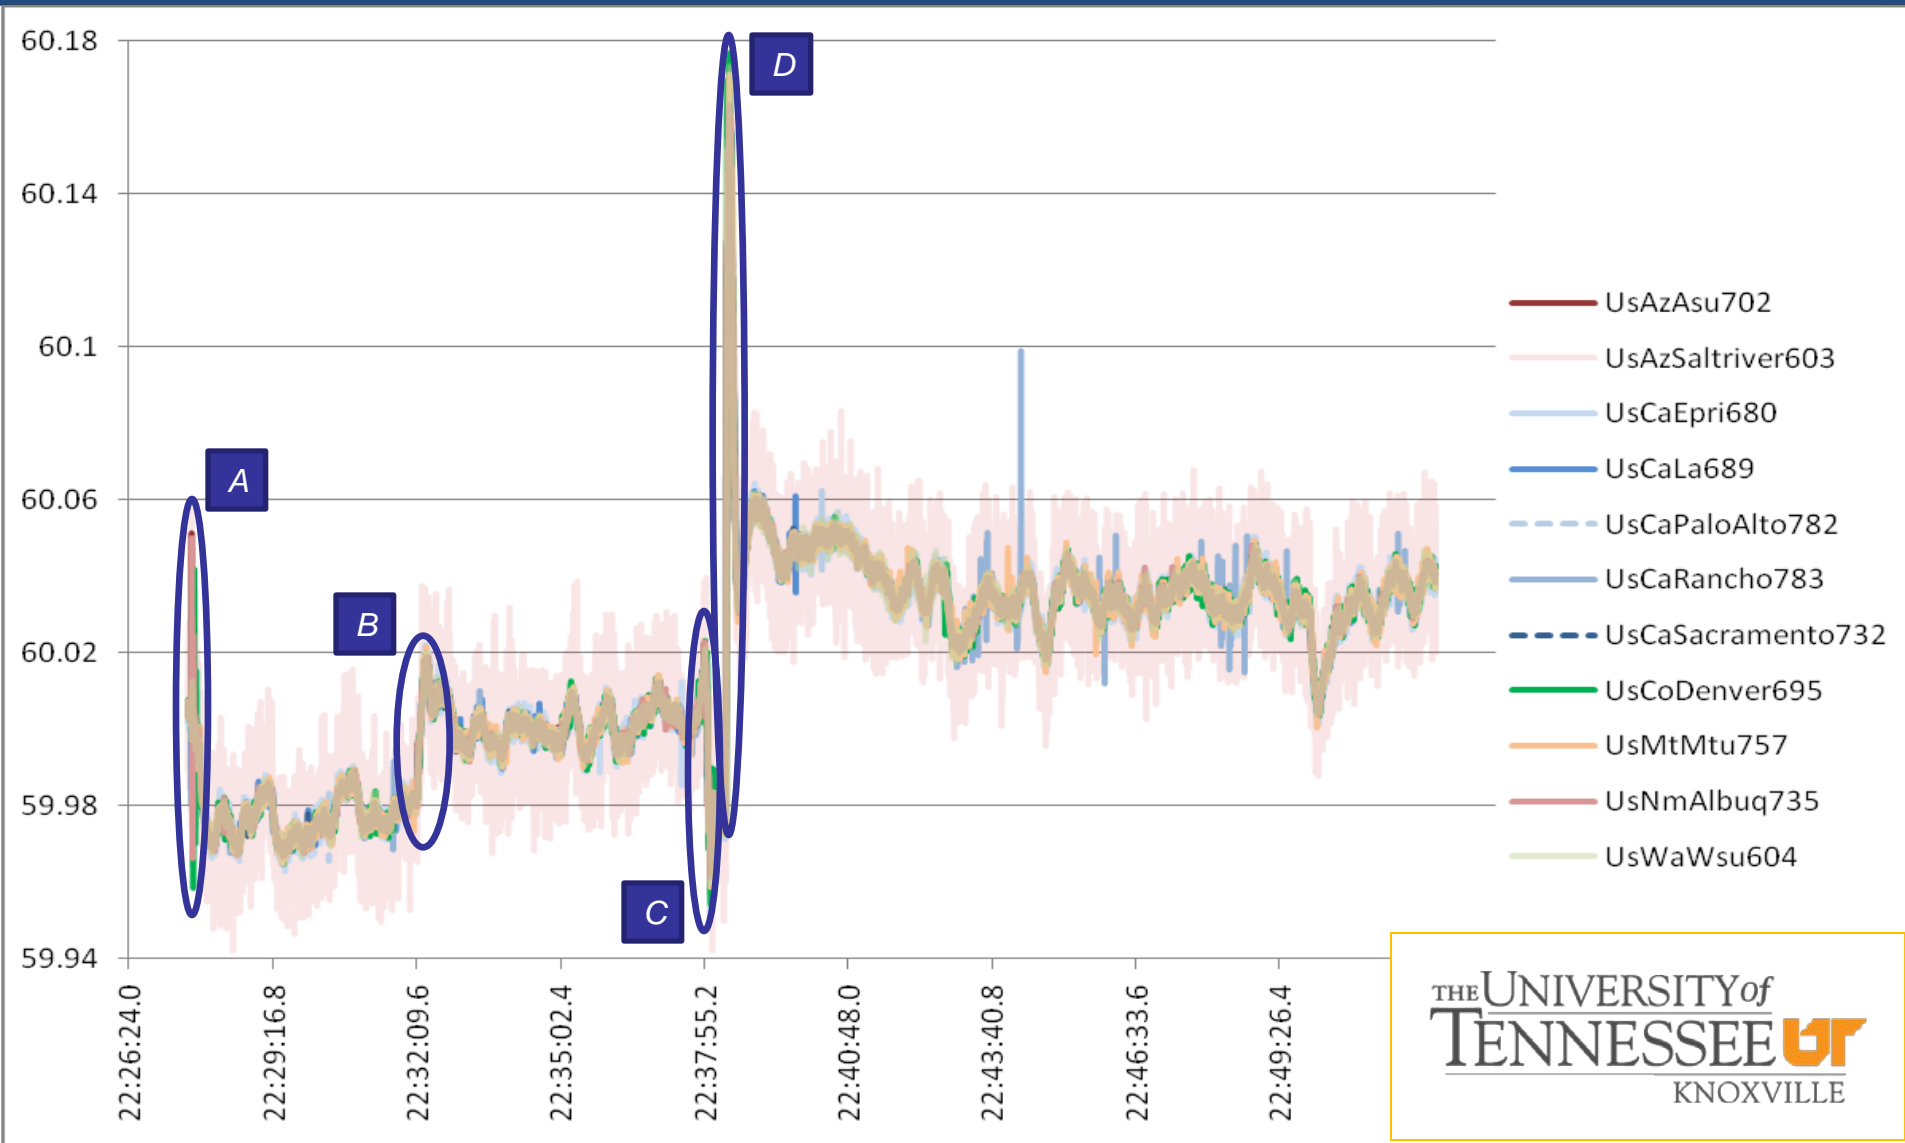
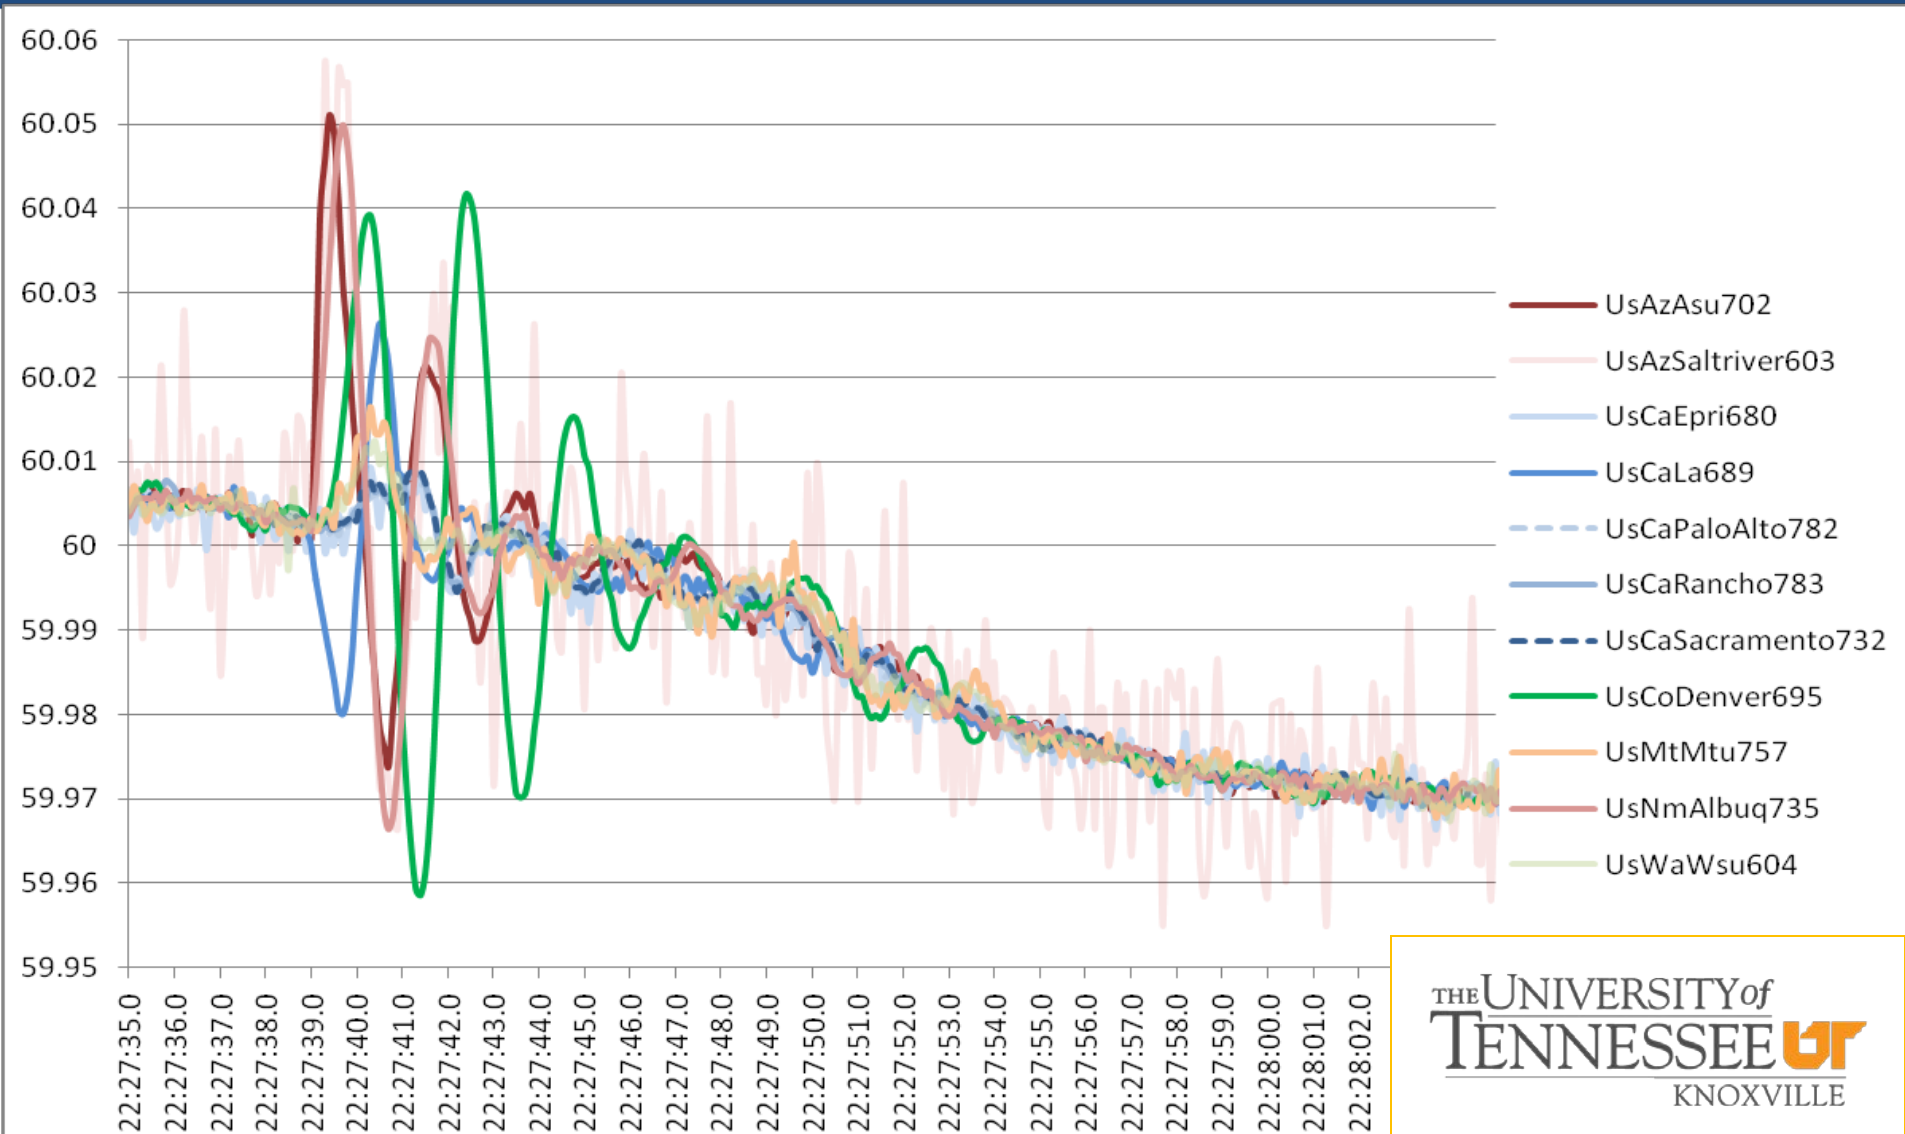
25 Minutes of Frequency

- The frequency shows four main events
 - A. The initial **separation** around **22:27:39 (UTC)**, with a 'slow' frequency dip of about -30 mHz over about 25 seconds
 - B. A frequency **ramp** beginning around **22:32:10** increasing frequency +30 mHz over about 15 seconds
 - C. A frequency **drop** around **22:37:55** of over -40 mHz (B-A) over about 12 seconds
 - D. A frequency **jump** around **22:38:21** of over +150 mHz (C-A) in less than 5 seconds, settling at around +80 mHz (B-A) in about 20 seconds

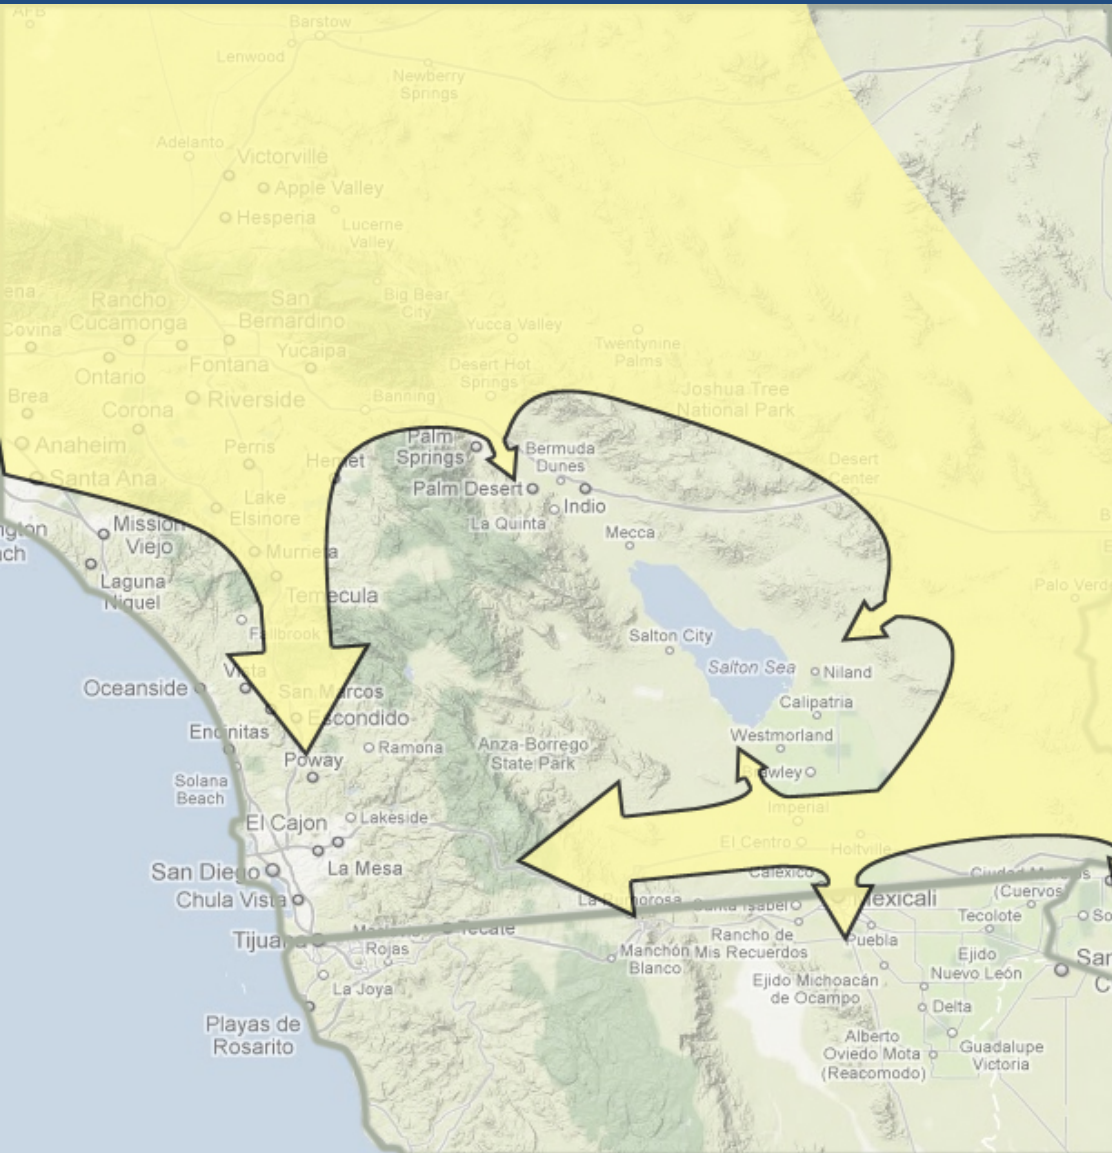
Phase 1 – Pre-Disturbance

- *Hot, shoulder season day; some generation and transmission outages*
- *High loading on some key facilities: H-NG at 78% of normal rating; CV transformers at 83%*
- *44 minutes before loss of H-NG, IID's RTCA results showed loss of CV-1 transformer would load CV-2 transformer above its relay trip point*
- *15:27:39: APS technician skipped a critical step in isolating the series capacitor bank at North Gila substation; H-NG trips*

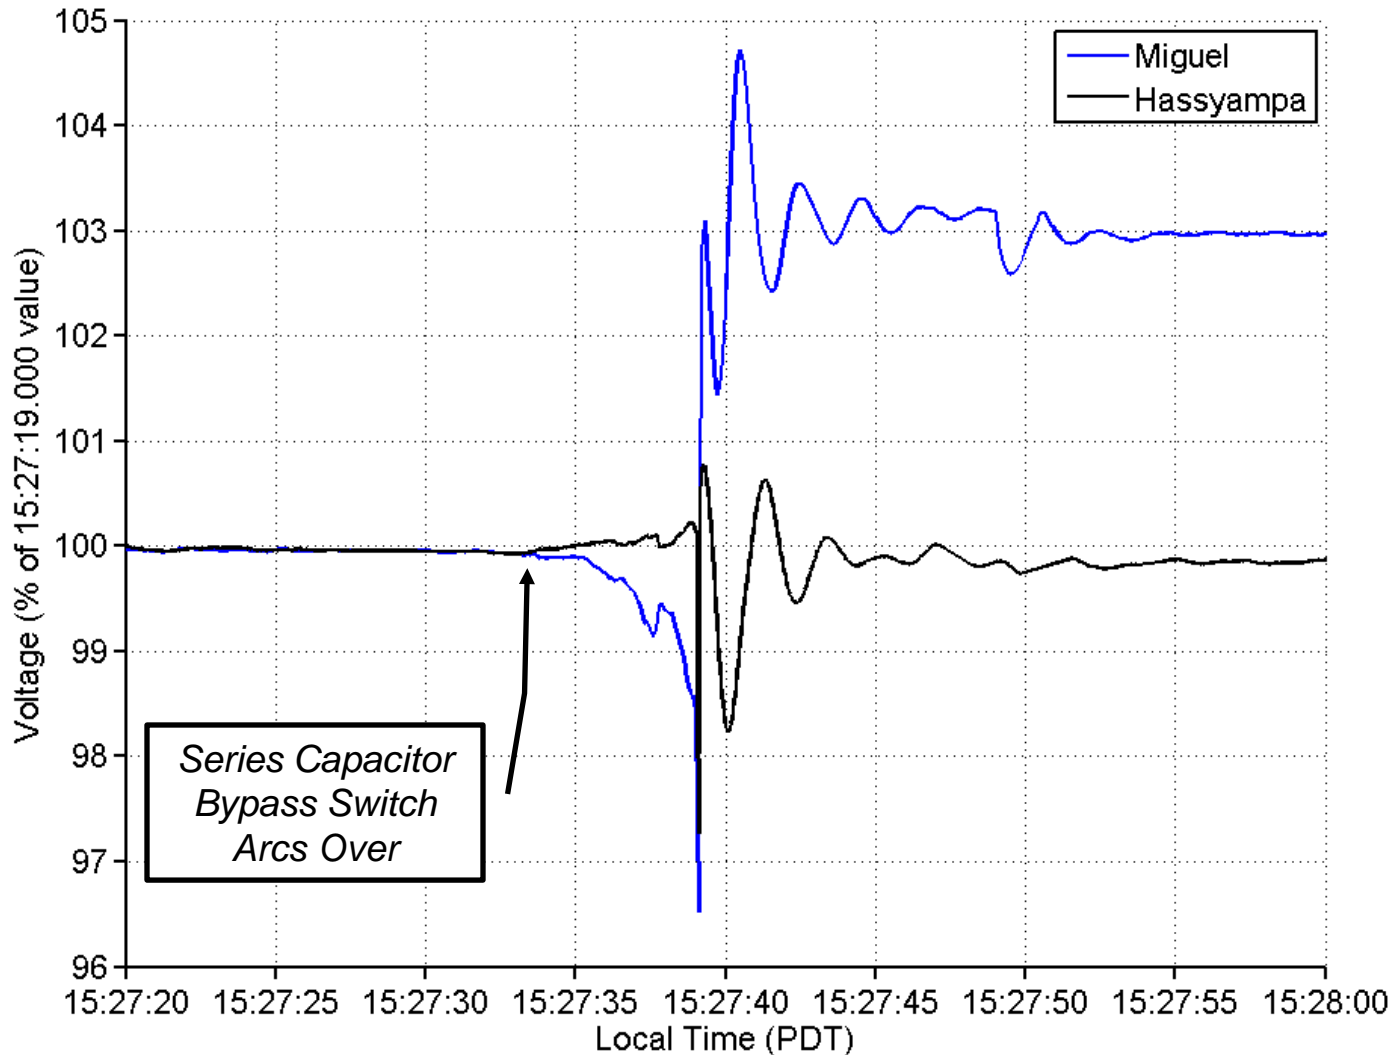
Initiating Event – Voltage Divergence Hassayampa – North Gila 500 kV Trip

- *H-NG 500 kV trips at 15:27:39*
- *APS tells WECC RC line expected to be restored quickly*
- *H-NG flow redistributes: 77% to SCE-SDGE (Path 44); remainder to IID, and WALC*
- *CV transformers immediately overloaded above relay settings*
- *Path 44 at 5,900 amps; 8,000 amp limit on SONGS separation scheme*

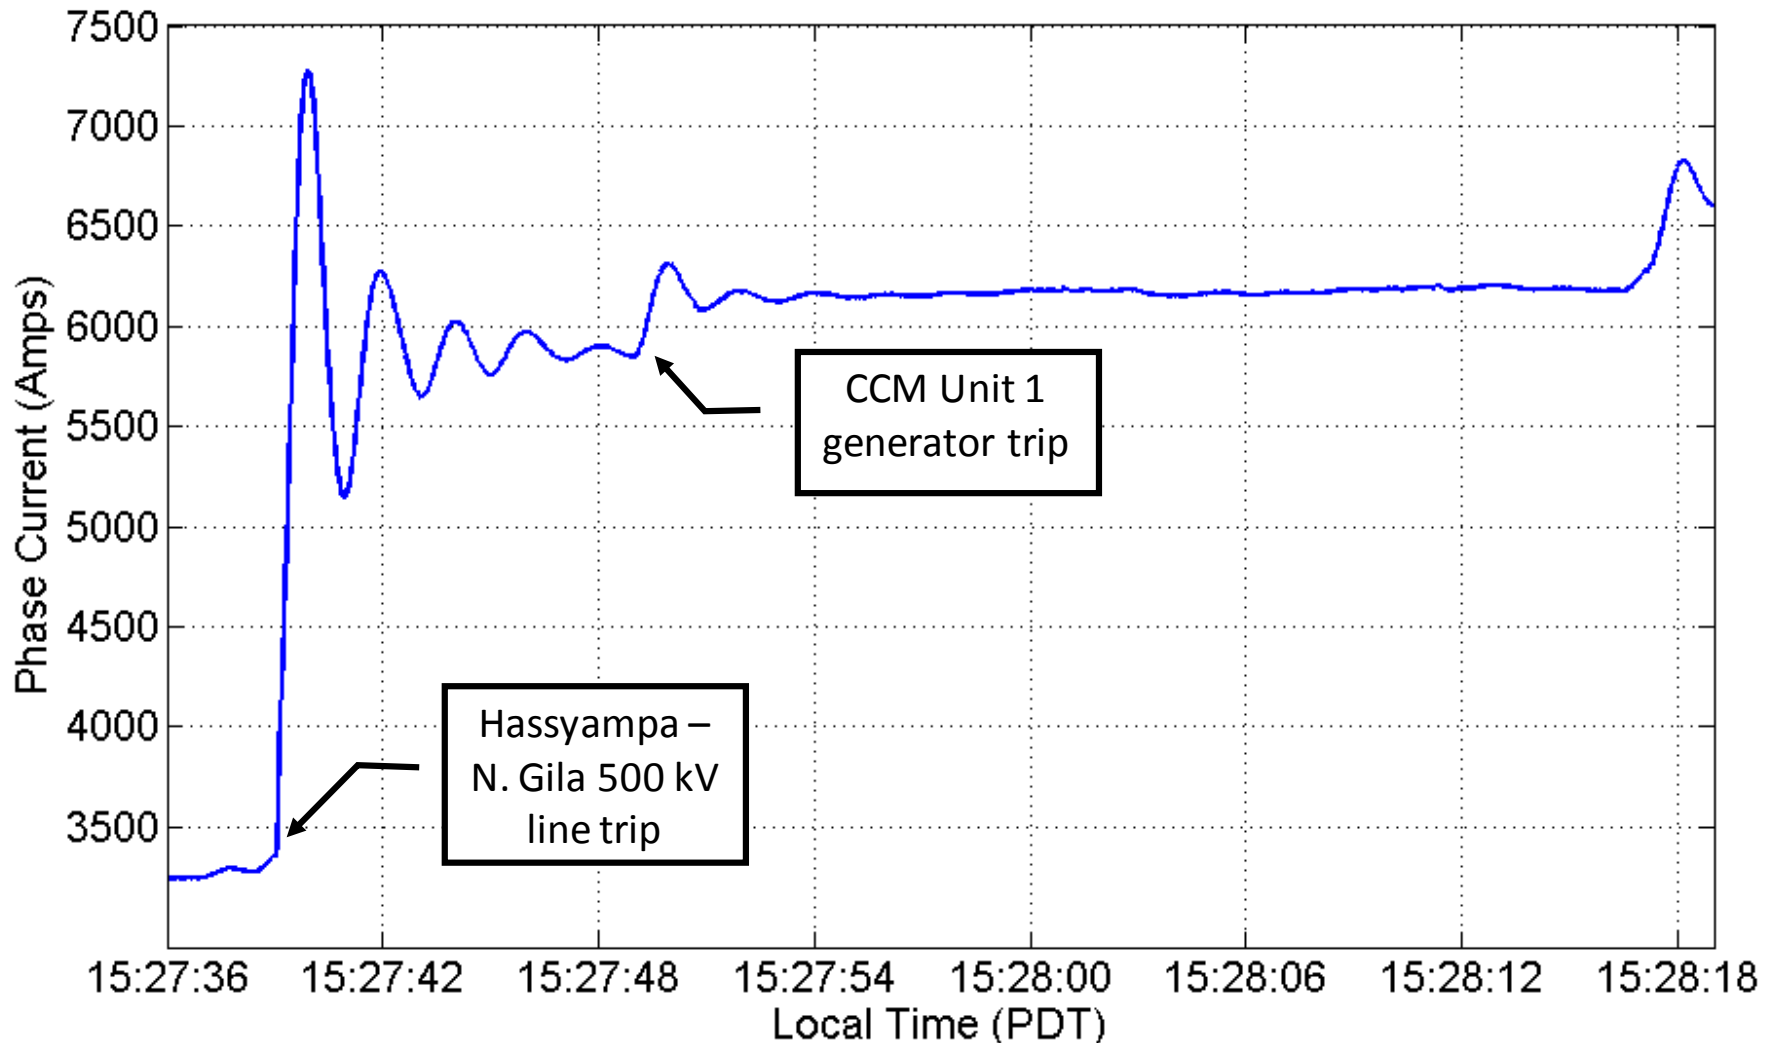
South of SONGS Current

Hass. – N. Gila 500 kV Line Trip

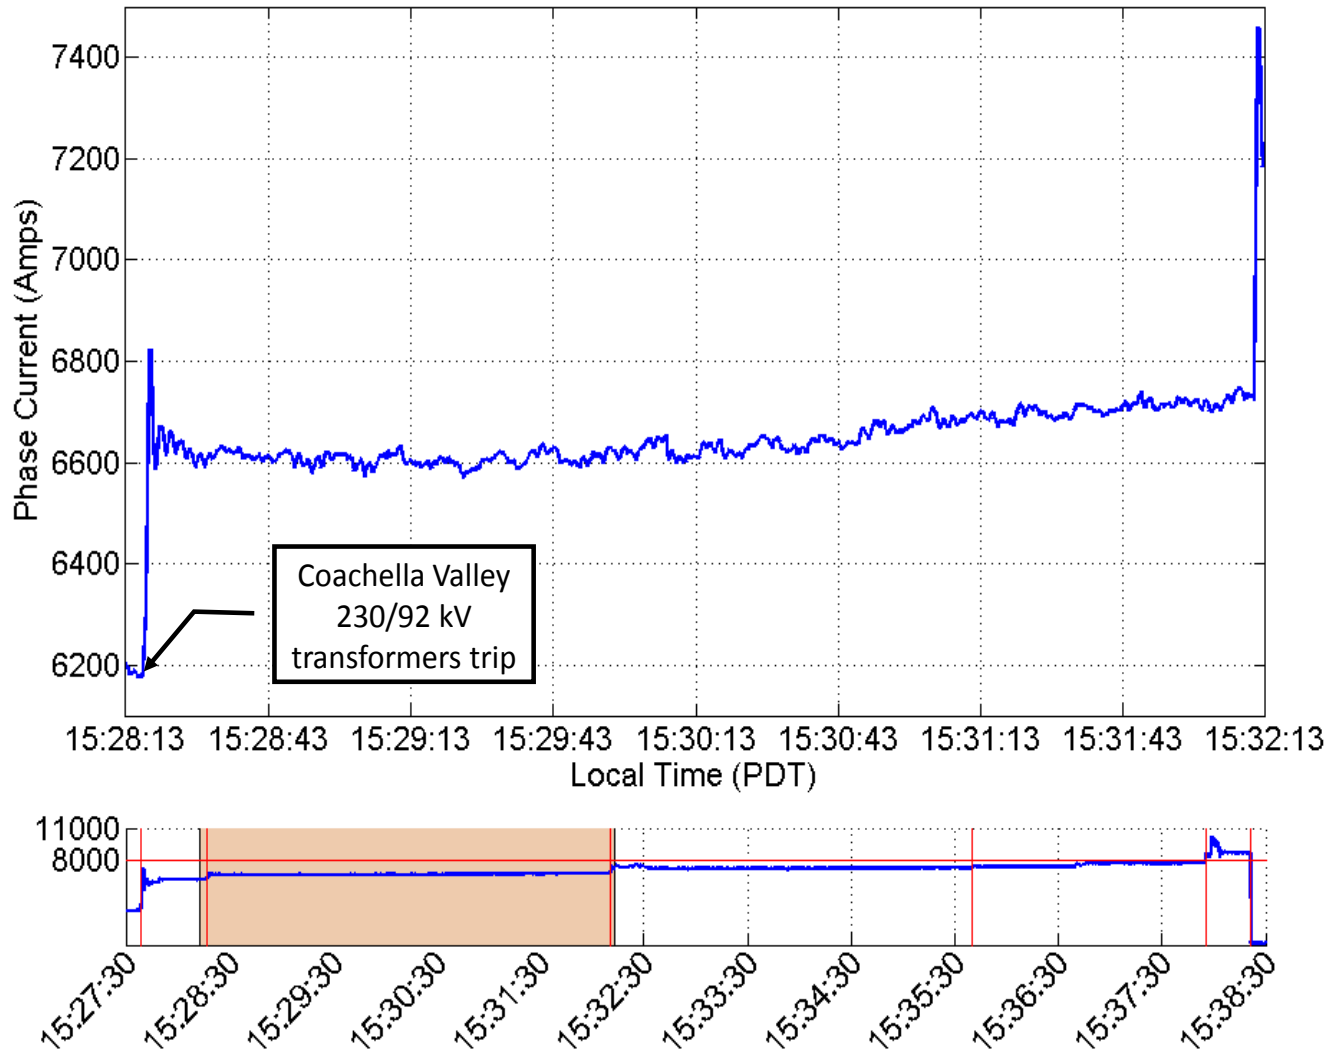
South of SONGS Current

Coachella Valley Transf. Trip

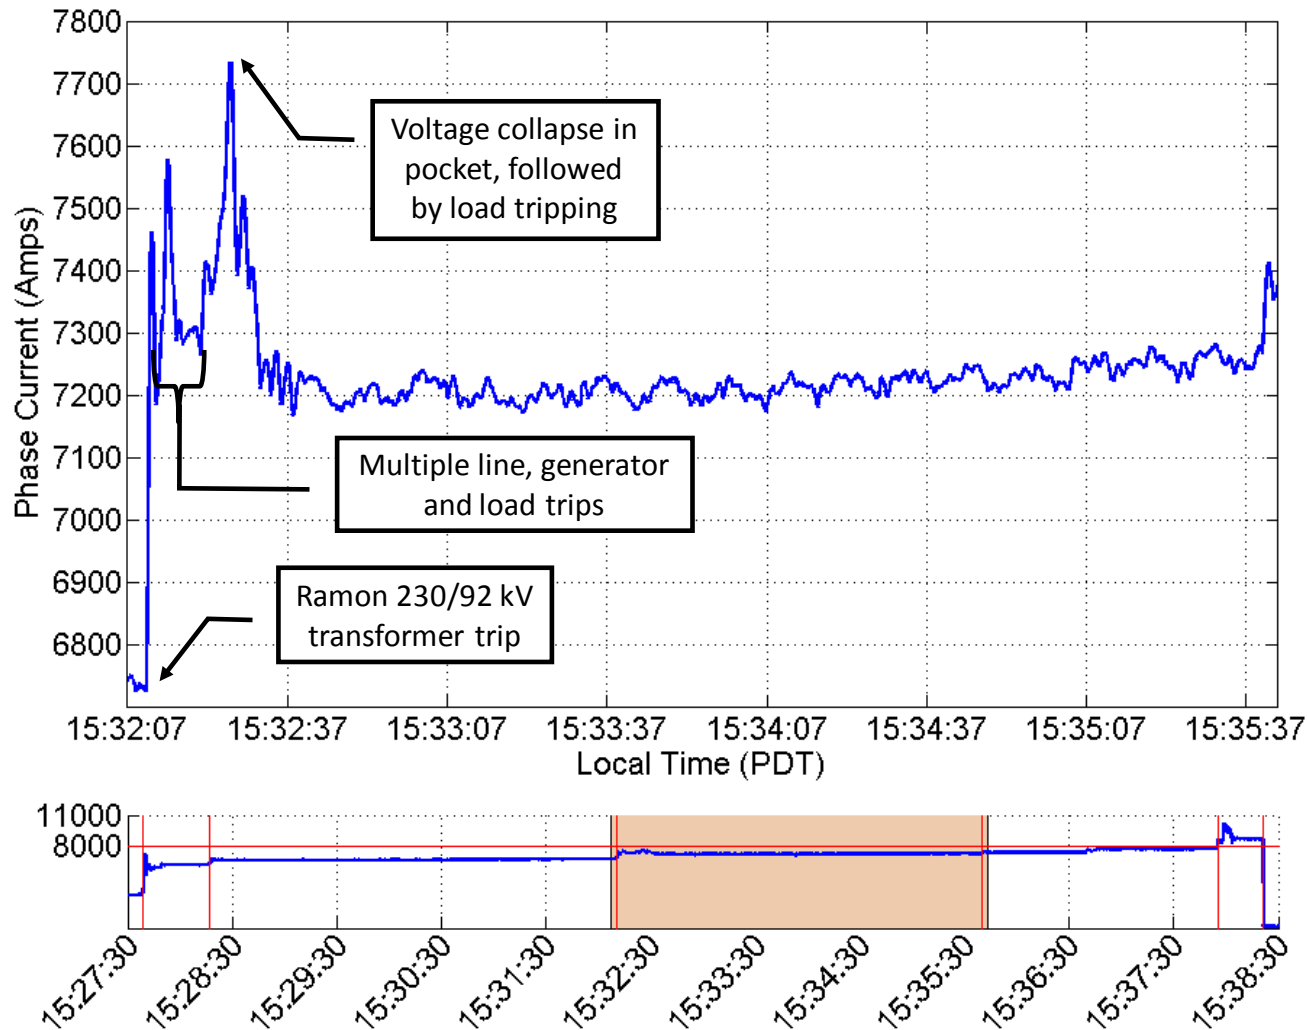
South of SONGS Current

- 15:32:10 Ramon 230/92kV transformer trips on overload relay
- 15:32:13 Blythe-Niland 161kV line trips
- 15:32:15 Niland – CV 161kV line trips
- IID undervoltage load shedding; loss of generation and 92 kV transmission lines
- Severe low voltage in WALC 161 kV system
- Loading on Path 44 increases to 7,800 amps; settles at 7,200 amps

Ramon Transformer Trip

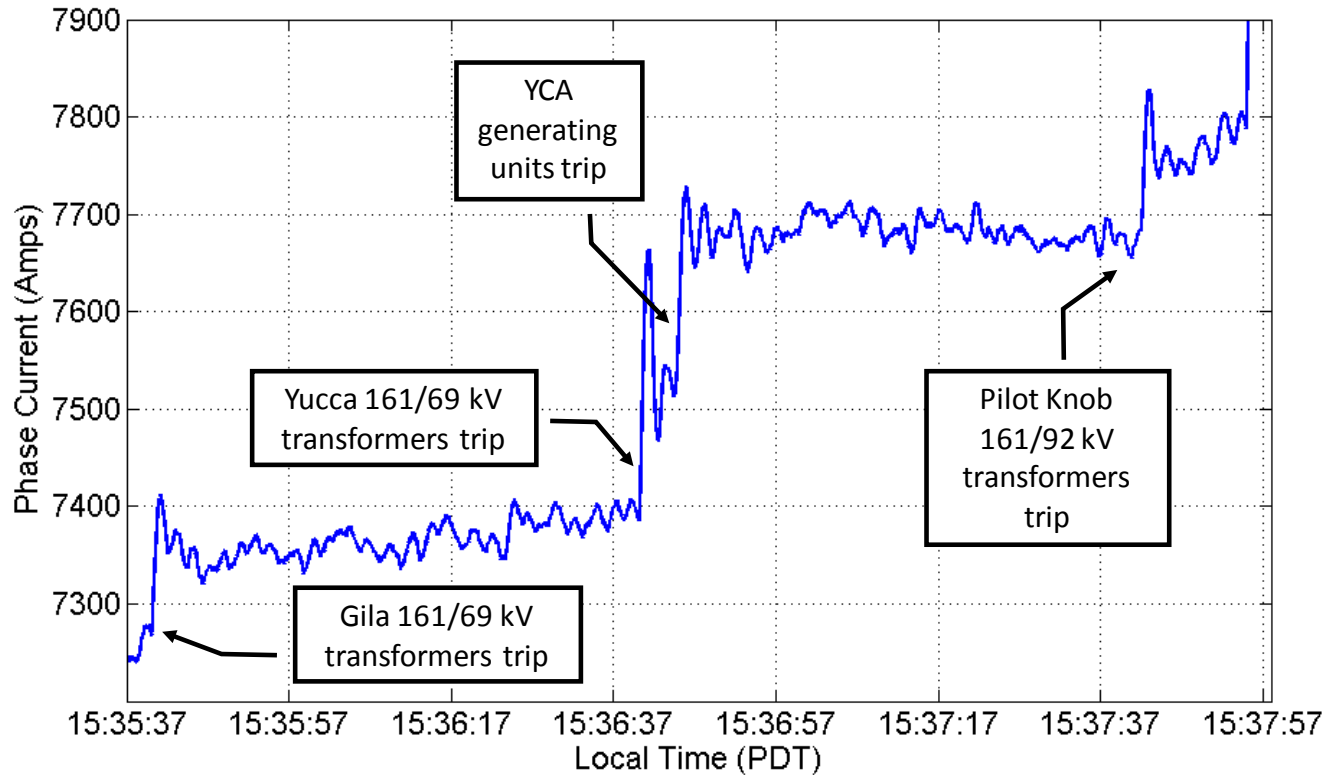
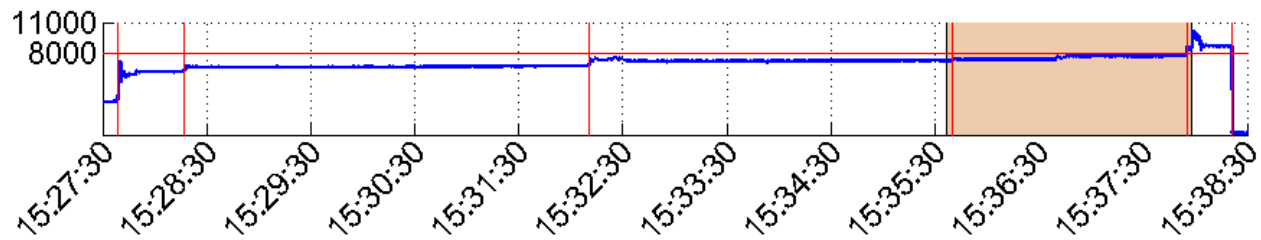
South of SONGS Current

- *Yuma AZ Separates from IID and WALC when Gila and Yucca transformers trip*
- *Yuma load pocket isolated on single tie to SDG&E*
- *Loading on Path 44 increases to 7,400 amps after Gila transformer trip; to 7,800 amps after Yucca transformers and generator trip*

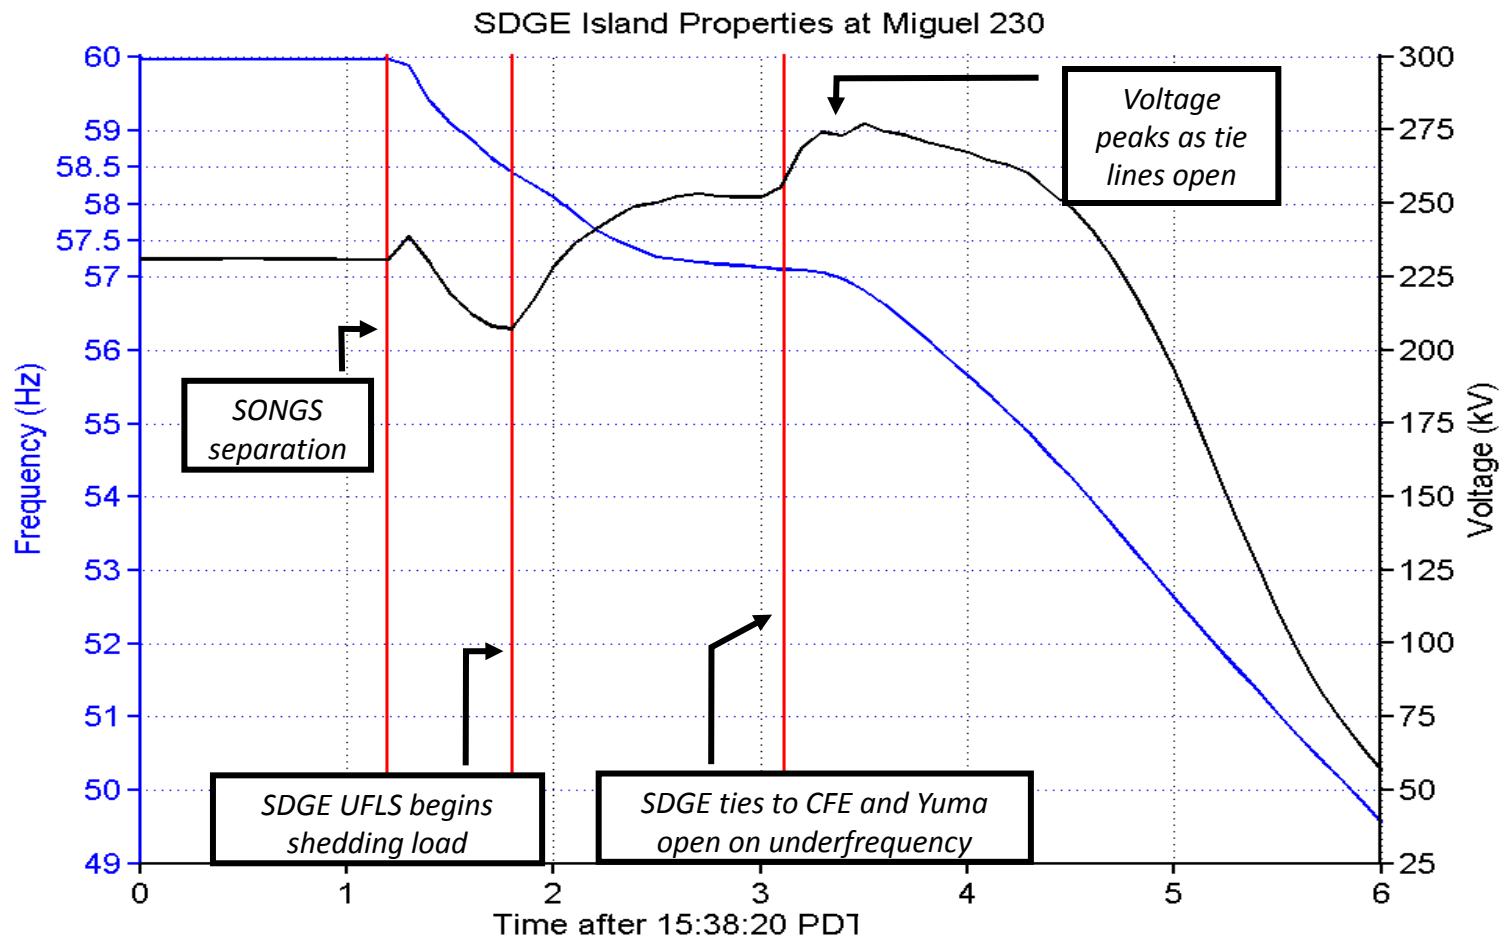
Phase 7 – CFE Separates

- *SDG&E and CFE UFLS continues*
- *CFE separates from SDG&E*

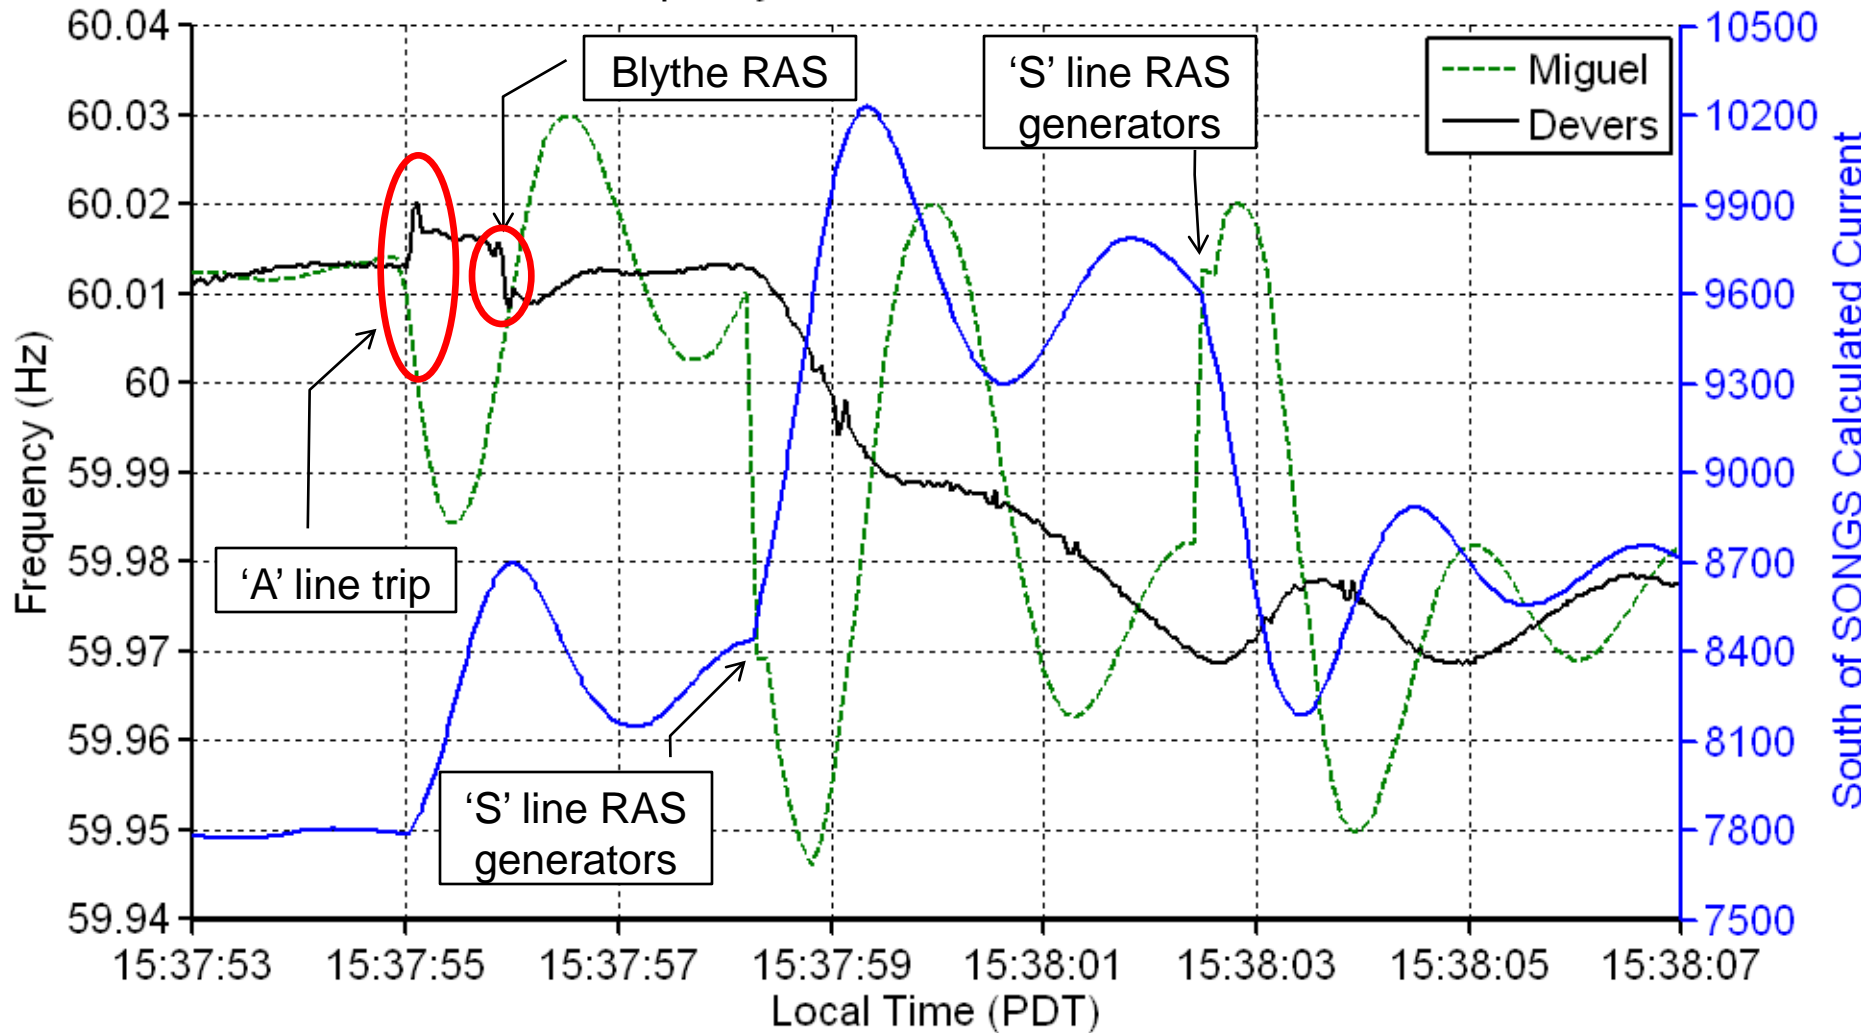
Phase 6 Example

Frequency and South of SONGS Flow

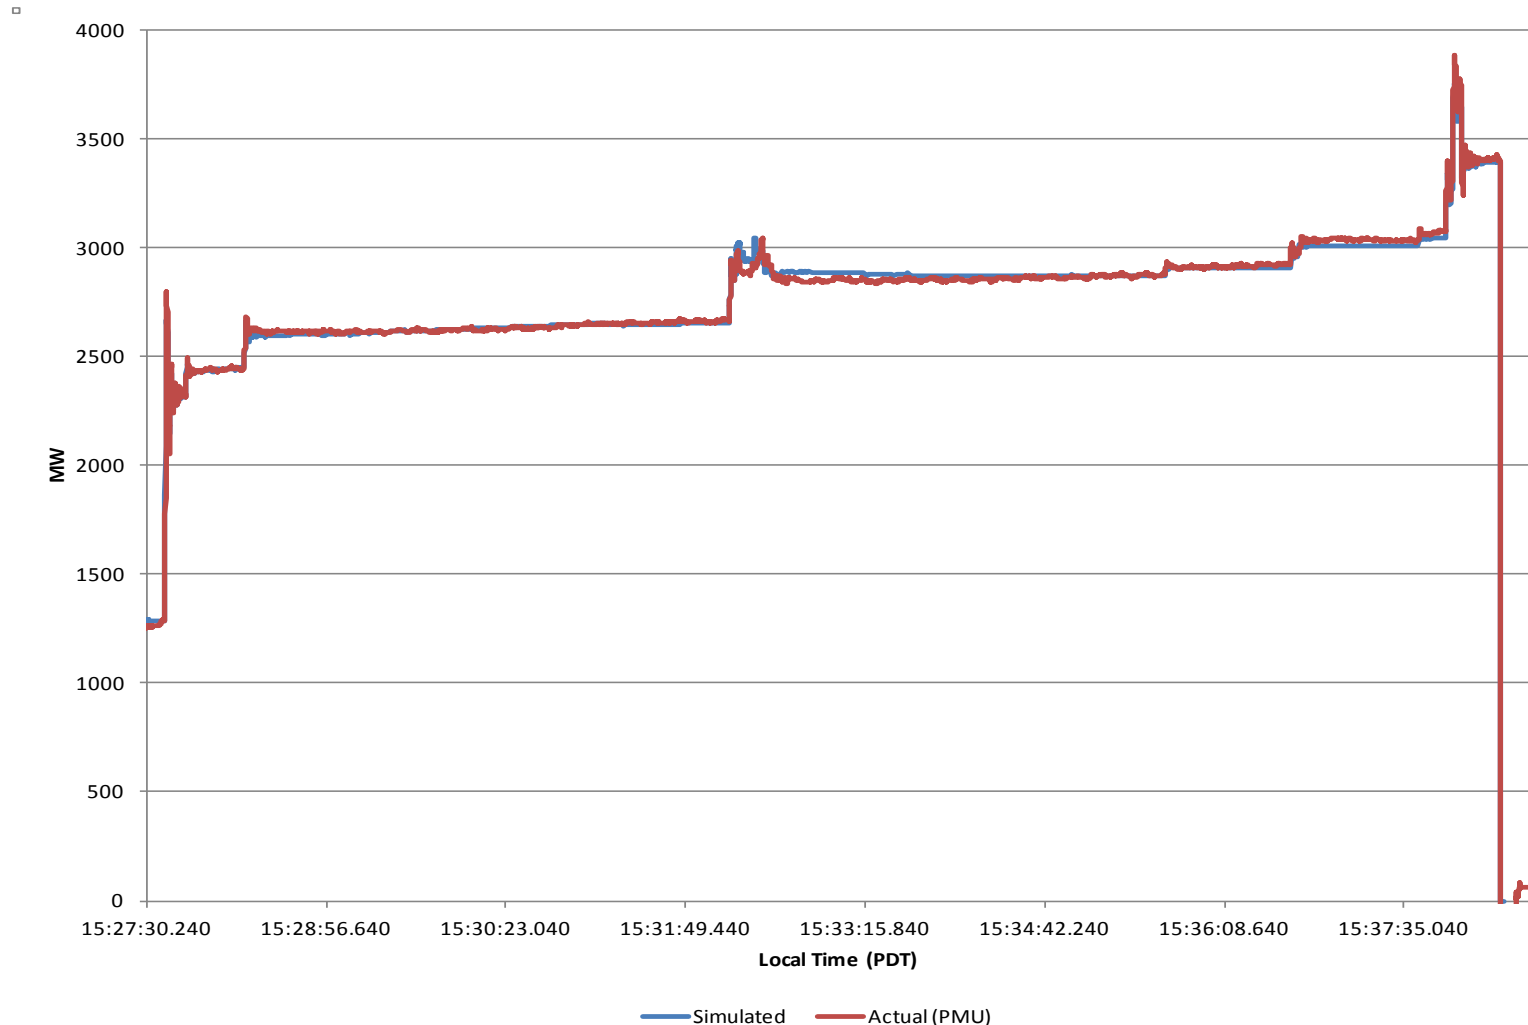
South of SONGS Flows

Simulation vs. Actual Flows
