Using PMU's in Iceland

NASPI Work Group Meeting

June 2008, Bellevue, Washington

Nils Gústavsson
Manager System Operation

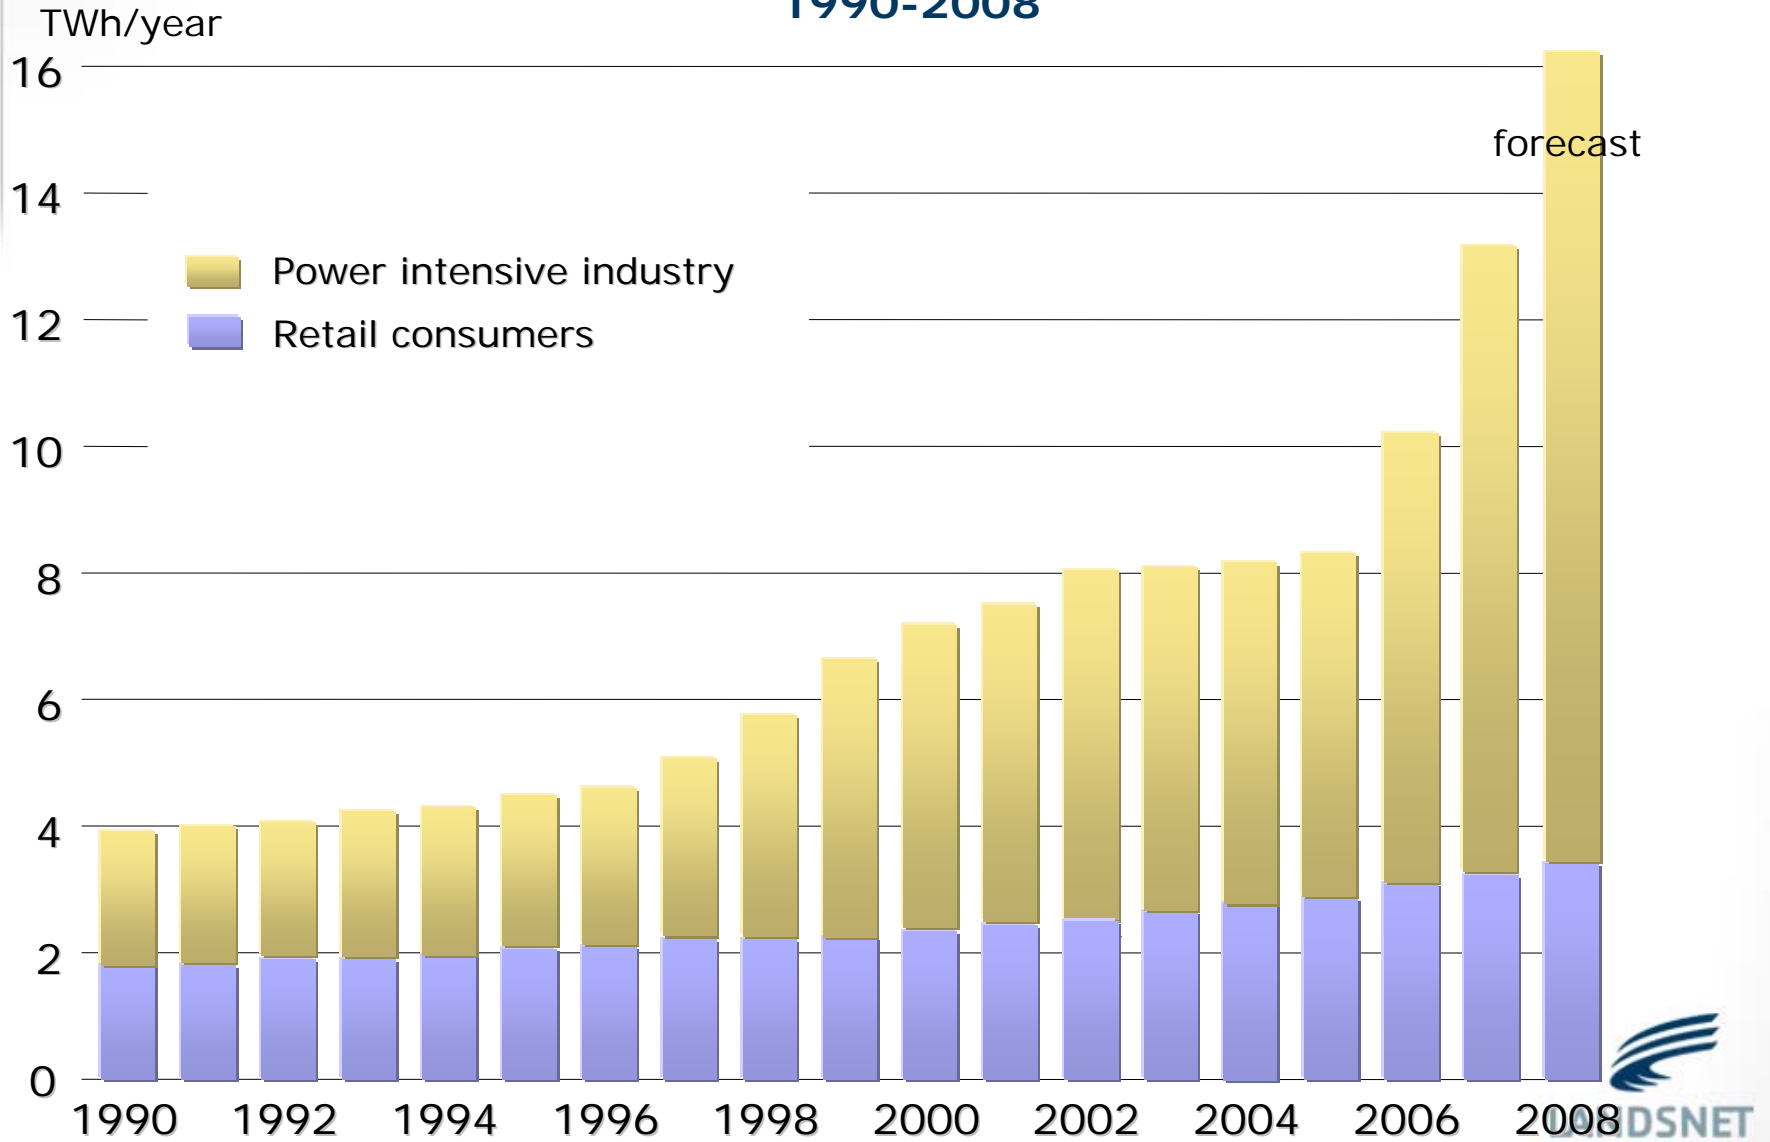
Electricity consumption in Iceland 1990-2008

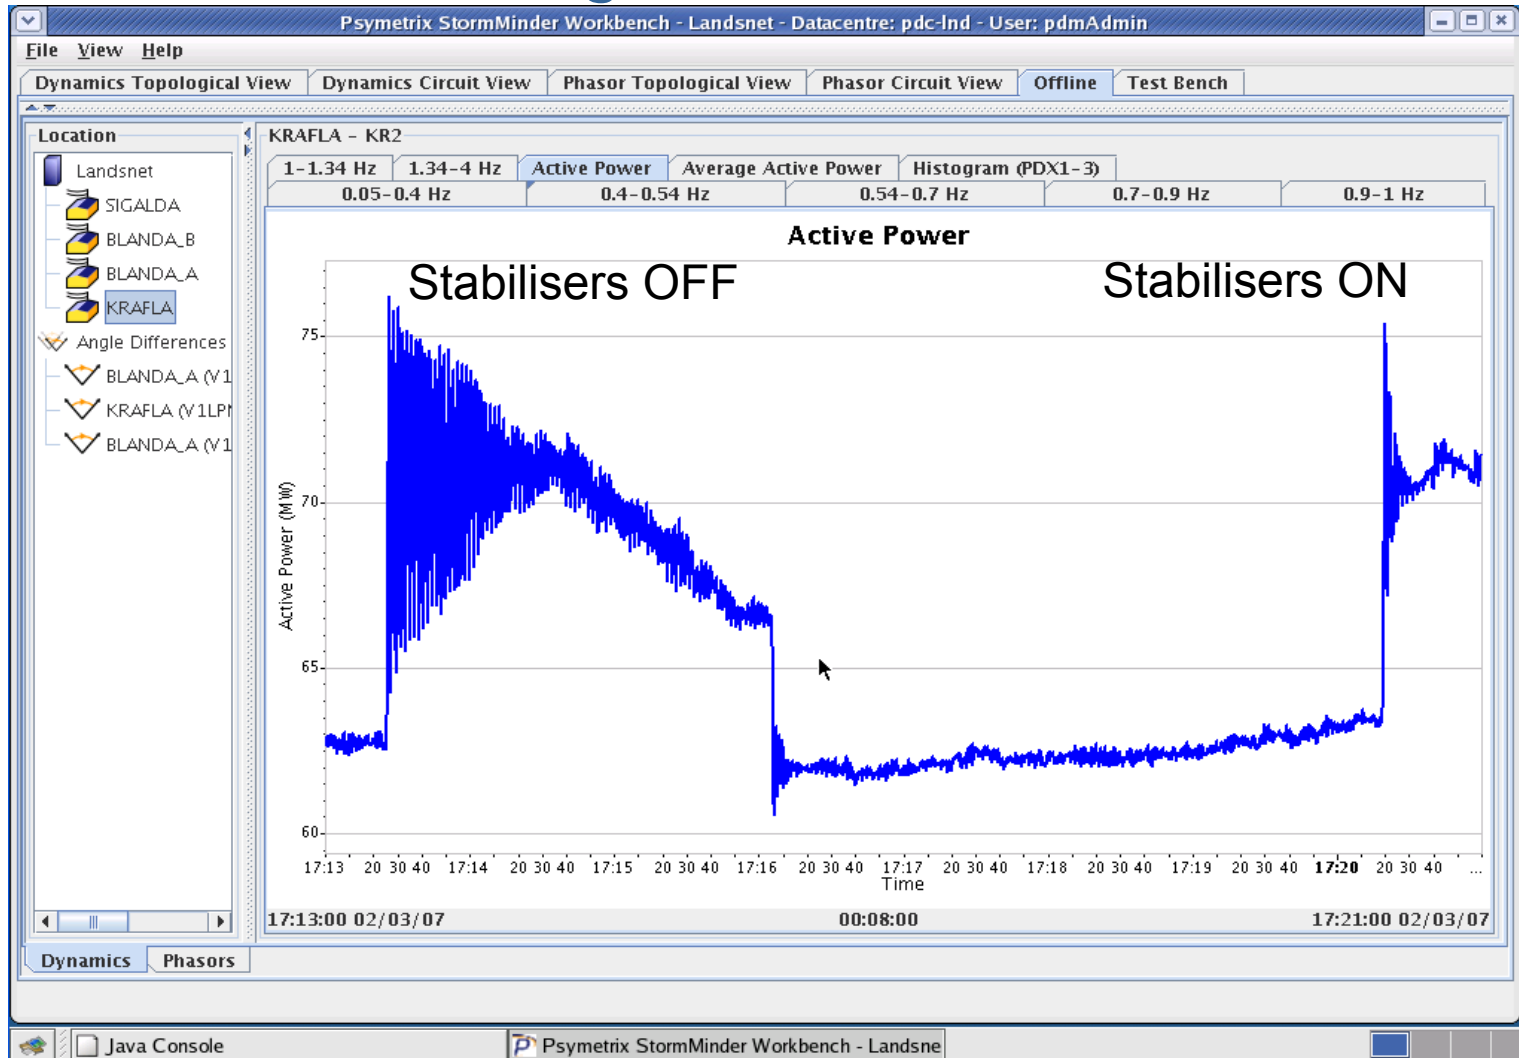
Power System Stabiliser Tuning (2)

► Network switching tests

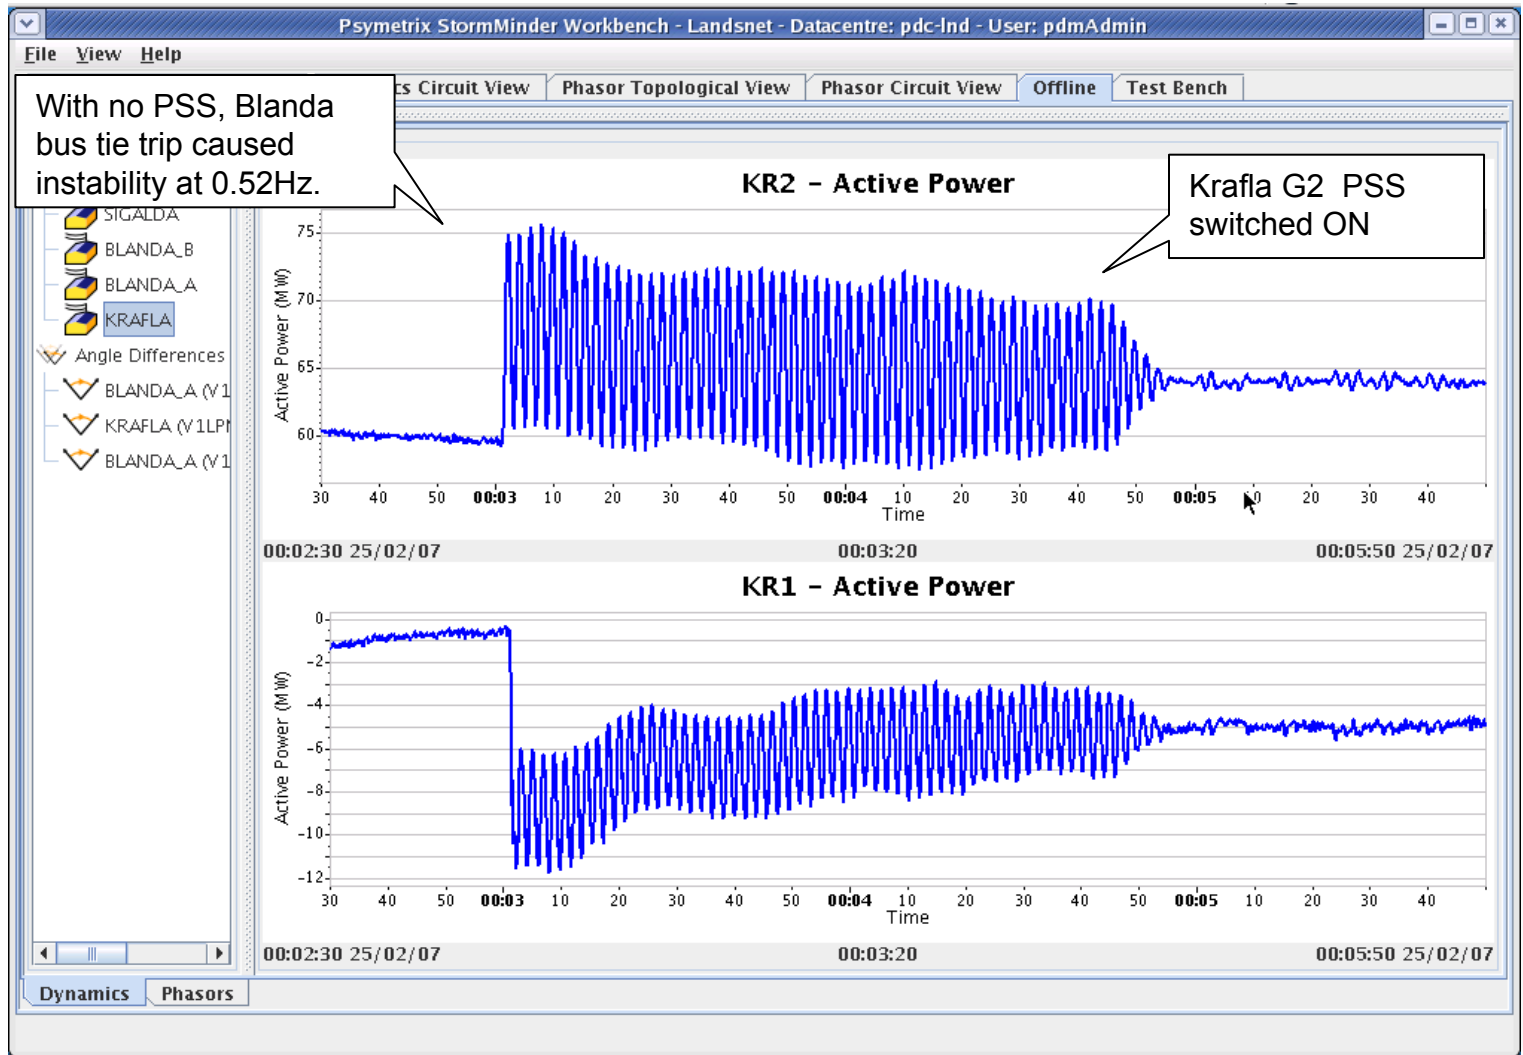
Power System Stabiliser Tuning (3)

► Network & PSS switching tests

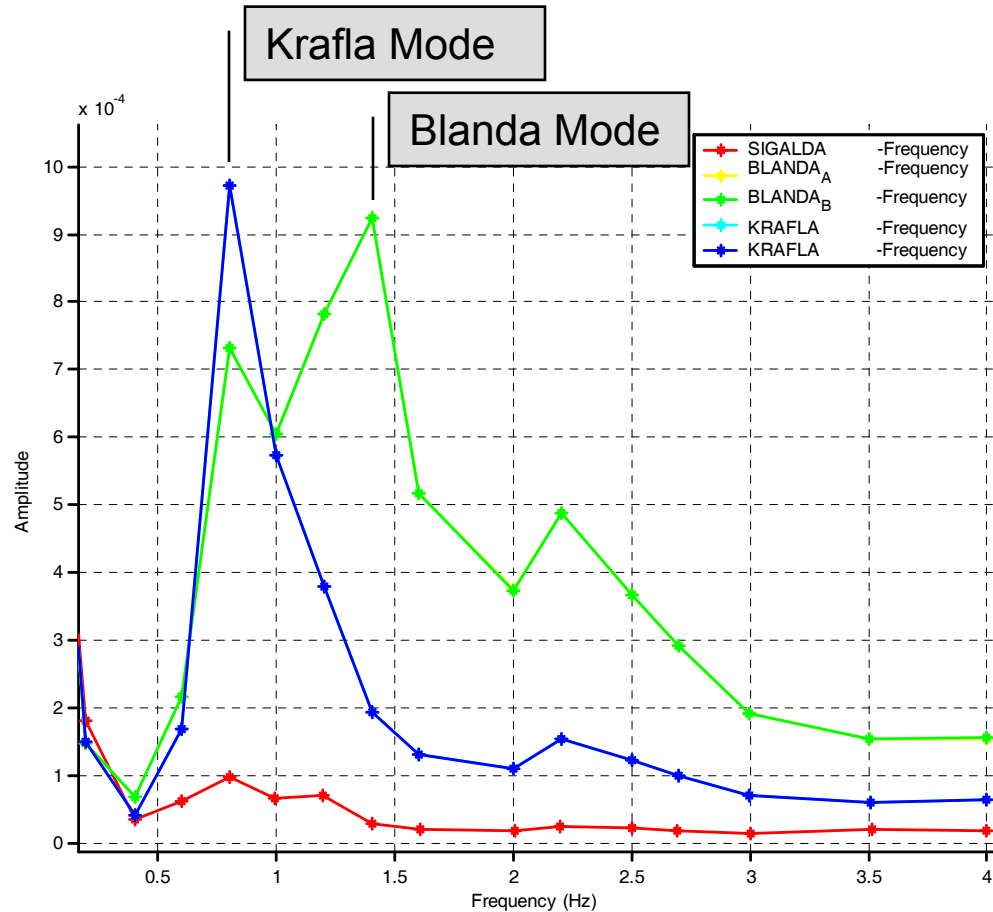
Wide-Area Response to Blanda AVR Injection
(System Frequency measurement)

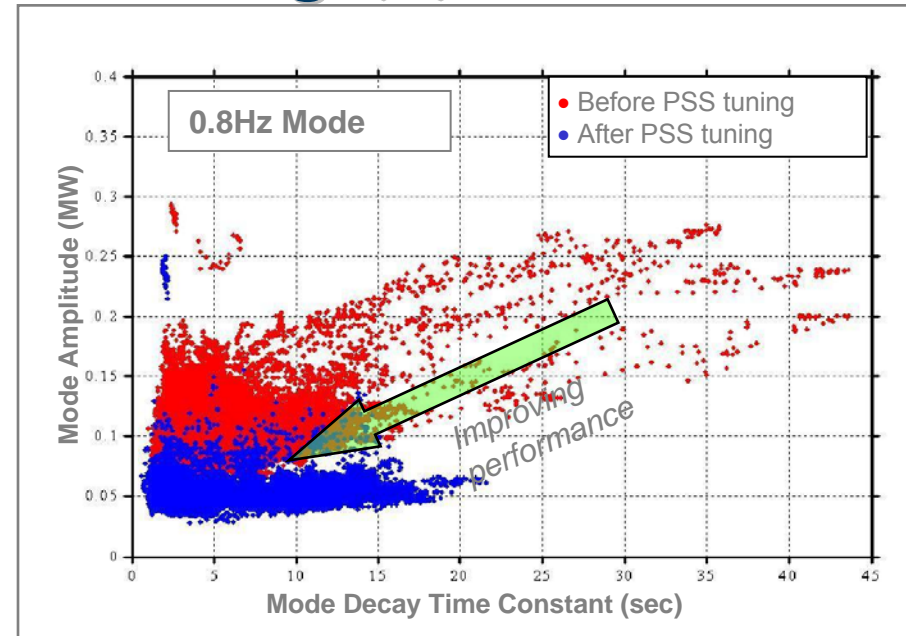
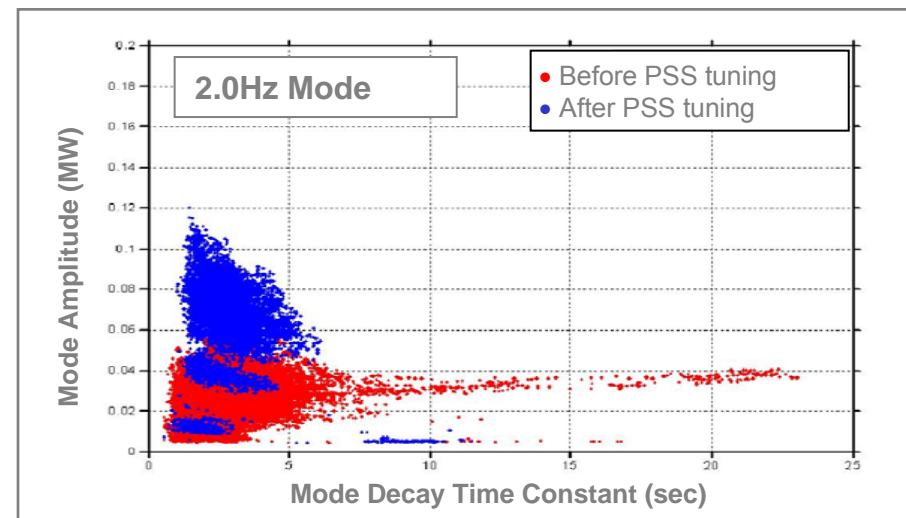
- ▶ Long-term observation of damping
 - » 2 modes clearly improved
 - » No degradation in performance

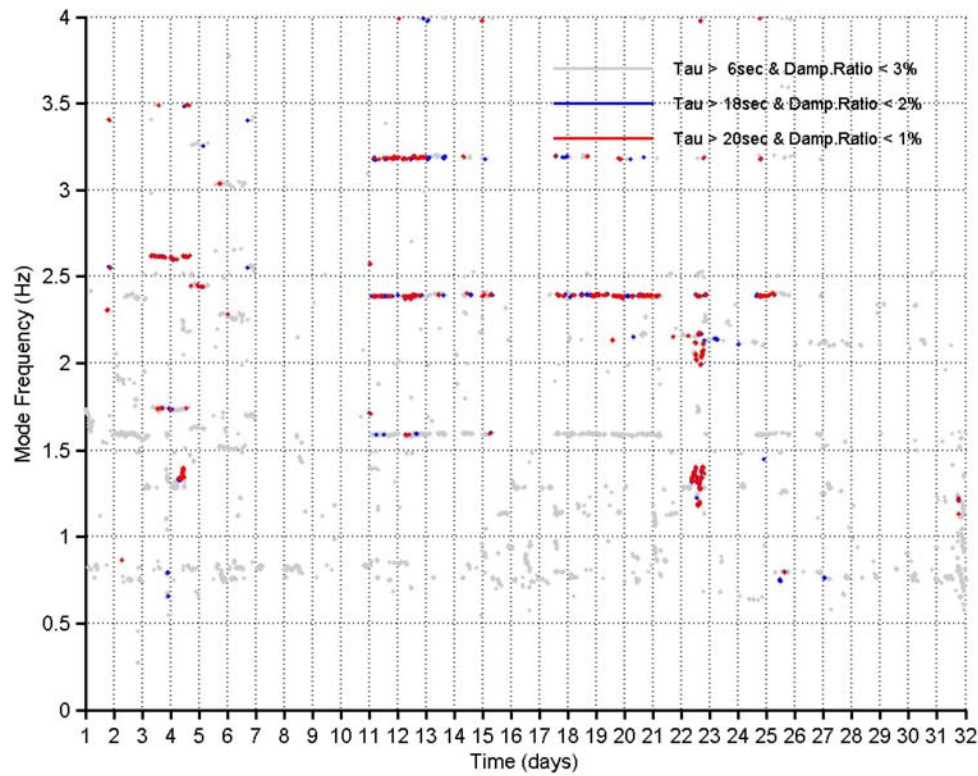
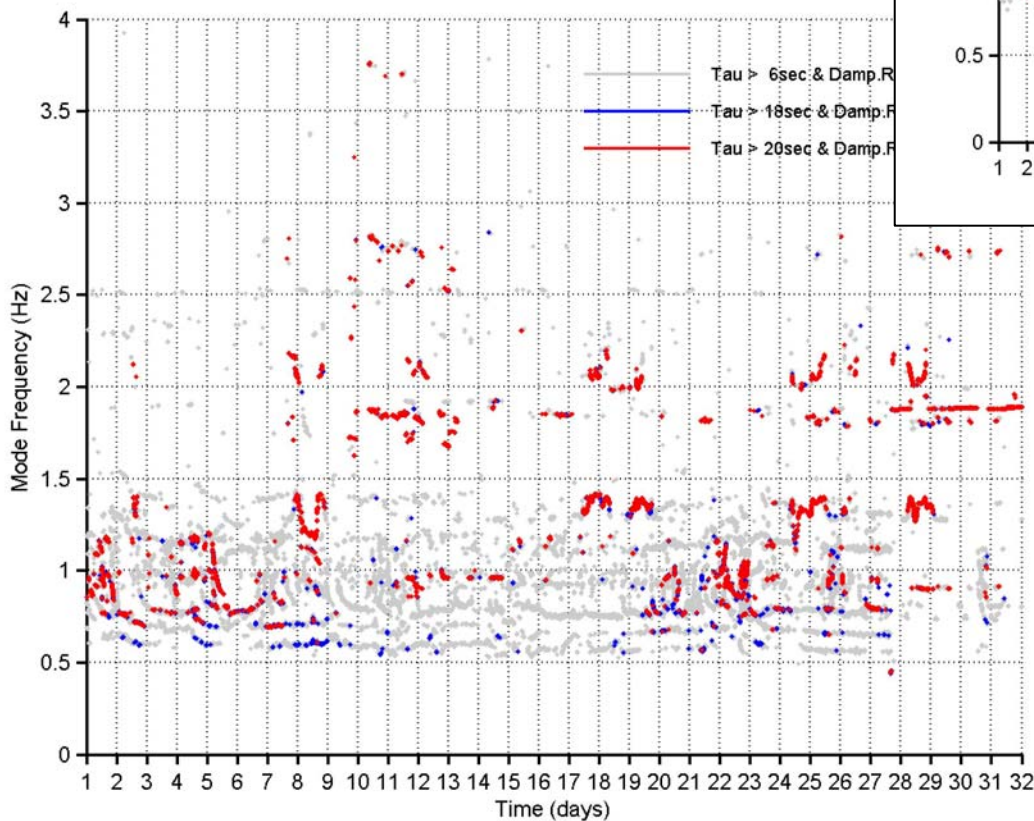
► New hydroplant online

Without PSS

↑
With PSS

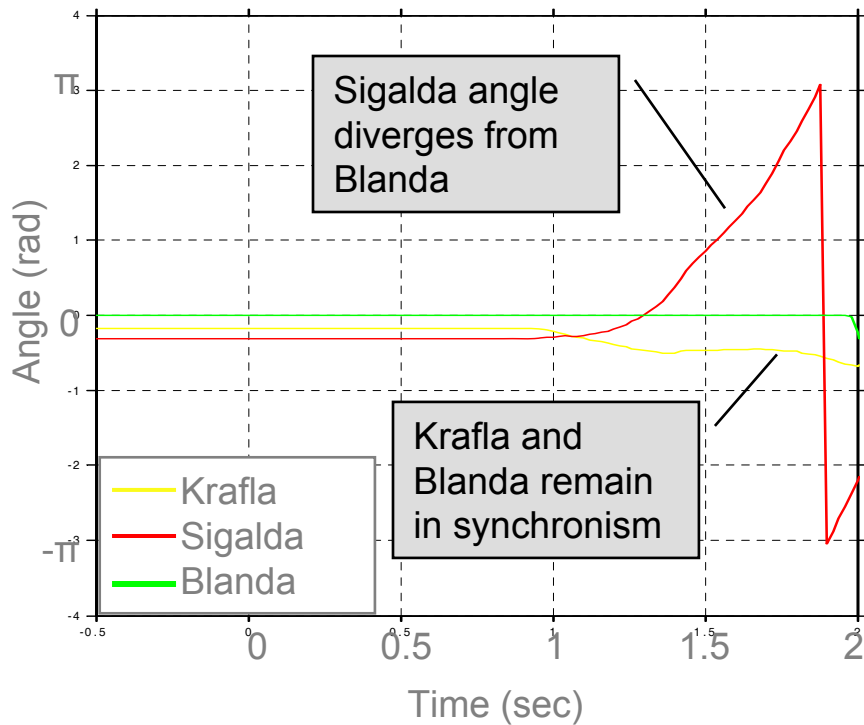
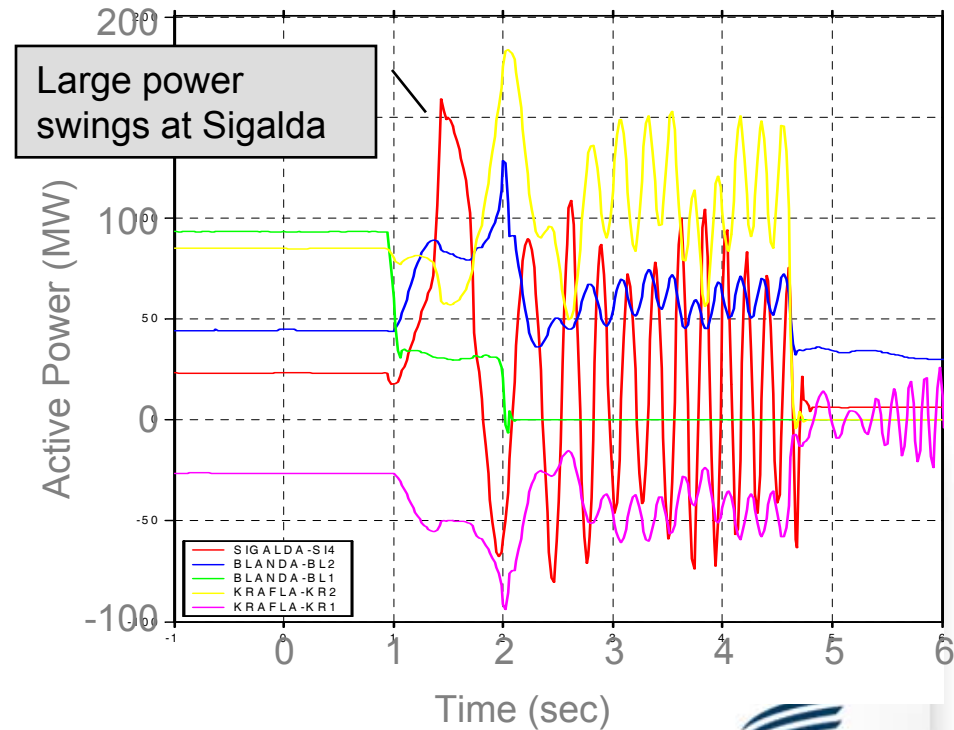
- ▶ PMU data used for analysing disturbances
- ▶ E.g. Identifying loss of synchronism

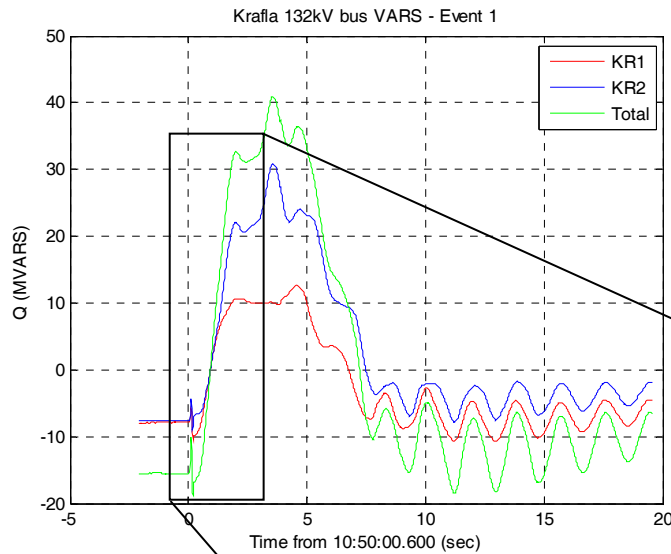
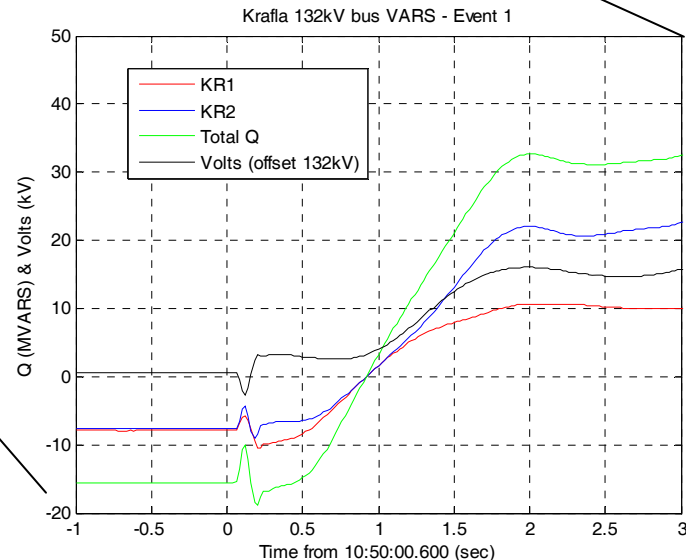
Identification of Controller Malfunction

- ▶ PMU measurements used to identify incorrect AVR response
- ▶ Circuit fault identified and resolved
- ▶ Issue resolved – confirmed by PMU measurements

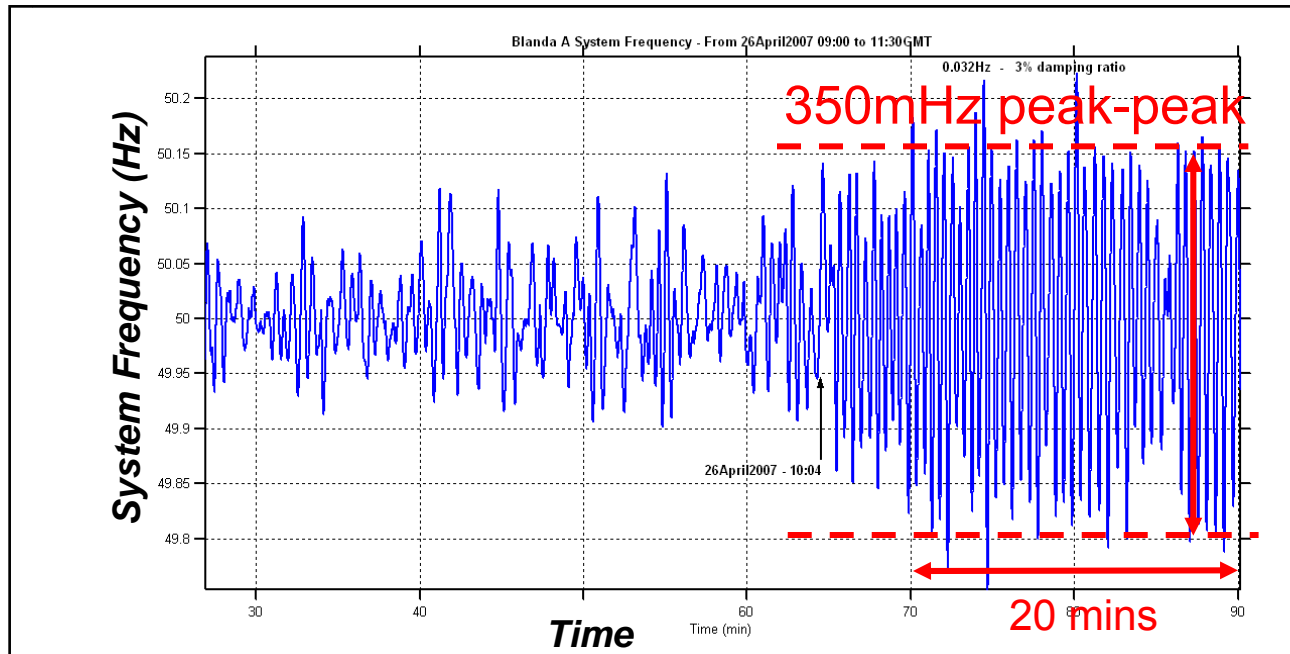
Future: Governor/ AGC Stability

- ▶ Addressing Governor/AGC Frequency Oscillations
- ▶ Detected frequency 0.015 to 0.045Hz
