# Forced Oscillation Examples

*Phenomena, analyses and resolutions*

# Persistent 1 Hz Oscillation

*Combined Cycle Unit, 2 Gas + 1 Steam*

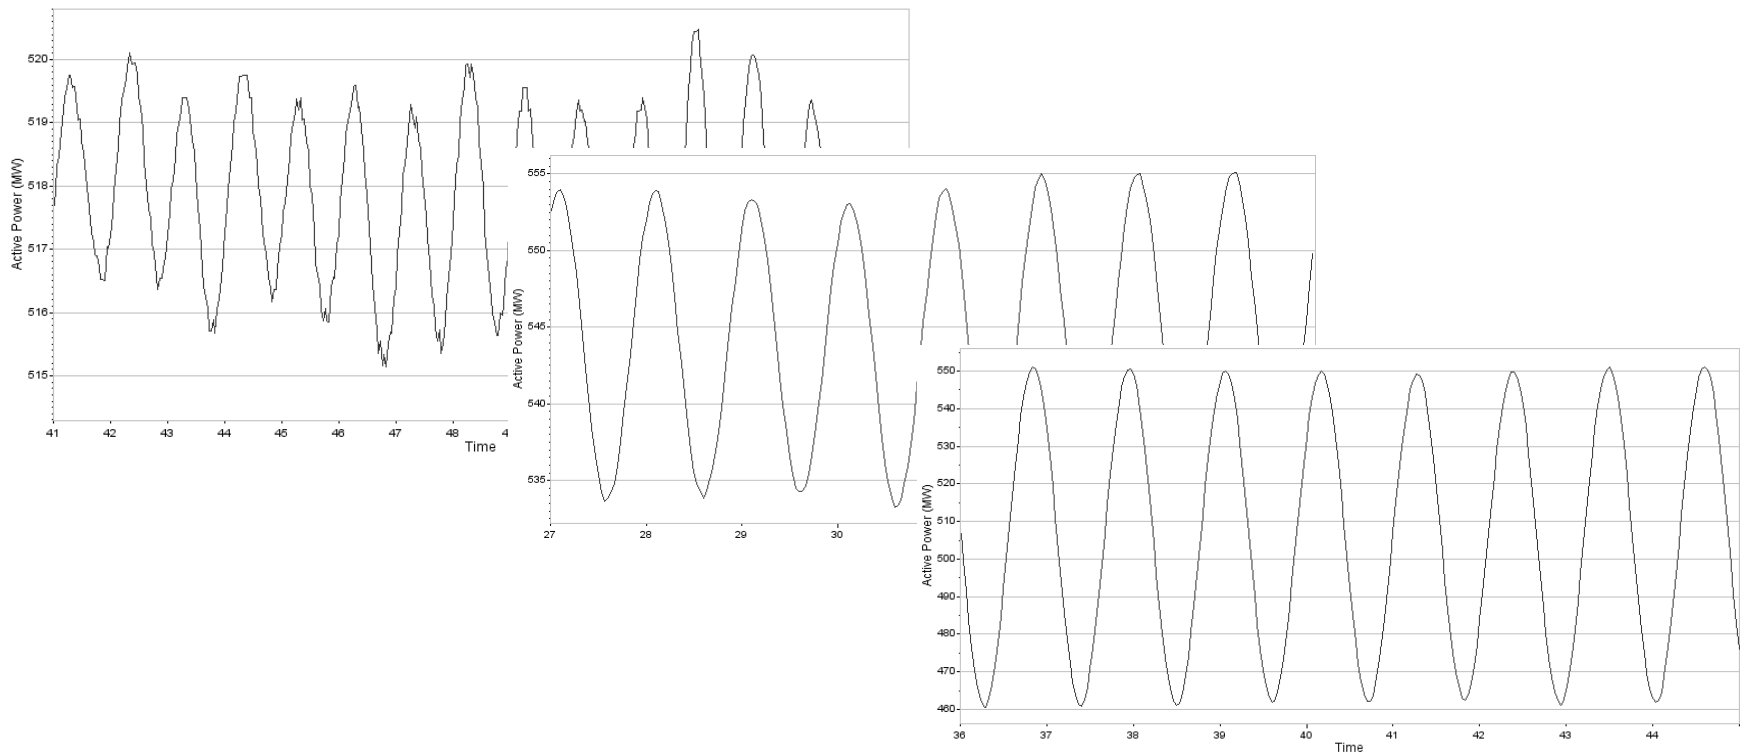
- Normally < 5 MW pk-pk
- Raised to 20 MW pk-pk from time to time
- Occasionally grew to 100 MW pk-pk

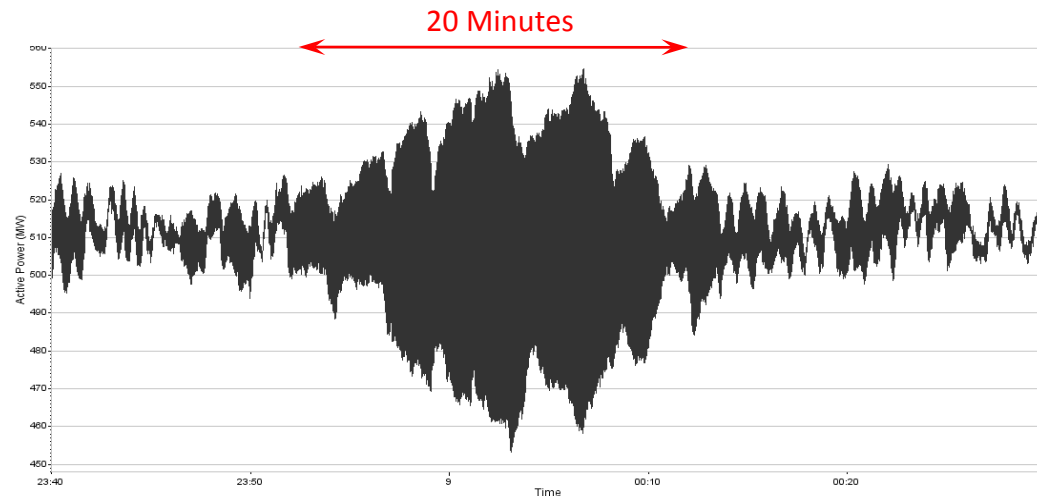
- A 100 MW pk-pk example
- Observed in PhasorPoint after the event

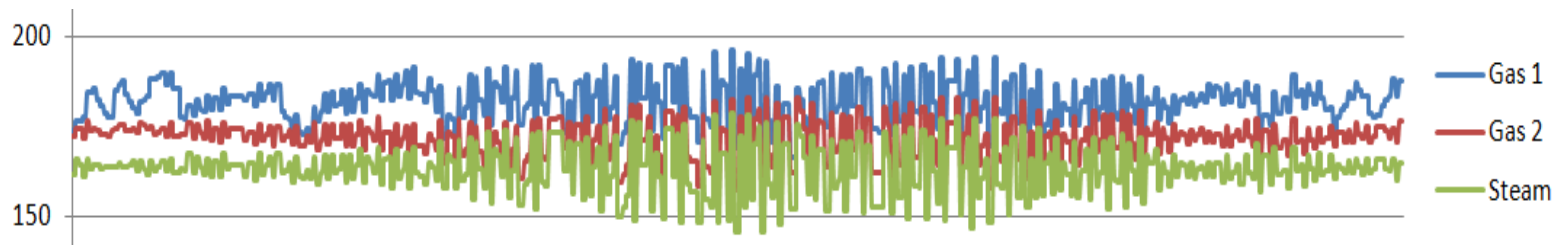
- SCADA Data
  - Oscillations are from all three units

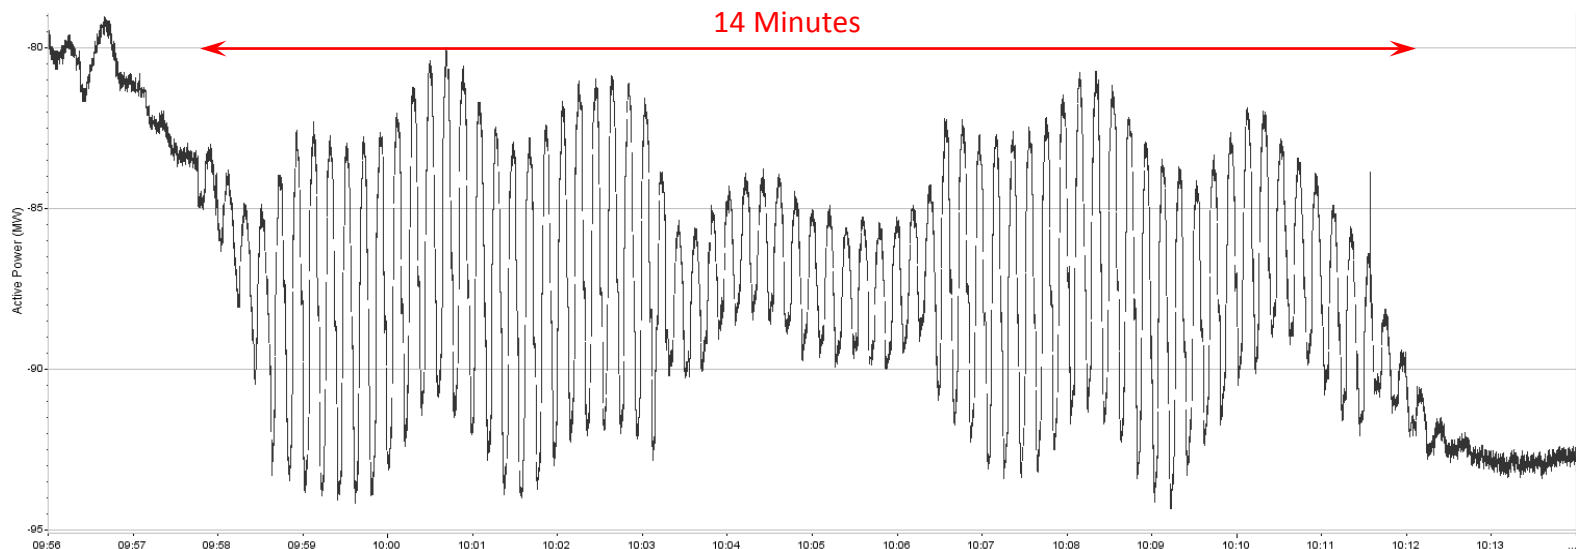
- A 10 MW pk-pk example
  - Alert sent from PhasorPoint and Oscillation Source Location (OSL) tool

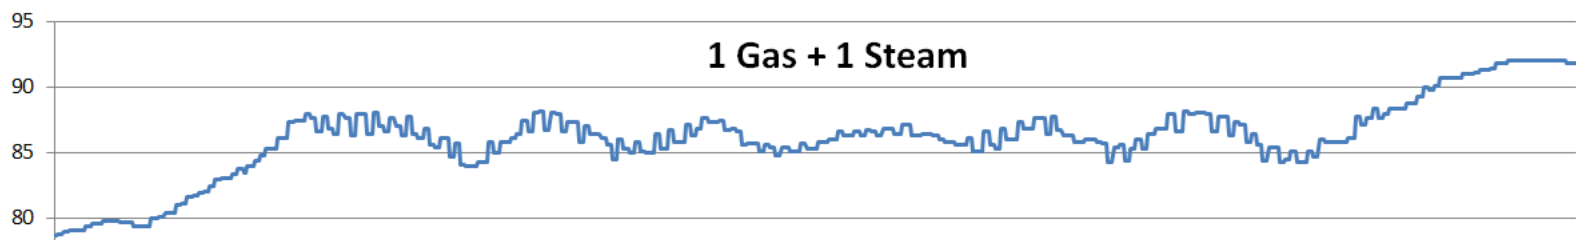
- SCADA data showed a 2 MW pk-pk variations

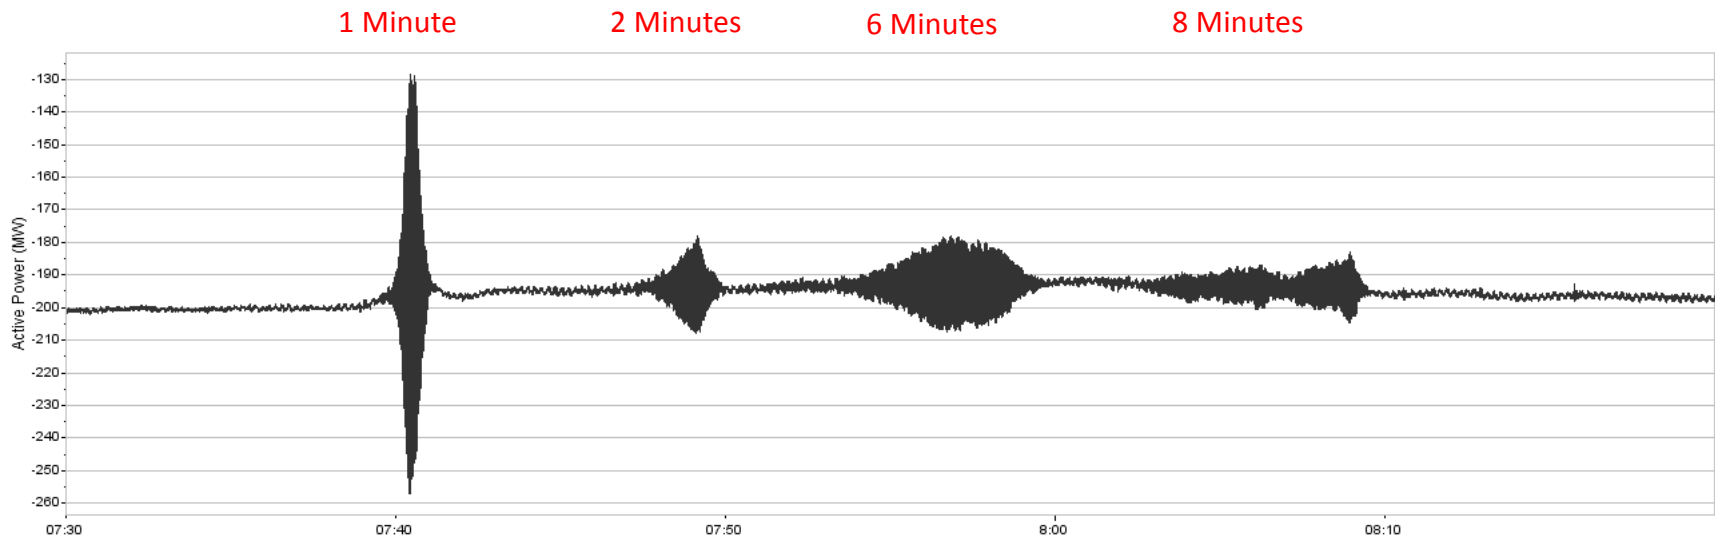
- A series of 4 oscillation events
  - The largest is 130 MW pk-pk

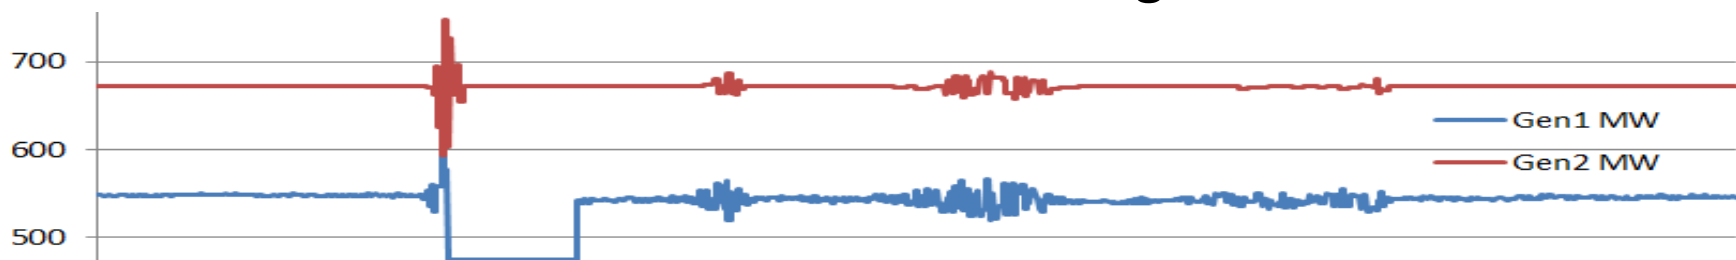
- SCADA data showed variations on both generators

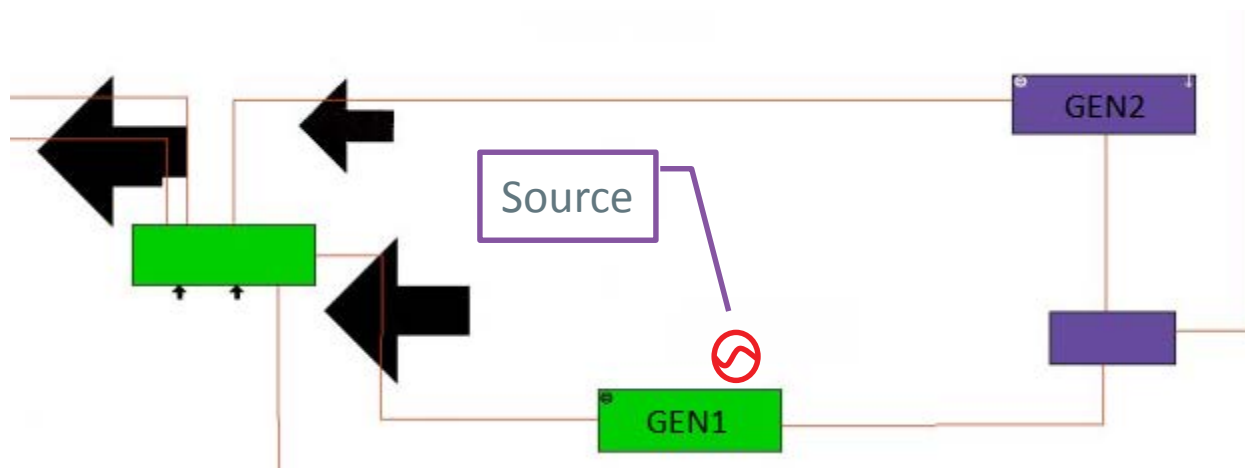
- PhasorPoint and OSL tool alarmed the operations support
- OSL identified two suspects and GEN1 as primary suspect
  - Unobservable line between Gen1 and Gen2
  - Gen1 had a larger Dissipating Energy (DE) factor (arrow size)

- Outage record showed that Gen1 was conducting a full load leading Var test during the time period
- Gen1 was identified as the source of the oscillation
