USE OF SYNCHROPHASORS AT OG&E

INTRODUCTION

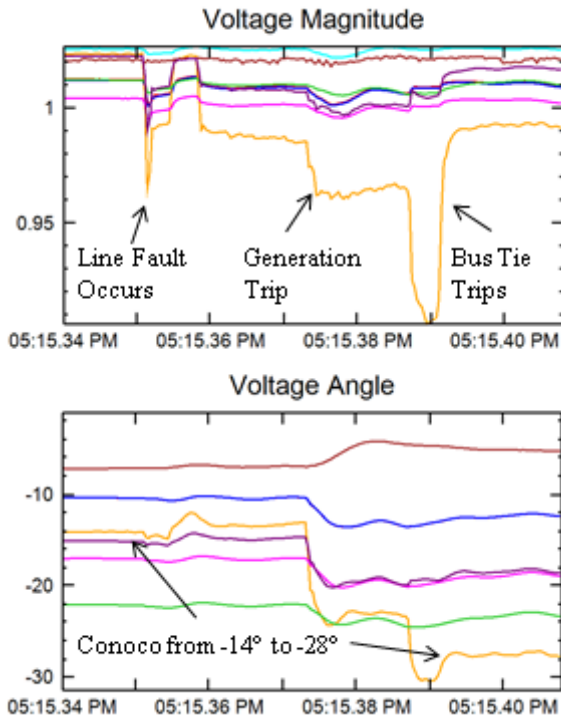
Figure 4 – Five Second Fault Event Shows System Stress

On August 10th, 2009 a fault occurred on the 138kV Sooner – Cow Creek/Stillwater line. The Sooner end of the line failed to trip because of a wiring problem in the relay potential circuit due to multiple grounds. Protection on the Sooner Unit 1 generator detected the fault and tripped the unit. The 400MVA bus tie autotransformer also saw the fault and tripped. Being close to Sooner on the 138kV system, notice how the Conoco North voltage responds to this event in figure 4. Its voltage angle relative to Muskogee was -14 degrees before the event and dropped to -28 degrees after, which indicates stress to the system.

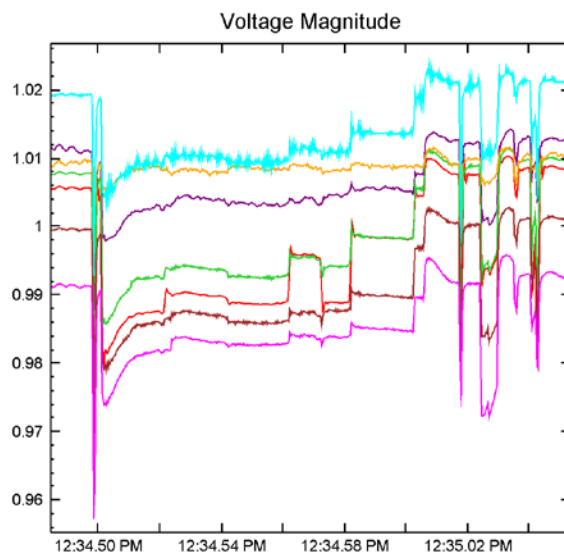
Figure 5 – Ten Second Fault Event Shows System Stress

In March of 2011, a track hoe contacted one of OG&E's 138kV lines out of Horseshoe Lake substation, resulting in a line to ground fault. The line operated once, reclosed and then failed to operate. This is one of the utility's largest stations, so it took 19 breakers behind Horseshoe Lake to clear the fault remotely. The fault was finally cleared when it went phase to phase and could be detected by the distance relays. The electromechanical ground relays could not detect the fault because the current polarizing circuit was compromised by a bad underground control cable. The result, shown in Figure 5, affected 32,000 customers and took 2 hours and 17 minutes to restore power, which equates to 4.38 million customer minutes interrupted (CMI).

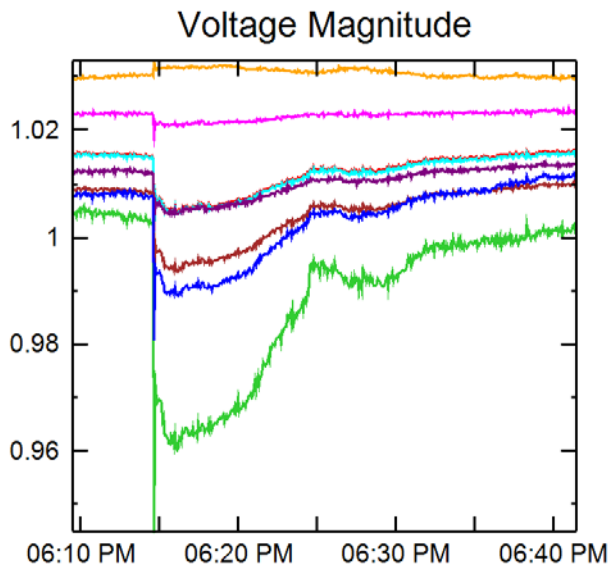
Figure 6 – Voltage Recovery Assessment

Synchrophasors have also been used to assess system voltage recovery following a disturbance. Delayed voltage recovery is currently a hot topic of study for NERC as SCADA lacks the resolution to detect these events. The potential impact for such an event is to take down large amounts of metro load and potentially cascade to large scale blackouts, especially during peak conditions. On June 11th 2009, the utility observed a disturbance followed by an extended period of low voltage in southern Oklahoma, as shown in figure 6. It appeared to be a generator trip, so it was determined from confirmation with the control center that it wasn't any of OG&E's units. Engineers then contacted interconnecting utilities to find that it wasn't any of their units either, but they also noticed the low voltage in southern Oklahoma. It turned out to be a unit at the Tolk power plant in the Texas panhandle over 300 miles away. This type of event is not detectable with current planning standards because it involves multiple contingencies across many transmission owners' systems.

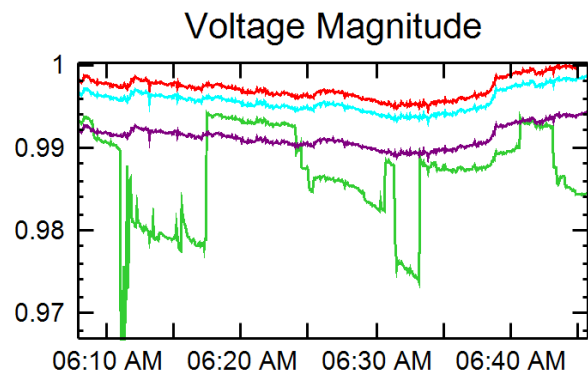
Figure 7 – Loose PT connection discovered

Another valuable use of synchrophasor data is the detection of equipment failure, most of which is not detectable by SCADA monitoring systems. Many instances have been observed where the positive sequence voltage magnitude spikes randomly or drops to 66% of nominal. These were determined to be caused by loose connections at the safety switch or terminal cabinets, loose caps on renewable fuses, animal damage to wiring, and blown potential transformer fuses. In some cases there was a protection misoperation associated with the failure. Even modern digital relays do not always detect these conditions, confusing the directional element logic or not properly declaring the loss of potential. If a particular substation has multiple bus or line PT's that are monitored, loose primary connections or failing CCVT's can also be detected since the intermittent signal problem will manifest itself on every PT at the station. The best defense against these conditions is to have field personnel dispatched as soon as the problem is identified to correct the problem and prevent protective relay misoperations. The green trace in Figure 7 shows an example of a loose PT connection at the secondary fuses.

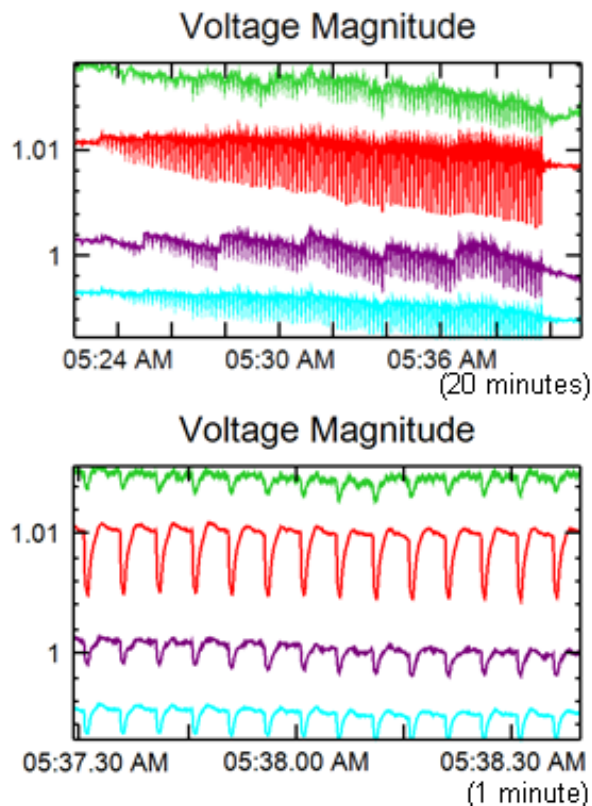
Figure 12 – Generation Unit Oscillations

Beginning shortly after bringing the first PMU's online, OG&E discovered strange voltage oscillations on the EHV system at a frequency of 0.2 Hz as shown in Figure 12. The oscillations were most pronounced at one of the PMU's near a combined cycle natural gas generation facility. The observed signal was strongest on the MVAR plot, so it was suspected to be a generation control problem. Using the snapshots of the event and the specific dates and times that it occurred, the utility contacted the power plant manager, asking if it corresponded with any of the daily plant operations. The plant manager indicated that there was indeed a correlation and found that it was being caused by a problem within a particular unit's VAR control scheme. This particular generation unit's start up procedure placed it in a VAR control mode which was subsequently switched by an operator into voltage control mode once the unit was synchronized. This switch in control mode was the trigger which stopped the oscillations. As a result the plant was able to resolve the control issues with this particular unit and prevent

further stability problems. Without the sensitive synchrophasor measurements, this anomaly would have gone undetected and could have potentially escalated into a more widespread event.

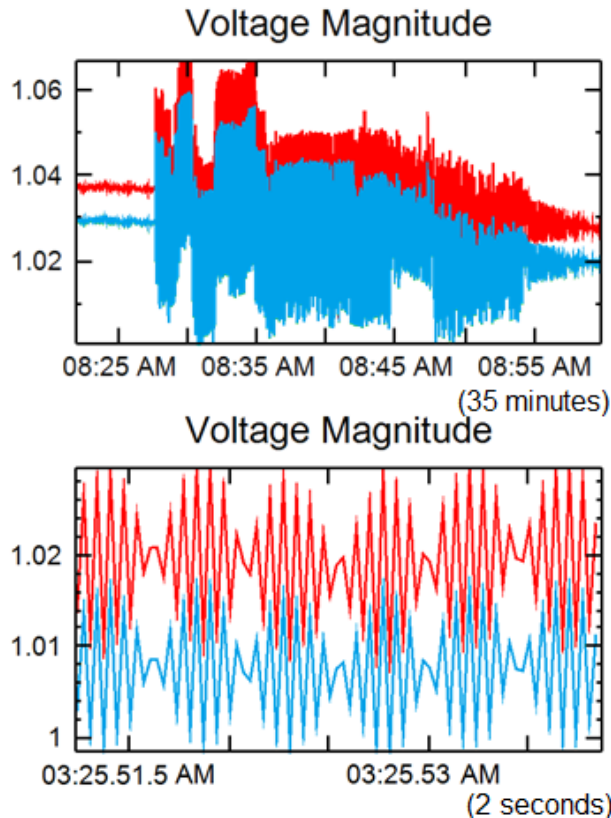
Figure 13 – Windfarm Oscillations

Each new wind farm facility brought online in OG&E's service territory is accompanied by PMU measurements at the point of interconnection. In December 2010, the utility began observing sub-synchronous oscillations on the transmission system in a concentrated portion of the grid in northwestern Oklahoma as shown in Figure 13.

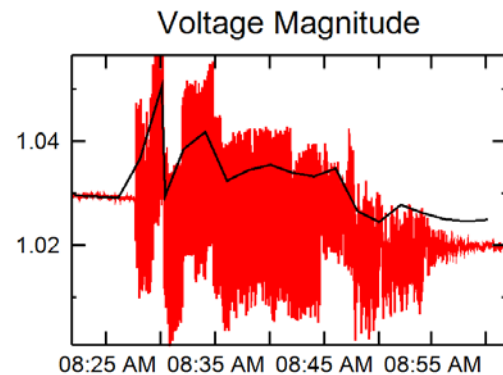
Figure 15 – Comparison of PMU and SCADA data

It is worthwhile to compare the resolution of the PMU data with SCADA measurements. For the oscillation event, engineers requested the SCADA data for the same time frame. Figure 15 shows the PMU data in red, with the black trace showing the SCADA data. The voltage oscillations were obviously not detectable with SCADA.

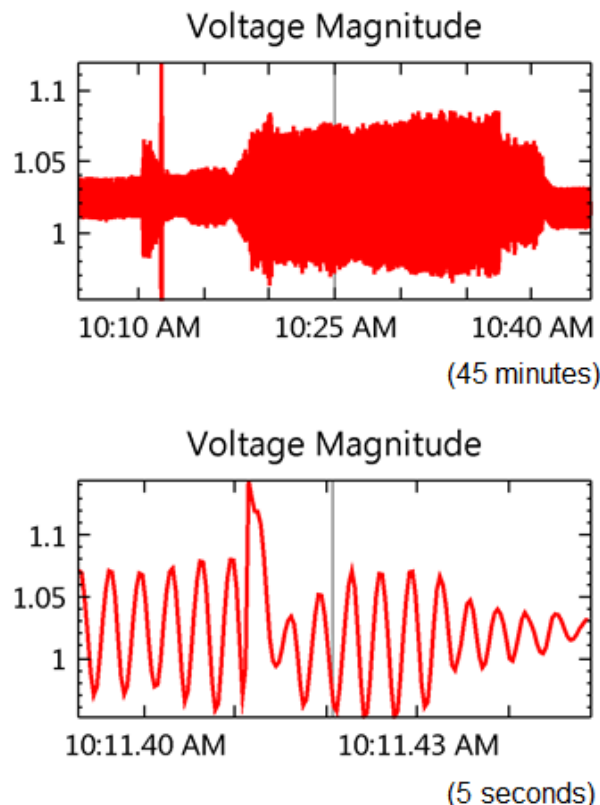
Figure 16 – New 3Hz Wind Farm Oscillation Event

The utility experienced another oscillation event at a new wind farm that was recently placed into service. In December of 2012 a line outage caused a major oscillation at a new 60MW wind farm interconnected at 69kV. The voltage variations were as high as 18% at a frequency of 3Hz as shown in Figure 16. It took about a half an hour to curtail the plant and restore the system to normal operation. The event adversely affected the operations at a nearby large industrial customer. The utility collaborated with the manufacturer to devise a solution that is currently undergoing testing.

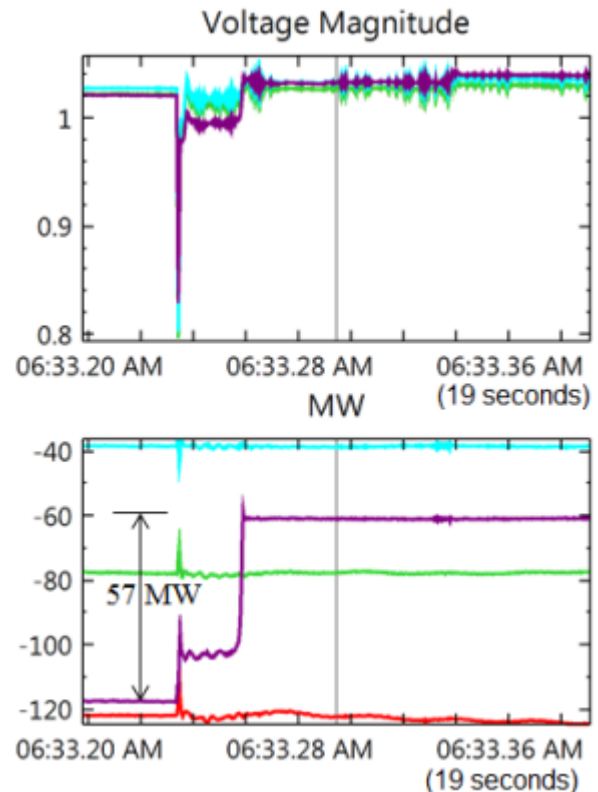
Figure 17 – Monitor Wind Farm Low Voltage Ride Through

The loss of the second line caused the wind farms to begin oscillating and it persisted for about a half an hour until the plant's output was curtailed. During this fault event, the voltage pull down was about 80% for 5 cycles, which is typical for a 138kV line with communications.

However, one of the area wind plants lost about 57MW when the fault occurred as shown in Figure 17.

The turbine's low voltage ride through capability should have been able to handle this grid disturbance. However there have been several other instances of ride through failure at other wind facilities as well. This remains something to watch out for as the wind penetration increases throughout the service territory.

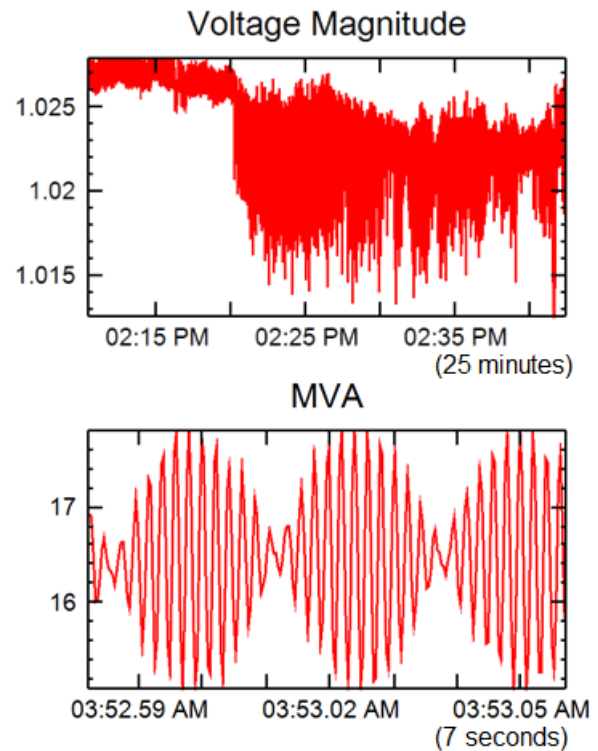
Figure 19 – Monitoring Power Quality

Besides the known customer impact due to voltage oscillations, the synchrophasor data can also be used for monitoring power quality. It has been observed that large industrial loads can inject noise onto the transmission system that is visible on the voltage, current, and frequency waveforms. The first waveform in Figure 19 shows the beginning of an arc furnace burn

as seen by the 161kV bus at an adjacent substation. The second waveform shows the load characteristic of a refinery injecting sub-harmonics at 4.62 and 5.0 Hz. Synchrophasors allow for real time power quality monitoring that cannot be observed by SCADA or DFRs.

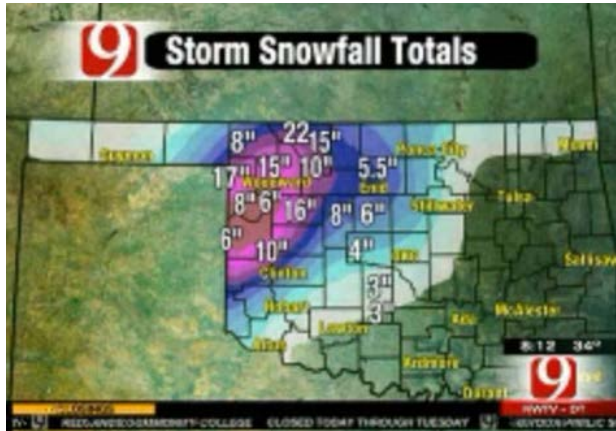
Figure 20 – Major Winter Storm Event

A severe winter storm moved into northwest Oklahoma on February 25, 2013 dumping as much as 22 inches of heavy wet snow as shown in Figure 20. Numerous line outages occurred during the storm, which progressed throughout the day. With synchrophasor data, the utility was able to see the system weaken as lines locked out. The following figures show the progression of the event with voltage angles in northwest Oklahoma referenced to Oklahoma City.

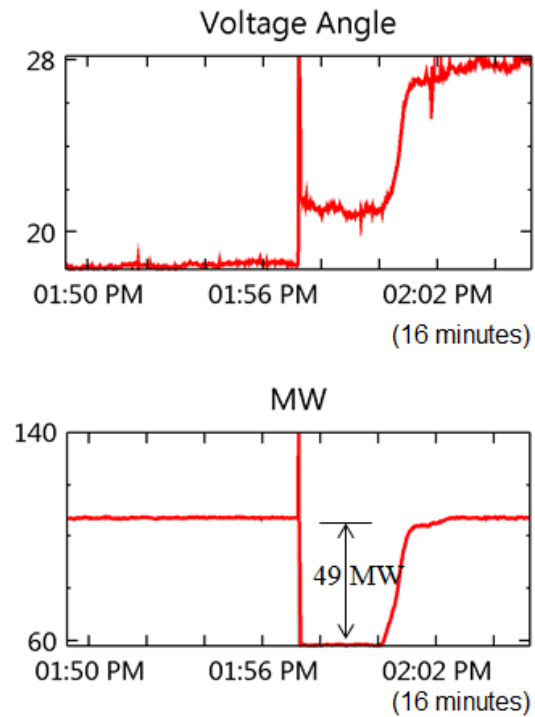
Figure 22 – 345kV Tatonga Line Trips

At 1:57PM the 345kV Northwest-Tatonga line trips out, which is the major tie line to northwest Oklahoma. The voltage angle at Centennial prior to the fault is 18 degrees leading, and it increases to 28 degrees after the line locks out as shown in Figure 22. The increase in angle suggests that there is excess generation in northwest Oklahoma that is being exported to the larger load pockets in the south and east. The Centennial wind farm displayed partial failure of the low voltage ride through as 49MW was lost for several minutes and then restored.

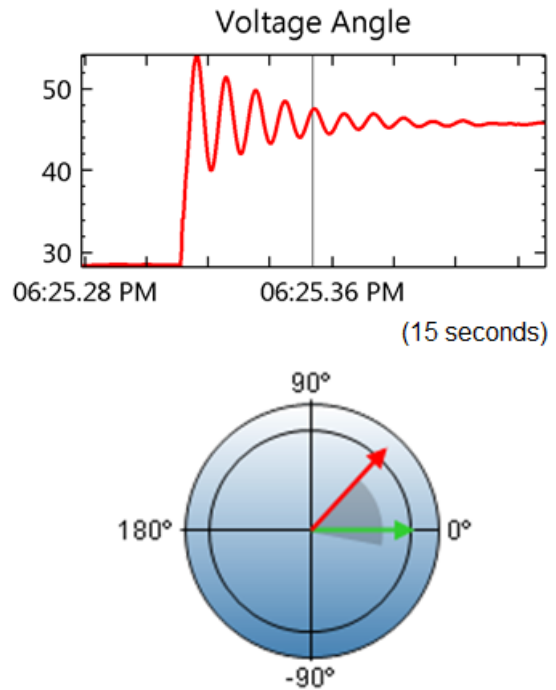
Figure 24 - Dewey - El Reno Line Trips

At 6:25PM the 138kV Dewey – El Reno line trips and the voltage angle moves from 28 to 46 degrees as shown in Figure 24. The line automatically reclosed from El Reno on the Oklahoma City side but the angle is beyond the sync check of 30° for hot line in phase reclosing at Dewey. The ring down period is extended to about 10 seconds, showing the system becoming weaker with the line outage.

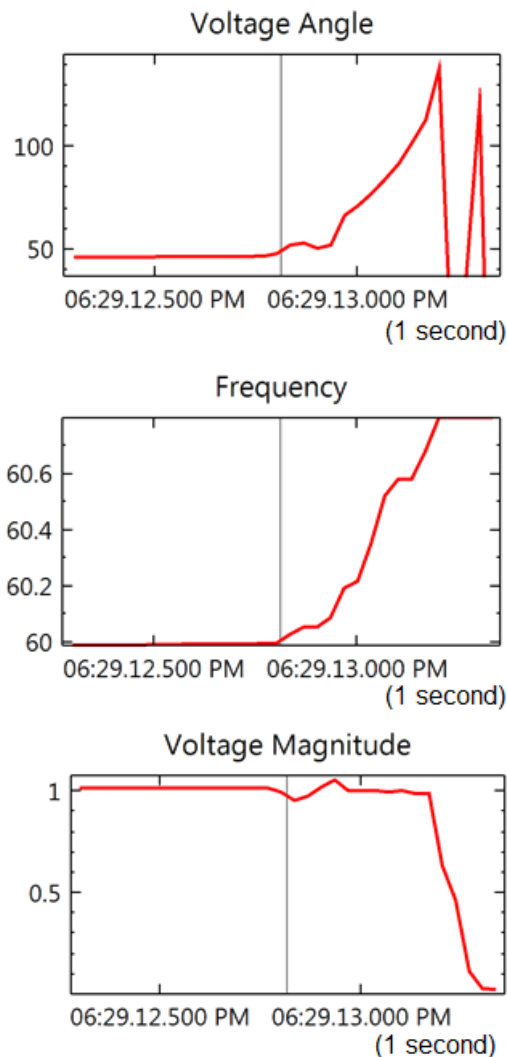
Figure 25 – 138kV South 4th St – Imo Line Trips

At 6:29PM the 138kV South 4th Street – Imo line trips. The system is unable to cope with the excess generation and the frequency immediately begins to ramp up. The voltage angle increases from 46 to 136 degrees as the voltage collapses. It only took 0.6 seconds from the time the last fault occurred until the load pocket was in the dark. Interestingly enough since the 138kV Dewey – El Reno line was hot from the Oklahoma City side, the automatic hot line-dead bus reclosing was able to restore the island within 20 seconds. With the wind farms then offline, the northwest Oklahoma area load was able to be picked up from the lines that reclosed.
