TVA Solar Commissioning Experience

September 28, 2022

Jonathan Sides, PE

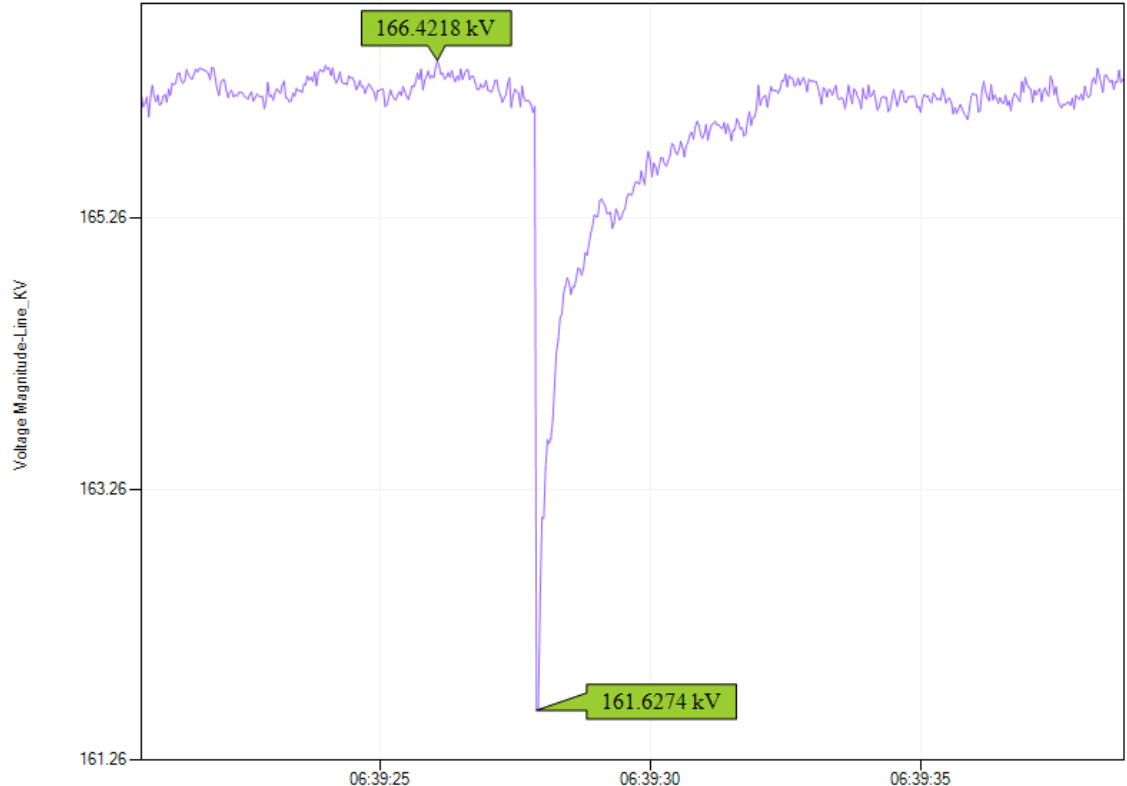
Part 1: Voltage Flicker Test

- Purpose: To ensure the Facility is designed and operated so the energization of the Main Step-Up Transformer will not induce a voltage sag on the TVA transmission system exceeding 5%.
- Testing: Energize main power transformer and energize one secondary collector system transformer at a time until all secondary transformers are energized.

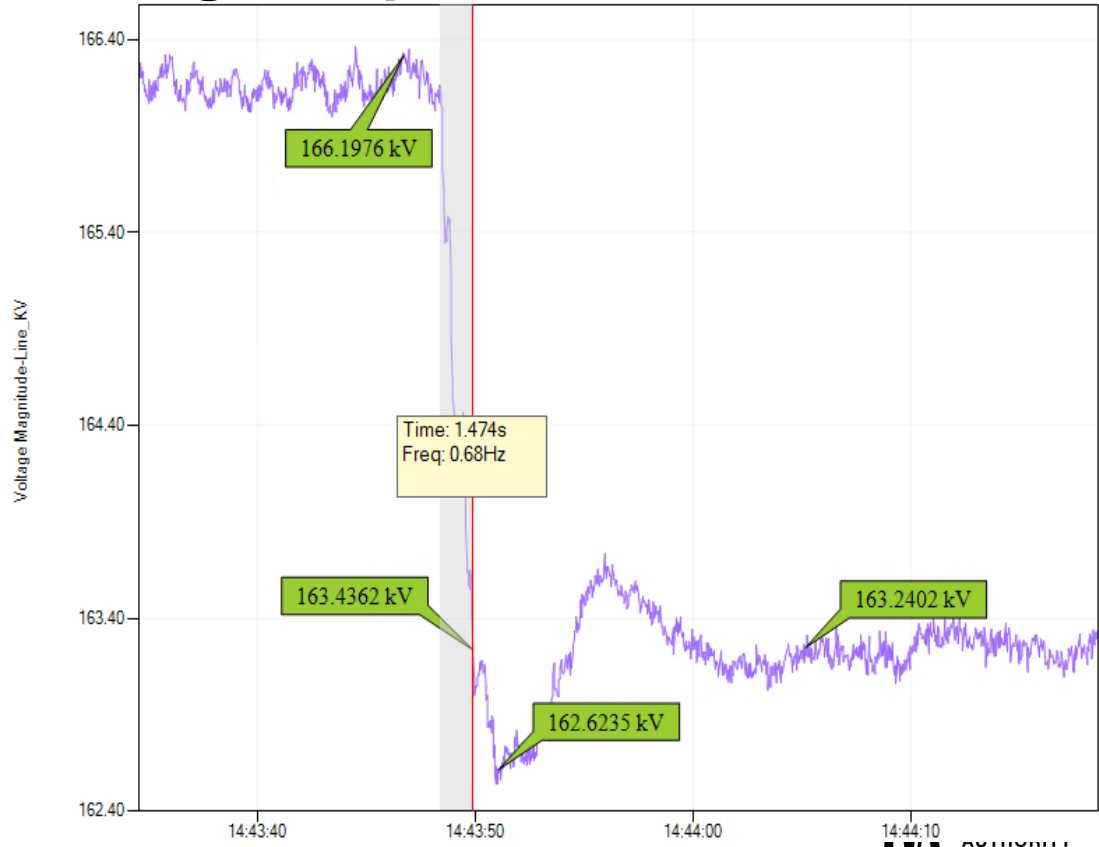
Part 2: Voltage Step Test

- Purpose: Verify the Facility's voltage regulation equipment is sufficient to prevent causing excessive voltage variation on the TVA transmission system.
- Testing: Adjust the automatic voltage regulator set point 4kV above and below the initial set point and verify the voltage control response is less than two seconds for weak system conditions and should not exceed thirty seconds for the all ties closed condition.
- Overshoot is measured to verify that damping ratio is sufficient

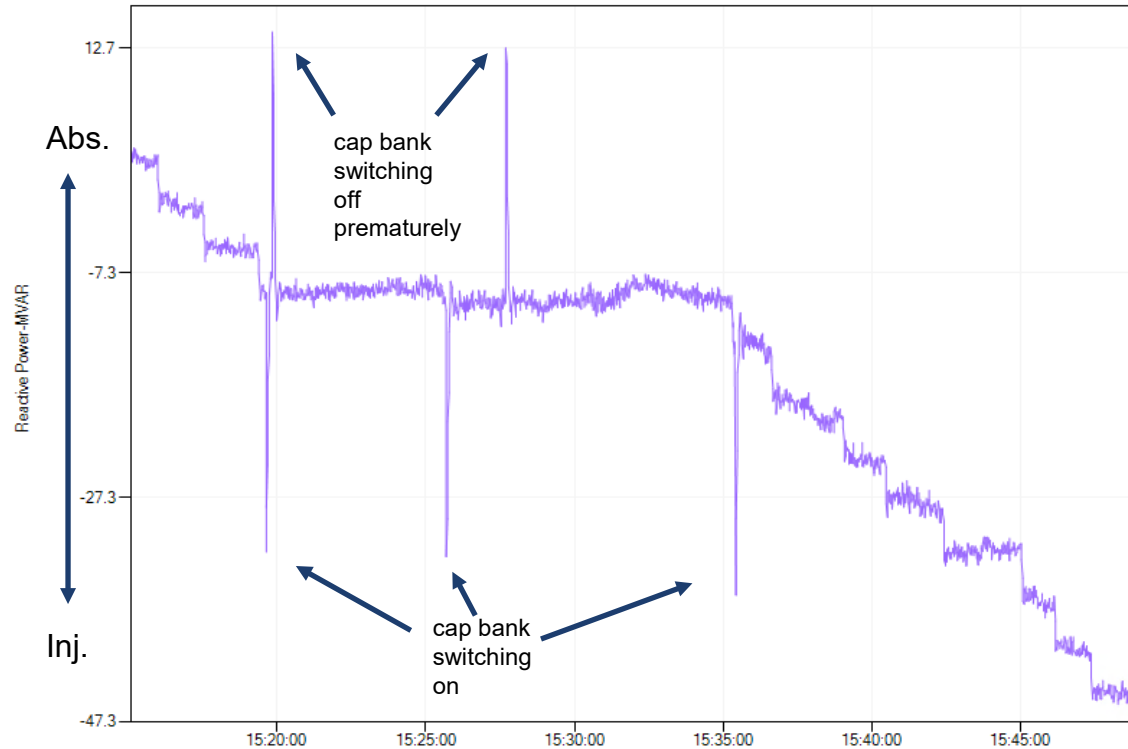
Part 3: Reactive Capability Test

- Purpose: Demonstrate the Facility can provide dynamic reactive power within the range of 0.95 lagging to 0.95 leading at the generator bus at continuous rated power output.
- Testing: Adjust the voltage set point of the Facility in increments of 0.5kV until the required reactive power output/absorption is met.

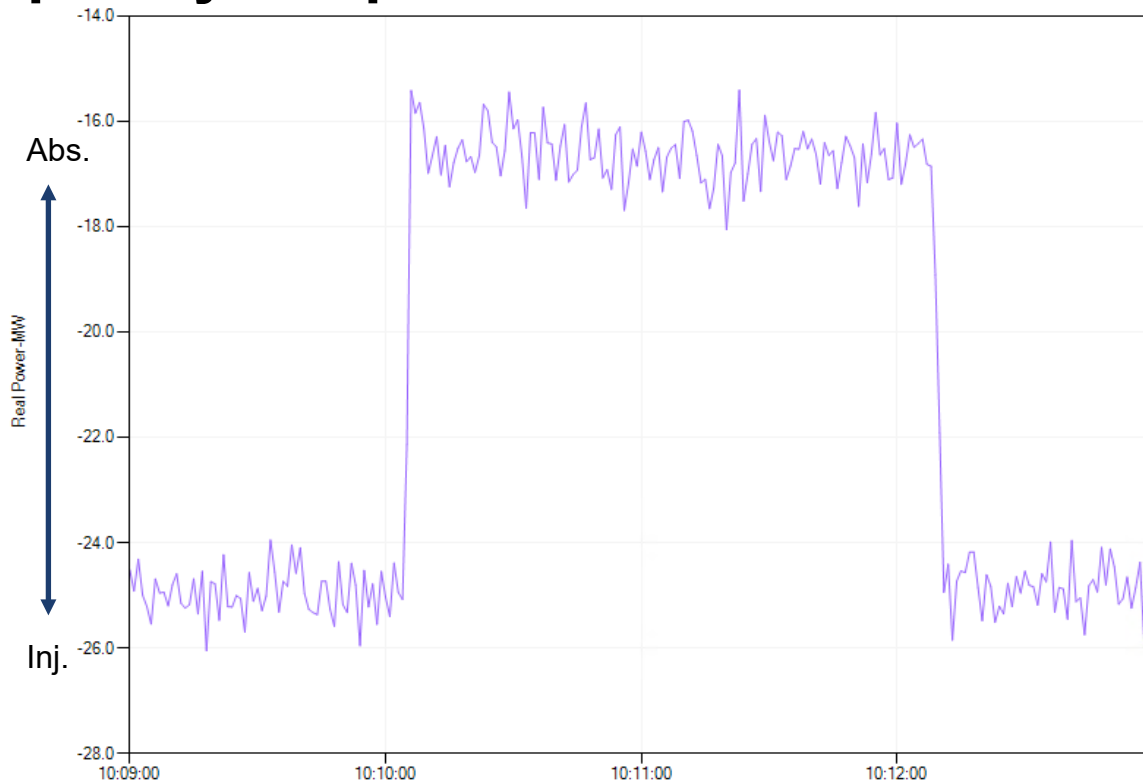
Part 4: Frequency Response Test

- Purpose: Show the Facility can autonomously adjust the real power output within the droop and dead band parameters in the direction needed to correct frequency deviations.
- Testing: Adjust frequency offset to simulate a frequency mismatch between the Facility and the TVA transmission system and measure the real output response. Initiate a loss a communication to some of the inverters, adjust the frequency offset and measure the real power output response.
- Overshoot is measured to verify that damping ratio is sufficient.

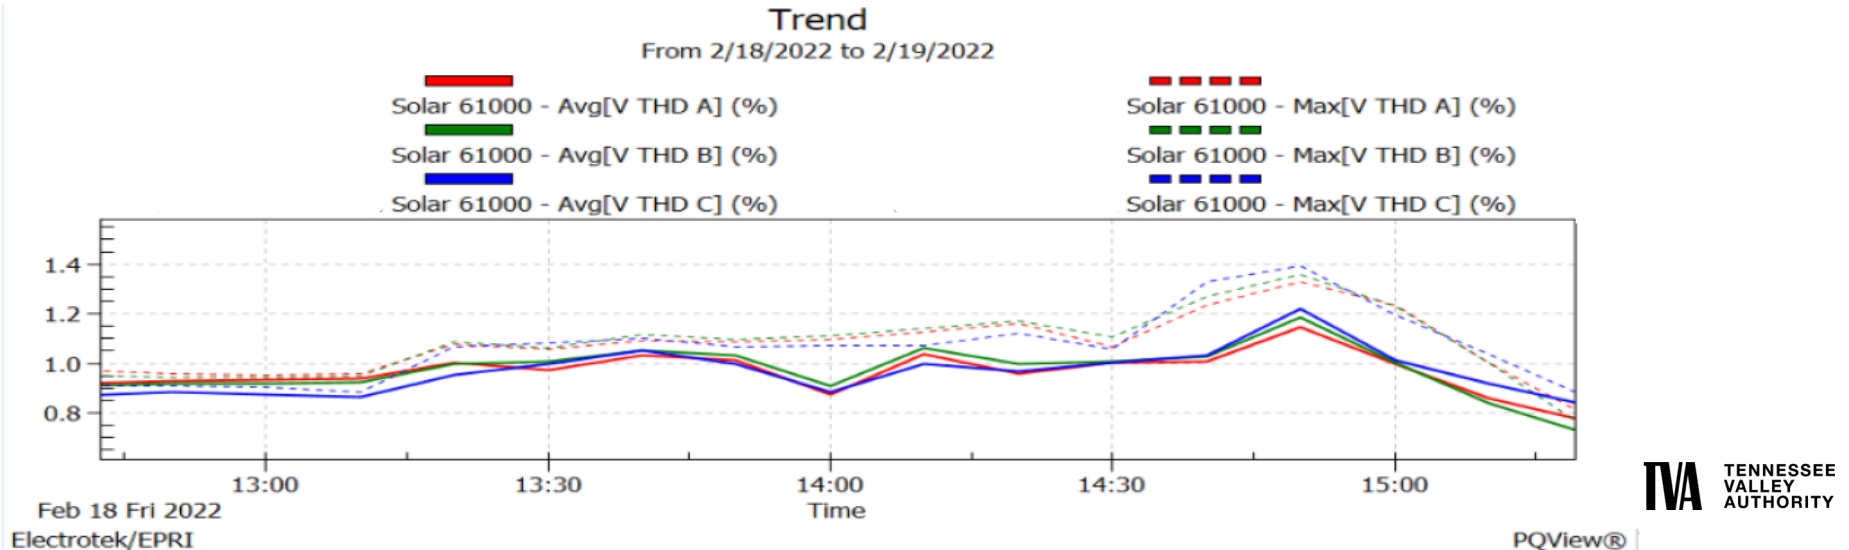
Part 5: Distortion Test

- Purpose: Validate the Facility's production of total harmonic distortion and individual harmonic distortion injected into the TVA transmission system is below the levels specified in IEEE 519.
- Testing: Switch in local and remote capacitor banks and record the harmonic distortion measured at the point of interconnection.
